CIRCULAR DOOR KNOCKER STRIKING PLATE - CU ALLOY - MODERN TIMES - SWITZERLAND

Artefact name Circular door knocker striking plate

Authors Marianne. Senn (EMPA, Dübendorf, Zurich, Switzerland) & Christian. Degrigny (HE-Arc CR, Neuchâtel, Neuchâtel,

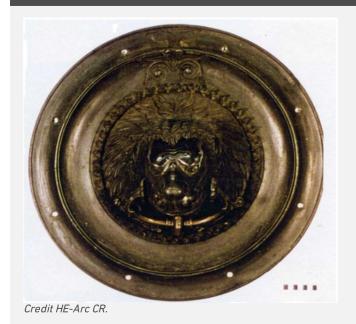
Fig. 1: Circular base from a door knocker (after Benoît, 1994),

Description of the artefact Circular base no 2 (from a set of two) of a door knocker with a protruding lion head holding a hinge in his

fangs, Ø.ext = 64cm. The circular base is covered by a gilded (?) decorative relief (Fig. 1, Benoit, 1994, 6).

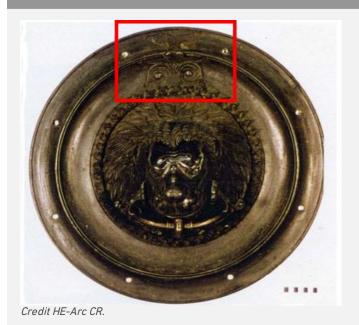
Fig. 2: Possible location of sampling area,

Description of sampleNo information is given on where the sample has been taken. A supposed location is however illustrated in

Fig. 2. The polished sample shows a well preserved metal surface with some cracks covered by a thin

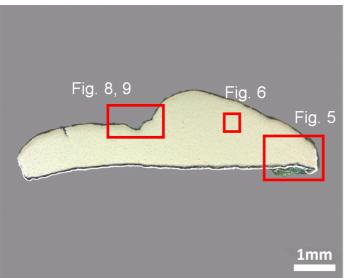
Fig. 3: Micrograph of the cross-section of the sample taken from the circular base showing the location of Figs. 5 to 6 and 8 to 9, $\,$

corrosion crust (Fig. 3).

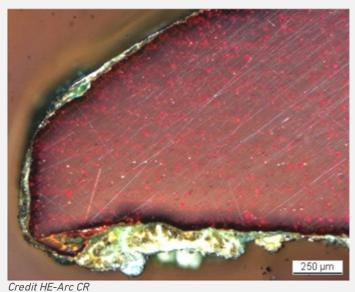
Fig. 5: Micrograph of the metal sample from Fig. 3 (reversed picture), unetched, polarised light. The red copper oxide inclusions form rows in the copper alloy matrix.,

The average thickness of the corrosion crust is about $90\mu m$, but may be thinner or thicker depending on the area of origin (Fig. 5). Under polarized light, we observe a multilayer system with a dense and thin inner red corrosion layer (CP2, probably cuprite/Cu20) on the metal (Fig. 8) containing chlorides (Fig. 9 and Table 3). This is followed by bands of heterogeneous green corrosion products (CP1, possibly copper chloride / sulphate / carbonate). This outer corrosion layer is contaminated with atmospheric components (Si, Al, Cl, C and O and perhaps gypsum particles (CaSO4)) (Fig. 9).

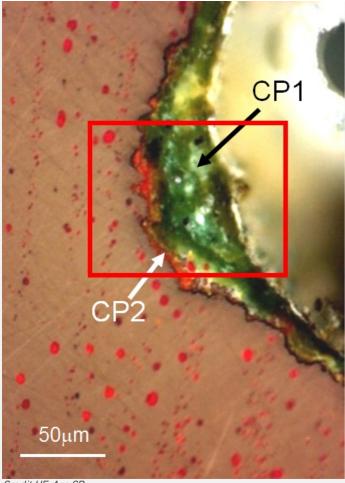
Fig. 8: Micrograph of the metal sample from Fig. 3 (rotated by 90°) and corresponding to the stratigraphy of Fig. 4, polarised light. Metal with red copper oxide inclusions. The black particles in the green corrosion layer are quartz inclusions. The area selected for elemental chemical distribution (Fig. 9) is marked by a red rectangle,

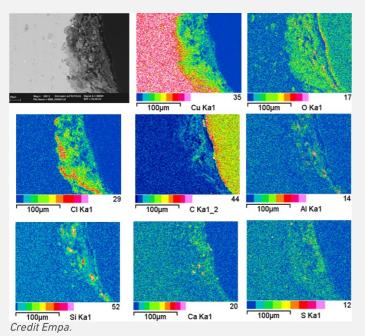
Table 2: Chemical composition (mass %) of the inclusions (light-grey and white in Fig. 9) in the metal. Method of analysis: SEM/EDS, Laboratory of Analytical Chemistry, Empa.

Fig. 9: SEM image, BSE-mode, and elemental chemical distribution of the selected area of Fig. 8. Method of examination: SEM/EDS, Laboratory of Analytical Chemistry, Empa,
