CIRCULAR DOOR KNOCKER STRIKING PLATE - CU ALLOY - MODERN TIMES - SWITZERLAND

Artefact name Circular door knocker striking plate

Authors Marianne. Senn (EMPA, Dübendorf, Zurich, Switzerland) & Christian. Degrigny (HE-Arc CR, Neuchâtel, Neuchâtel, Switzerland)

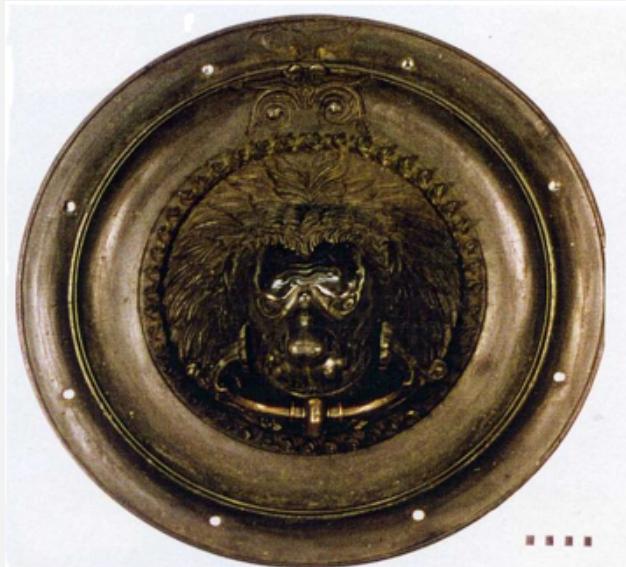
Fig. 1: Circular base from a door knocker (after Benoît, 1994),

Description of the artefact Circular base no 2 (from a set of two) of a door knocker with a protruding lion head holding a hinge in his fangs, Ø.ext = 64cm. The circular base is covered by a gilded (?) decorative relief (Fig. 1, Benoit, 1994, 6).

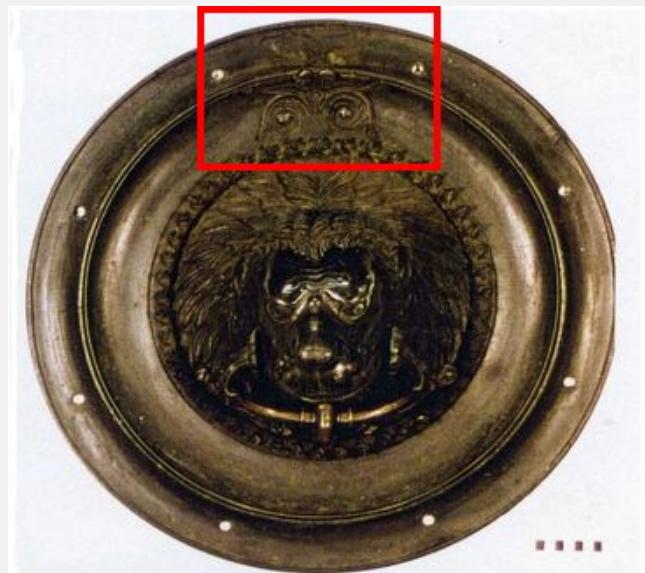
Fig. 2: Possible location of sampling area,

No information is given on where the sample has been taken. A supposed location is however illustrated in Fig. 2. The polished sample shows a well preserved metal surface with some cracks covered by a thin corrosion crust (Fig. 3).

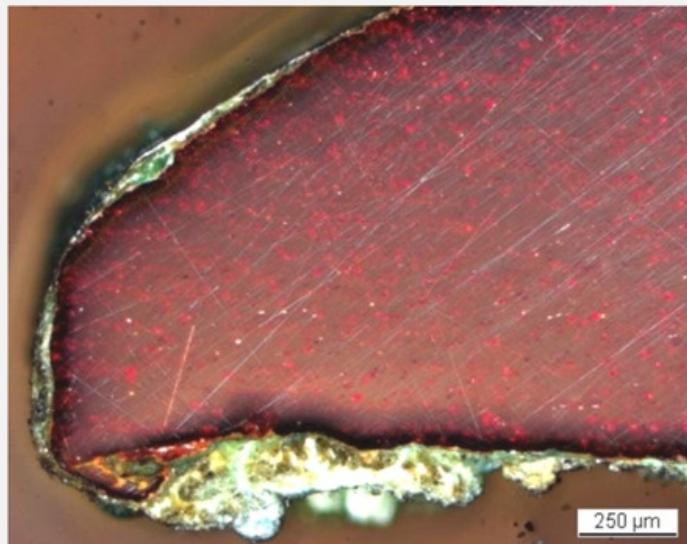
red (Figs. 5 and 8) while with SEM in BSE-mode they look light-grey (Fig. 9). Heavy metals inclusions appear white with SEM (BSE-mode, Fig. 9). Due to the rolling process the copper oxide inclusions are parallel to the longitudinal orientation of the sample (Figs. 5 and 6). They were identified as cuprite by Raman spectroscopy (Fig. 7). The etched alloy shows a structure of polygonal grains with annealing twins (Fig. 6). The grain size is variable. The average hardness of the alloy is HV1 80, which is quite high compared to the average hardness of a pure annealed copper of around HV1 40-50 (Schumann 1991, 627).

Fig. 5: Micrograph of the metal sample from Fig. 3 (reversed picture), unetched, polarised light. The red copper oxide inclusions form rows in the copper alloy matrix..

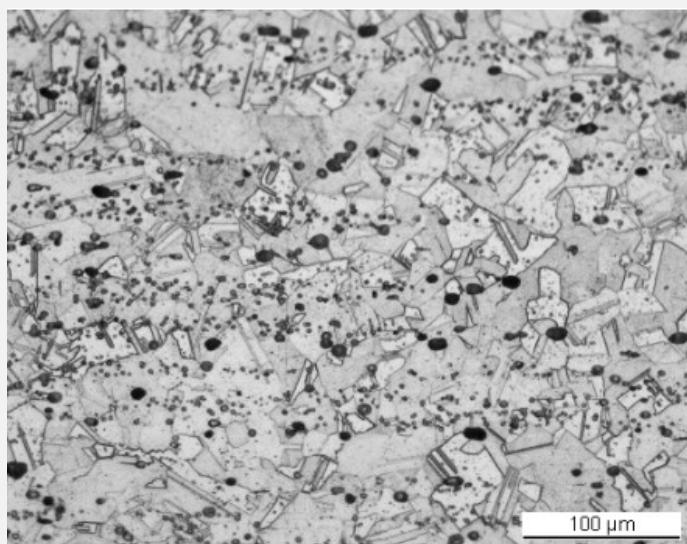
Fig. 6: Micrograph of the metal sample from Fig. 3 (detail), etched, bright field. The metal shows a structure of polygonal and twinned grains. Copper oxide inclusions are visible as dark spots,

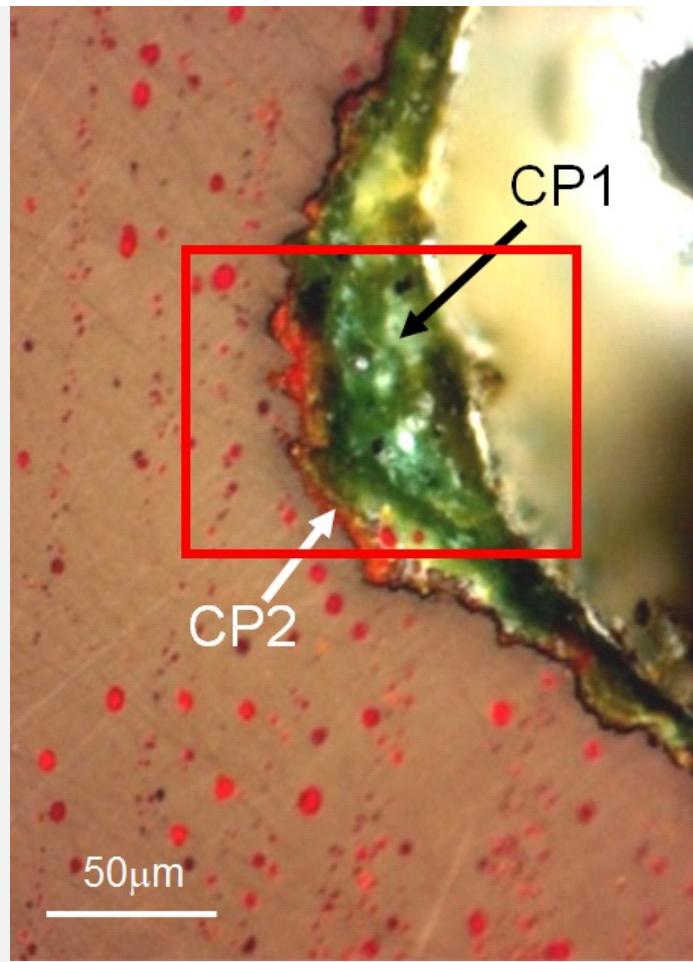
The average thickness of the corrosion crust is about 90µm, but may be thinner or thicker depending on the area of origin (Fig. 5). Under polarized light, we observe a multilayer system with a dense and thin inner red corrosion layer (CP2, probably cuprite/Cu₂O) on the metal (Fig. 8) containing chlorides (Fig. 9 and Table 3). This is followed by bands of heterogeneous green corrosion products (CP1, possibly copper chloride / sulphate / carbonate). This outer corrosion layer is contaminated with atmospheric components (Si, Al, Cl, C and O and perhaps gypsum particles (CaSO₄) (Fig. 9).

Fig. 8: Micrograph of the metal sample from Fig. 3 (rotated by 90°) and corresponding to the stratigraphy of Fig. 4, polarised light. Metal with red copper oxide inclusions. The black particles in the green corrosion layer are quartz inclusions. The area selected for elemental chemical distribution (Fig. 9) is marked by a red rectangle,
