SHINGLE OF A ROOF – CU ALLOY – MODERN TIMES – SWITZERLAND

Artefact name	Shingle of a roof
Authors	Marianne. Senn (EMPA, Dübendorf, Zurich, Switzerland) & Christian. Degriigny (HE-Arc CR, Neuchâtel, Neuchâtel, Switzerland)
Url	/artefacts/688/

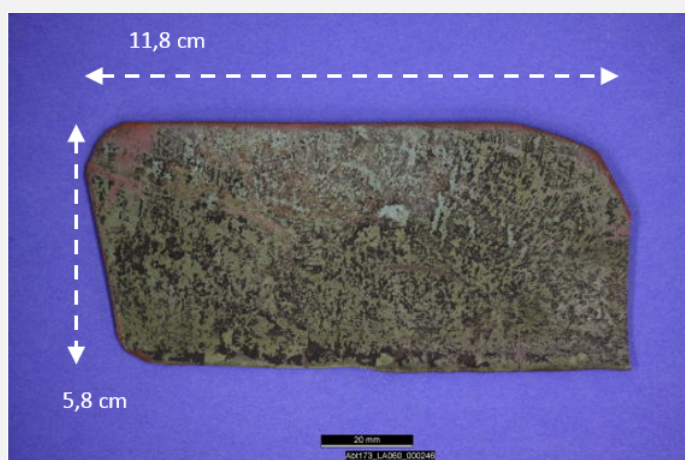
Fig. 1: Shingle of a roof, internal side,

Description of the artefact	Shingle, slightly curved, the internal side is covered with heterogeneously distributed green and black corrosion products (Fig. 1). The external side shows a regular dark green corrosion crust. Dimensions: L = 11.8cm; W = 5.8cm.
Type of artefact	Architectural element
Origin	Roof of the Abbey of St Gallen, Sankt Gallen, Saint Gallen, Switzerland
Recovering date	None
Chronology category	Modern Times
chronology tpq	<input type="text" value="1780"/> A.D. ▼
chronology taq	<input type="text" value="----"/> ▼
Chronology comment	
Burial conditions / environment	Outdoor atmosphere
Artefact location	Conservation Department of the Musées d'art et d'histoire, Genève, Geneva
Owner	Abbey of St Gallen, Sankt Gallen, Saint Gallen

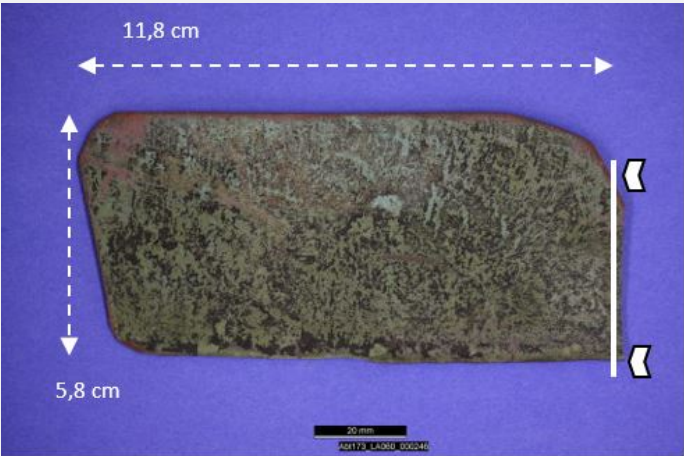
Fig. 2: showing the location of sampling area,

Two samples were taken (Fig. 2). The polished samples show a well-preserved metal surface with a thin corrosion crust (Fig. 3). T = 0.5mm.

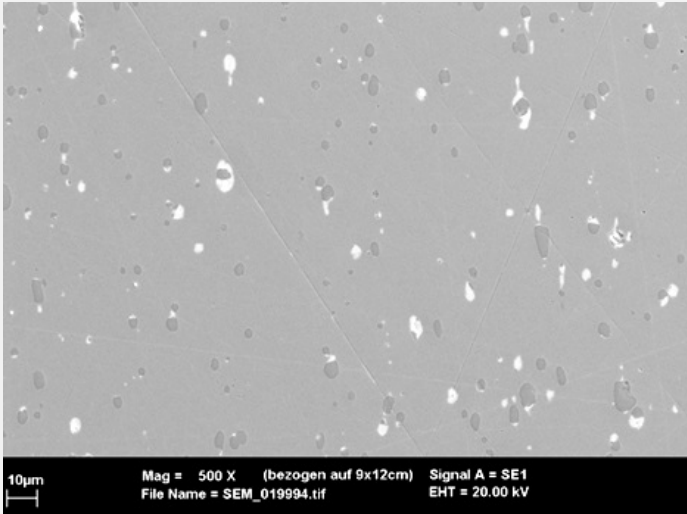
The remaining metal is a copper alloy (Table 1). The evenly distributed inclusions observed under SEM, SE-mode, are either light-grey or white (Fig. 5). The oval shape of the light-grey inclusions is due to deformation, probably by hot rolling (a common technique in the 18th century). Under polarised light they look red (Fig. 7) and their analysis reveals a composition similar to cuprite/Cu₂O (Table 2). The white inclusions are rich in Pb and are remnants of the refining process (Table 2). The etched copper shows a structure of polygonal and twinned grains (Fig. 6). The grain size is variable. The average hardness of the metal is about HV1 70.

Elements	O	Cu	Pb	As	Sb	Total
Light-grey inclusion	9.8	86	<	<	<	96
White inclusion	9	9.1	68	5.1	2.6	94

Table 2: Chemical composition (mass %) of the inclusions in the metal (from Fig. 5). Method of analysis: SEM/EDS, Laboratory of Analytical Chemistry, Empa.

Fig. 5: SEM image, SE-mode, of the metal sample from Fig. 3 (detail). Light-grey and white inclusions are distributed evenly,

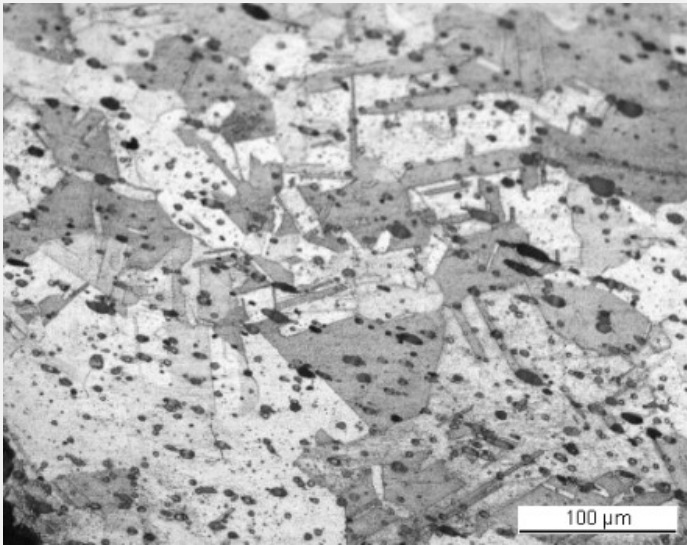
Microstructure	Polygonal and twinned grains, elongated inclusions
First metal element	Cu
Other metal elements	Pb

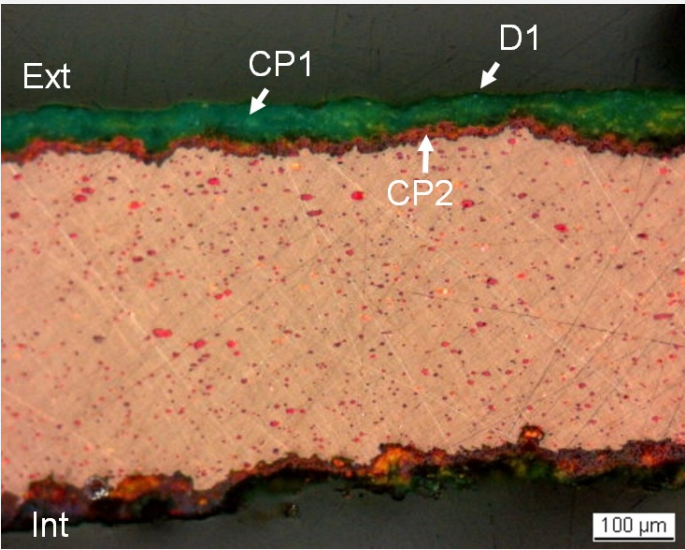
The corrosion crusts of the external and internal sides are distinctively different (Fig. 7). On the internal side an irregular red-orange corrosion layer has developed, and pitting corrosion has occurred. The more uniform corrosion layers on the external side are composed of a red-orange layer, followed by a thicker green outer layer. In some areas, dark-red corrosion products can be observed between the green and red-orange sub-layers. The same dark-red sub-layer can be seen in areas on the internal side covering the red-orange corrosion products. The red-orange corrosion layer on both sides (CP2) has a chemical composition similar to cuprite/ Cu_2O , while the green layer on the external side (CP1) contains Cu, S and O and is enriched on its upper surface with Si (Table 3 and Fig. 8). XRD analysis of the corrosion products on the external side of another shingle fragment from the same roof identified brochantite/ $\text{Cu}_4\text{SO}_4(\text{OH})_6$ and cuprite as corrosion products (Rapport d'analyse no. MAH 98-257). These results are confirmed by Raman spectroscopy of the external side of this sample where the same compounds were clearly identified (Figs. 9 and 10).

Fig. 7: Micrograph of the metal sample from Fig. 3 and corresponding to the stratigraphy of Fig. 4, polarised light. External side: the regular corrosion crust with outer green, inner red-orange corrosion products and intermediate dark-red corrosion products. Internal side: the irregular corrosion crust with inner red-orange and outer dark-red corrosion products,

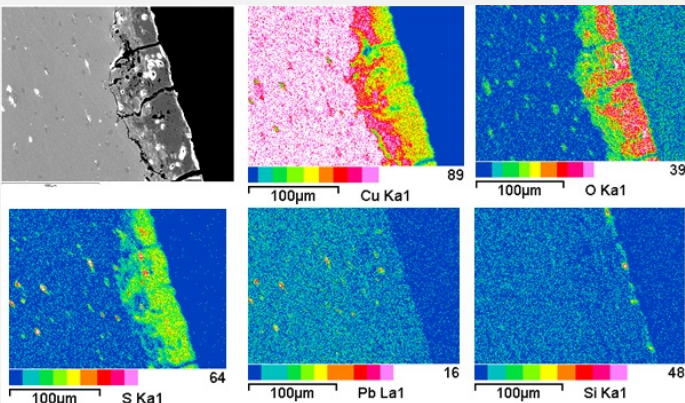
Fig. 8: SEM image, SE-mode, and elemental chemical distribution of the selected area of Fig. 3 (rotated image, detail). Method of examination: SEM/EDS, Laboratory of Analytical Chemistry, Empa,

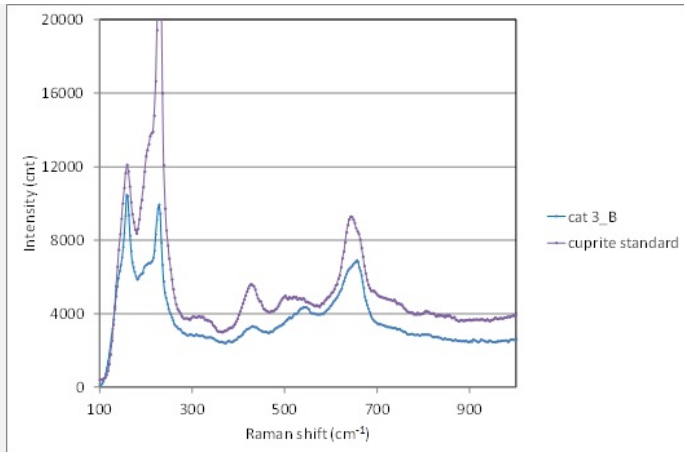
Fig. 9: Raman spectrum of the red-orange inner corrosion layer (CP2) of the external side (cat3_B) compared to a cuprite standard spectrum. Settings: laser wavelength 532nm, acquisition time 100s, one accumulation, filter D2 (0.75-0.8 mW), hole 500, slit 80, grating 600. Method of analysis: Raman spectroscopy, Lab Swiss National Museum, Affoltern a. Albis ZH,

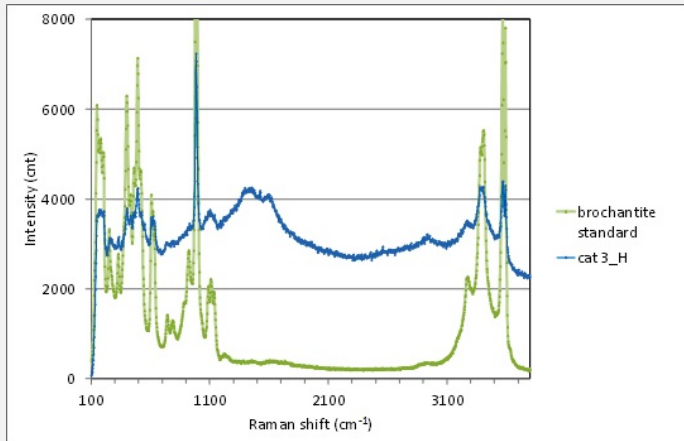
Fig. 10: Raman spectrum of the green outer corrosion layer (CP1) of the external side (cat3_H) compared to a brochantite standard spectrum. Settings: laser wavelength 532nm, acquisition time 100s, one accumulation, filter D2 (0.75-0.8 mW), hole 500, slit 80, grating 600. The peak indicated with an arrow on the cat3_H spectrum is due to fluorescence. Method of analysis: Raman spectroscopy, Lab Swiss National Museum, Affoltern a. Albis ZH,
