SHINGLE OF A ROOF – CU ALLOY – MODERN TIMES – SWITZERLAND

Artefact name	Shingle of a roof
Authors	Marianne. Senn (EMPA, Dübendorf, Zurich, Switzerland) & Christian. Degriany (HE-Arc CR, Neuchâtel, Neuchâtel, Switzerland)
Url	/artefacts/688/

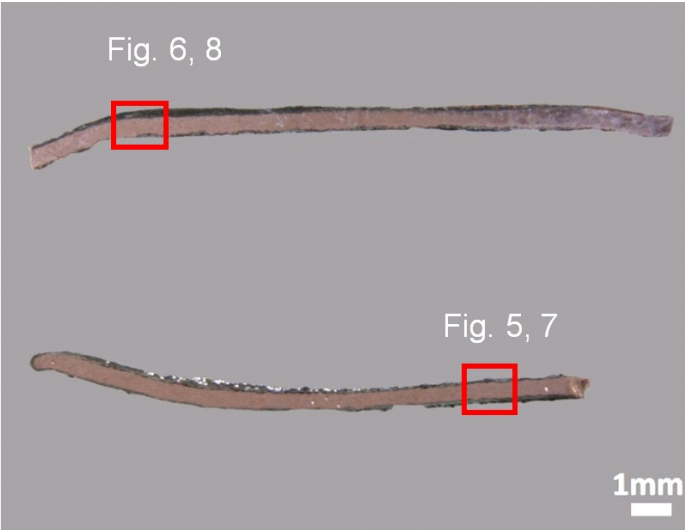
Fig. 3: Micrograph of the cross-sections of the sample taken from the shingle showing the location of Figs. 5 to 8,

Description of sample	Two samples were taken (Fig. 2). The polished samples show a well-preserved metal surface with a thin corrosion crust (Fig. 3). T = 0.5mm.
Alloy	Cu Alloy
Technology	Rolled (probably hot rolling) and annealed
Lab number of sample	MAH-98-257
Sample location	Empa (Marianne Senn)
Responsible institution	Conservation Department of the Musées d'art et d'histoire, Genève, Geneva
Date and aim of sampling	2009, integration of sample to the MIFAC-Métal project

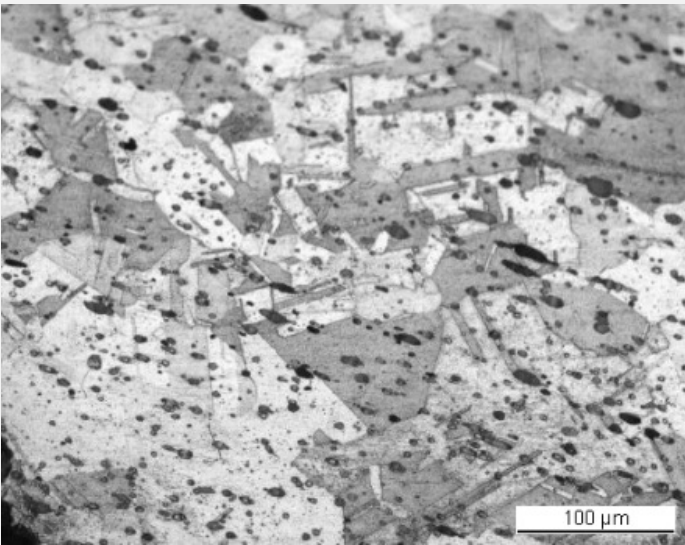
Fig. 6: Micrograph of the metal sample from Fig. 3 (detail), etched, bright field. The metal shows a structure of polygonal and twinned grains. Cuprite inclusions appear as dark spots,

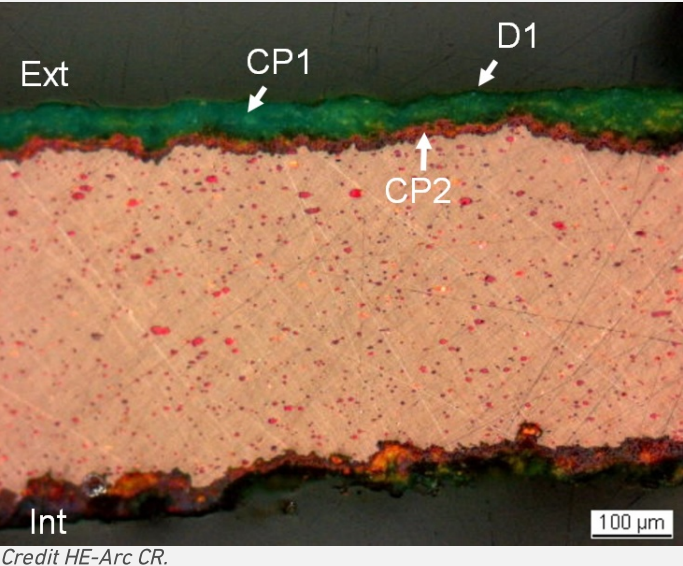
The corrosion crusts of the external and internal sides are distinctively different (Fig. 7). On the internal side an irregular red-orange corrosion layer has developed, and pitting corrosion has occurred. The more uniform corrosion layers on the external side are composed of a red-orange layer, followed by a thicker green outer layer. In some areas, dark-red corrosion products can be observed between the green and red-orange sub-layers. The same dark-red sub-layer can be seen in areas on the internal side covering the red-orange corrosion products. The red-orange corrosion layer on both sides (CP2) has a chemical composition similar to cuprite/ Cu_2O , while the green layer on the external side (CP1) contains Cu, S and O and is enriched on its upper surface with Si (Table 3 and Fig. 8). XRD analysis of the corrosion products on the external side of another shingle fragment from the same roof identified brochantite/ $\text{Cu}_4\text{SO}_4(\text{OH})_6$ and cuprite as corrosion products (Rapport d'analyse no. MAH 98-257). These results are confirmed by Raman spectroscopy of the external side of this sample where the same compounds were clearly identified (Figs. 9 and 10).

Fig. 7: Micrograph of the metal sample from Fig. 3 and corresponding to the stratigraphy of Fig. 4, polarised light. External side: the regular corrosion crust with outer green, inner red-orange corrosion products and intermediate dark-red corrosion products. Internal side: the irregular corrosion crust with inner red-orange and outer dark-red corrosion products,

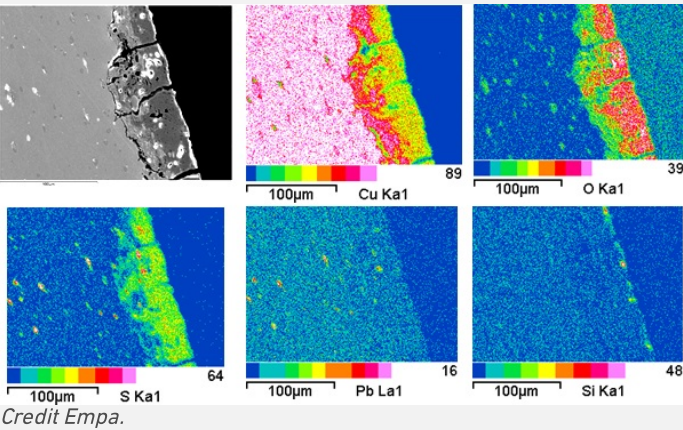
Fig. 8: SEM image, SE-mode, and elemental chemical distribution of the selected area of Fig. 3 (rotated image, detail). Method of examination: SEM/EDS, Laboratory of Analytical Chemistry, Empa,

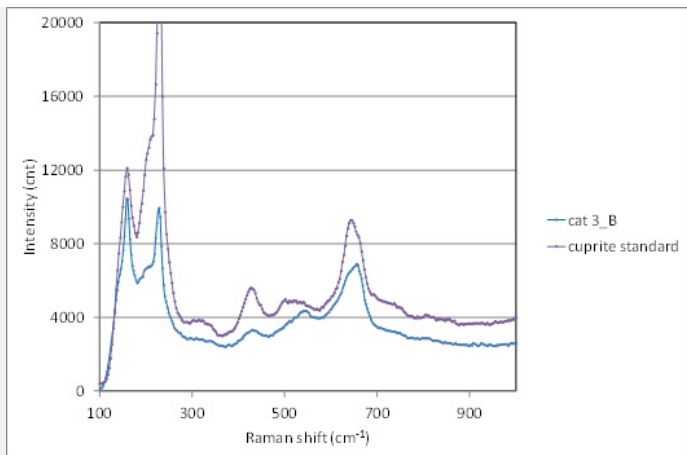
Fig. 9: Raman spectrum of the red-orange inner corrosion layer (CP2) of the external side (cat3_B) compared to a cuprite standard spectrum. Settings: laser wavelength 532nm, acquisition time 100s, one accumulation, filter D2 (0.75-0.8 mW), hole 500, slit 80, grating 600. Method of analysis: Raman spectroscopy, Lab Swiss National Museum, Affoltern a. Albis ZH,

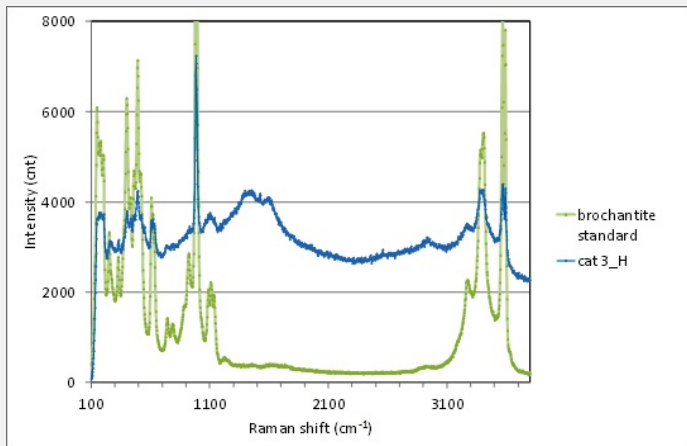
Fig. 10: Raman spectrum of the green outer corrosion layer (CP1) of the external side (cat3_H) compared to a brochantite standard spectrum. Settings: laser wavelength 532nm, acquisition time 100s, one accumulation, filter D2 (0.75-0.8 mW), hole 500, slit 80, grating 600. The peak indicated with an arrow on the cat3_H spectrum is due to fluorescence. Method of analysis: Raman spectroscopy, Lab Swiss National Museum, Affoltern a. Albis ZH,

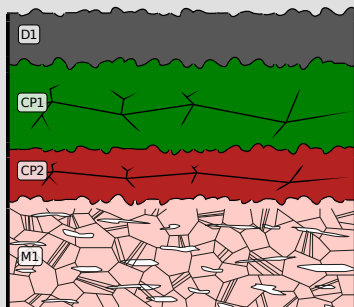
Fig. 4: Stratigraphic representation of the sample taken from the shingle in cross-section (dark field) using the MiCorr application. The characteristics of the strata are only accessible by clicking on the drawing that redirects you to the search tool by stratigraphy representation. This representation can be compared to Fig. 7, Credit HE-Arc CR.
