TANG FRAGMENT OF A KNIFE HR-6246 - TIN BRONZE - LATE BRONZE AGE - SWITZERLAND

Artefact name	Tang fragment of a knife HR-6246
Authors	Marianne. Senn (EMPA, Dübendorf, Zurich, Switzerland) & Christian. Degriigny (HE-Arc CR, Neuchâtel, Neuchâtel, Switzerland)
Url	/artefacts/690/

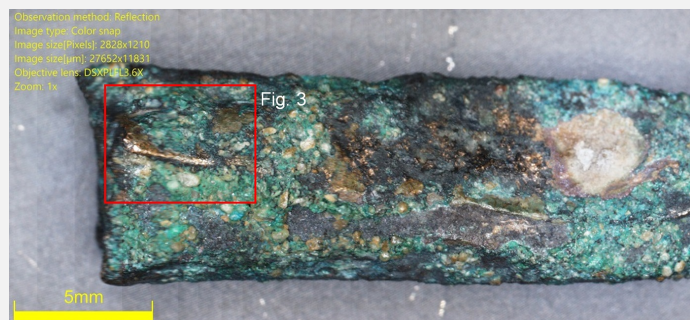
Fig. 1: Tang fragment of a knife with lake and terrestrial crust (after Rychner-Faraggi 1983, plate 35.35),

Description of the artefact	Tang fragment of a knife with lake (shiny brown) and terrestrial (granulated green-blue) crust (Fig. 1). Dimensions: L = 2.7cm; Ø = around 5mm; WT = 5.8g.
Type of artefact	Knife
Origin	Hauterive - Champréveyres, Neuchâtel, Neuchâtel, Switzerland
Recovering date	Excavation 1983-1985, object from layer 1 (layer with material from Bronze Age till 20th cent.)
Chronology category	Late Bronze Age
chronology tpq	1050 B.C. ▼
chronology taq	800 B.C. ▼
Chronology comment	Hallstatt A/B
Burial conditions / environment	Lake
Artefact location	Laténium, Neuchâtel, Neuchâtel
Owner	Laténium, Neuchâtel, Neuchâtel
Inv. number	Hr 6246
Recorded conservation data	Not conserved

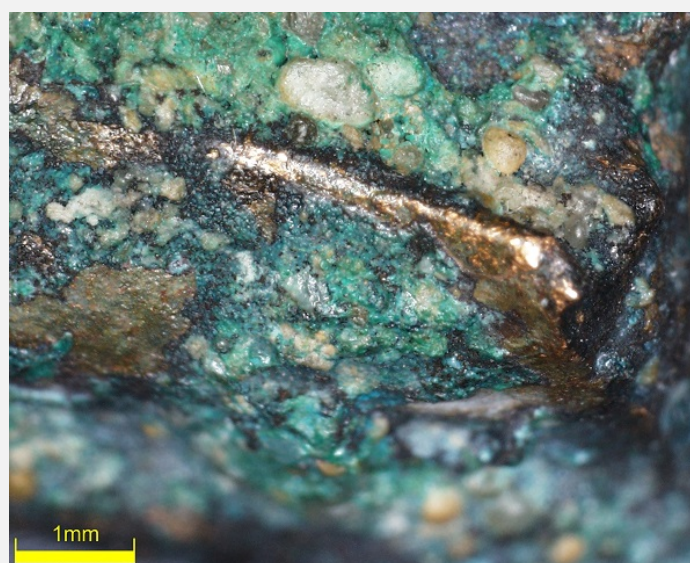
Fig. 2: Lake (shiny brown) and terrestrial (granulated green-blue) crust of the Tang with lacuna showing the underlying metal and detail of Fig. 3,

Fig. 3: Detail of Fig. 2 (rotated by 180°),

The corrosion crust has a thickness between 0.1mm and 0.7mm (Fig. 3). In bright field (Fig. 12), one can observe that the metal has been replaced by light-grey corrosion products. Adjacent to the metal is a thick, heterogeneous, dark-grey layer with a band of light-grey corrosion products. In polarised light (Fig. 13), all corrosion products which were previously light-grey appear brown-green-yellow, the dark-grey layer turquoise. The elemental chemical distribution of the SEM images (Figs. 14 and 15) reveals that the inner corrosion products are Sn-rich whereas the adjacent band is Cu and S-rich (Fig. 16). The outer layer contains large inclusions (quartz and others, Si, Al and Na, see Figs. 15-16) and is most probably composed of malachite/ $\text{Cu}_2(\text{CO}_3)(\text{OH})_2$ (only Cu and O are detected – Fig. 16). S is distributed throughout this layer. XRD analyses indicated the presence of posnjakite/ $\text{Cu}_4\text{SO}_4(\text{OH})_6\text{H}_2\text{O}$, chalcocite/ Cu_2S and djurleite/ $\text{Cu}_{1.93}\text{S}$ (Schweizer 1994).

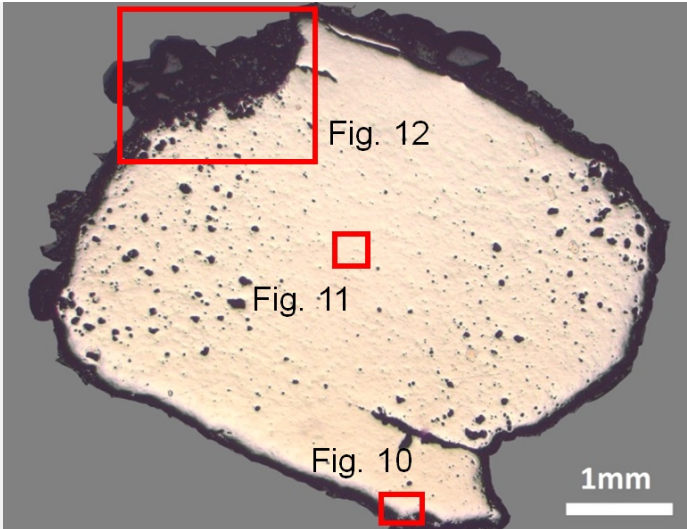
Fig. 8: Micrograph of the cross-section of the sample taken from the tang fragment showing the location of Figs. 10 to 12,

Description of sample	The cross-section corresponds to a lateral cut (Fig. 4). The surface is covered with a thick corrosion crust (Fig. 8).
Alloy	Tin Bronze
Technology	Cold worked after annealing
Lab number of sample	MAH 87-197
Sample location	Musées d'art et d'histoire, Genève, Geneva
Responsible institution	Musées d'art et d'histoire, Genève, Geneva
Date and aim of sampling	1987, metallography and corrosion characterisation

The remaining metal is a tin bronze (Table 1) with high porosity and large cracks both on the left and right edges of the sample (Fig. 8). The metal contains small, elongated copper sulphide (Table 2) and Pb inclusions that are oriented parallel to the cracks. Near the metal surface, slip lines are outlined by the development of intergranular corrosion (Fig. 10). The etched metal shows small, elongated grains with slip lines (Fig. 11). Annealing is visible in areas near the surface. The average hardness of the metal is HV1 145, but significant variations are observed, depending on where the measurements are taken.

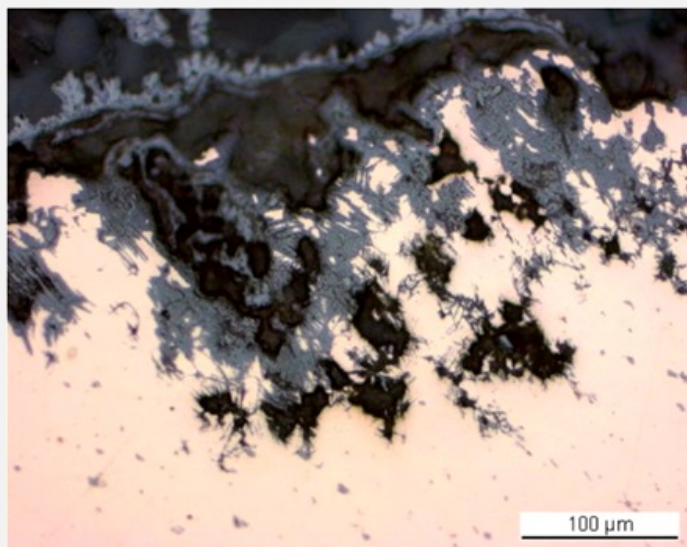
Fig. 10: Micrograph of the metal sample from Fig. 8 (inverted and reversed picture, detail), unetched, bright field. Corrosion products are in dark-grey whereas the metal is in pink. Slip lines are outlined by the development of intergranular corrosion,

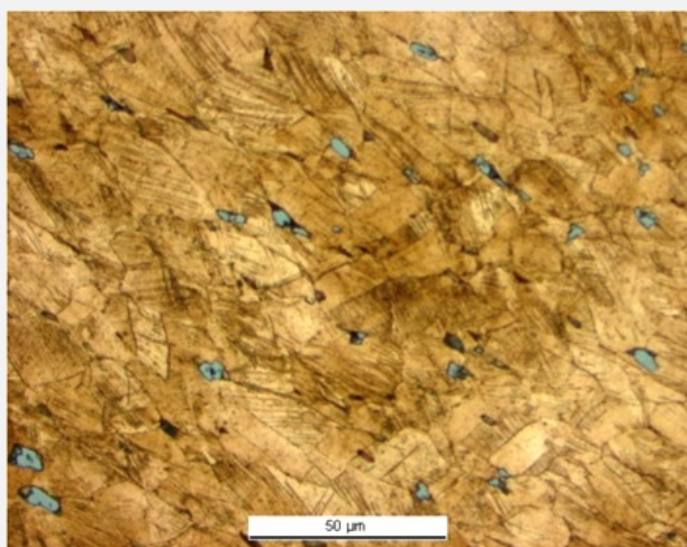
Fig. 11: Micrograph of the metal sample from Fig. 8 (detail), etched, bright field. We observe elongated grains with slip lines as well as grey copper sulphide inclusions,

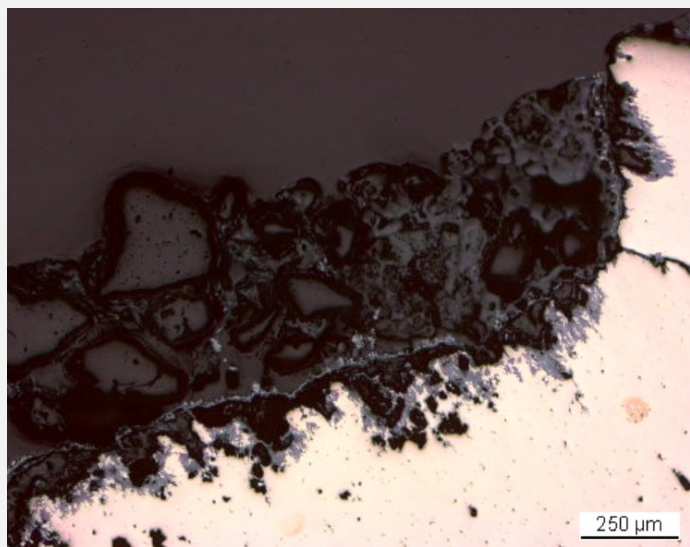
Fig. 12: Micrograph of the metal sample from Fig. 8 (detail), unetched, bright field. The inner light-grey corrosion products extend into the metal surface (in pink) and appear as a line within the dark-grey corrosion layer,

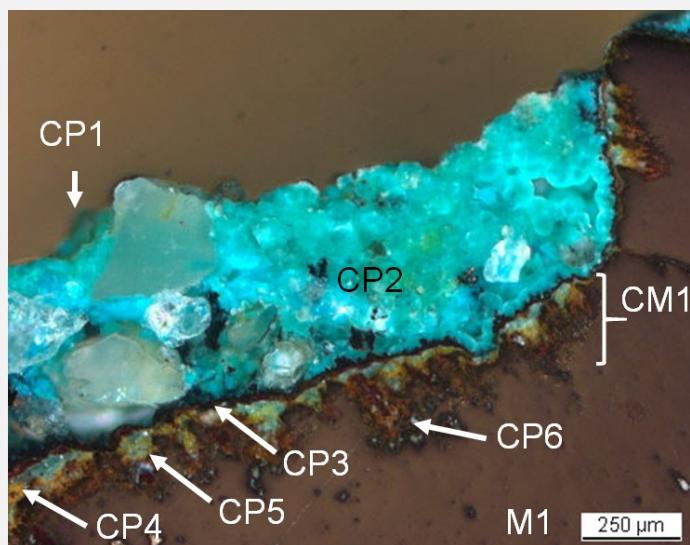
Fig. 13: Micrograph similar to Fig. 12 and corresponding to the stratigraphy of Fig. 9, polarized light. One can see that large mineral features are incorporated only in the corrosion layers above the brown-orange corrosion band,

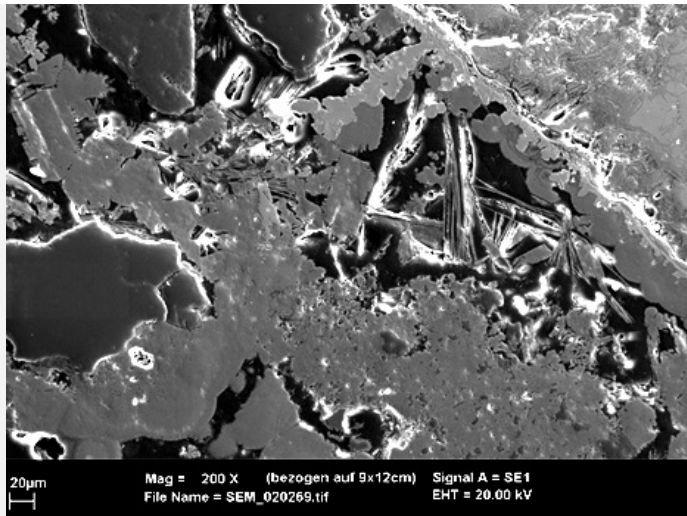
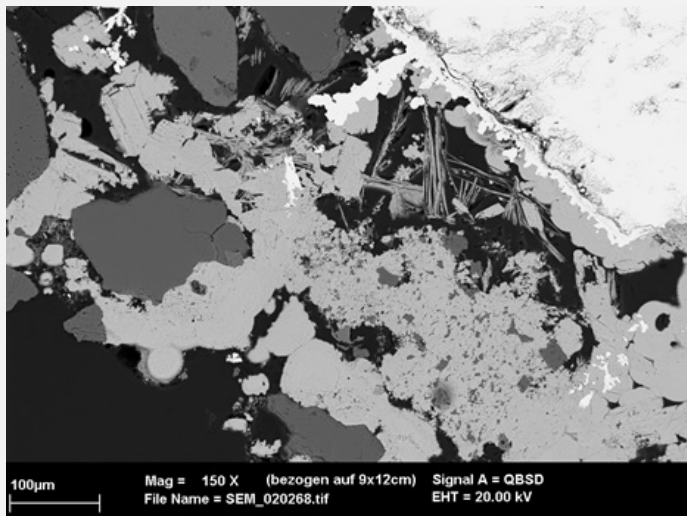
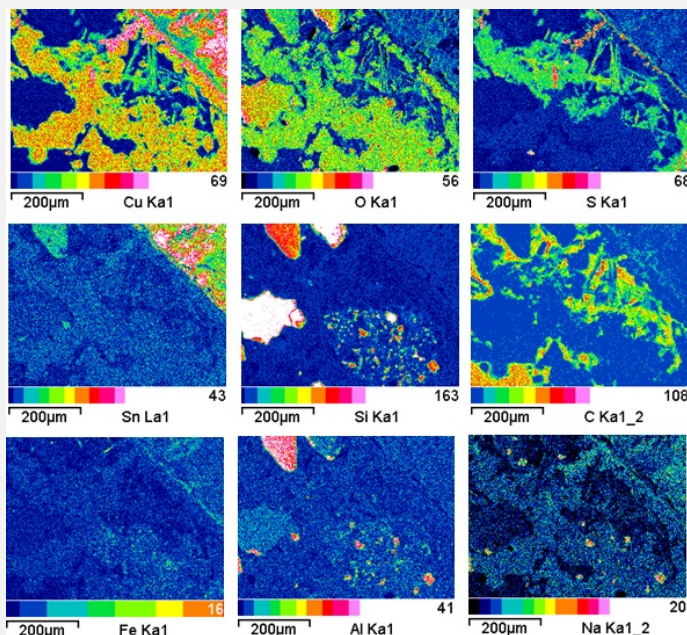
Fig. 14: SEM image (detail of Fig. 12), SE-mode. From bottom to top right: the thick, porous outer corrosion layer, the light-grey band and the remaining metal,

Fig. 15: SEM image, similar to Fig. 14, BSE-mode,

Fig. 16: EDS elemental chemical distribution of the SEM image of Fig. 14. Method of examination: SEM/EDS, Laboratory of Analytical Chemistry, Empa,
