SITULA EMT09-554.665 – TIN BRONZE – IRON AGE – SWITZERLAND

Artefact name Situla EMT09-554.665

Authors Christian. Degriigny (HE-Arc CR, Neuchâtel, Neuchâtel, Switzerland) & Marie-Jeanne. Scholl (HE-Arc CR, Neuchâtel, Neuchâtel, Switzerland) & Valentin. Boissonnas (HE-Arc CR, Neuchâtel, Neuchâtel, Switzerland)

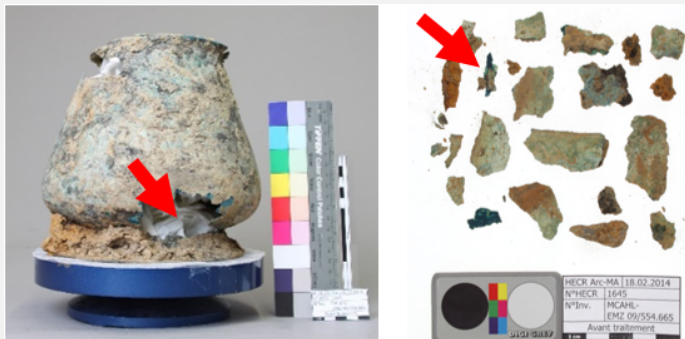
Fig. 2: Location of sampling area and sample selected from detached fragments,

Description of sample	The sample was cut from a detached fragment of the upper part of the main body of the situla in Fig. 2. The cross-section is representative of the entire thickness (0.5 mm) of the object's body where on the outside there is a thicker accumulation of corrosion layers including curly malachite clusters (Fig. 3). A metallic core is still present inside the corrosion products layers (Fig. 4).
Alloy	Tin Bronze
Technology	Cold worked (hammering on a counter-mould), annealed but no final annealing
Lab number of sample	None
Sample location	HE-Arc CR, Neuchâtel, Neuchâtel
Responsible institution	Musée cantonal d'archéologie et d'histoire, Lausanne, Vaud
Date and aim of sampling	2014, metallography and chemical analyses (FTIR, SEM-EDS)

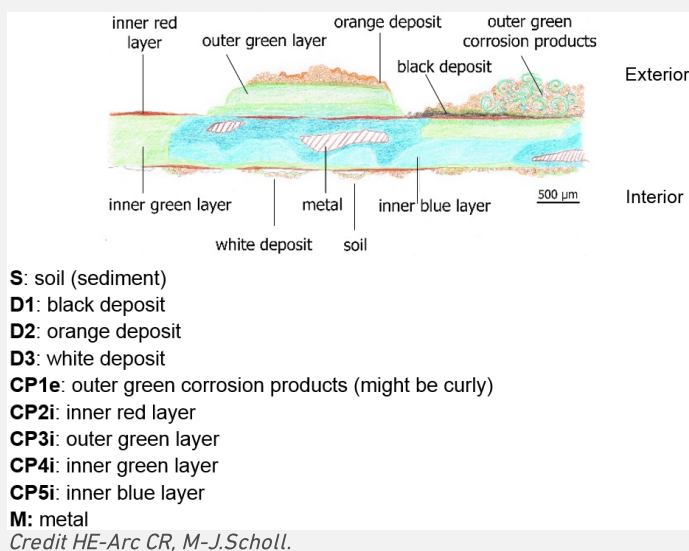
The schematic representation below gives an overview of the corrosion layers encountered on the situla from a first visual macroscopic observation (additional e and i within the coding correspond to strata in contact with the environment (e) and internal strata (i)).

Fig. 3: Stratigraphic representation of the situla in cross-section by macroscopic observation,

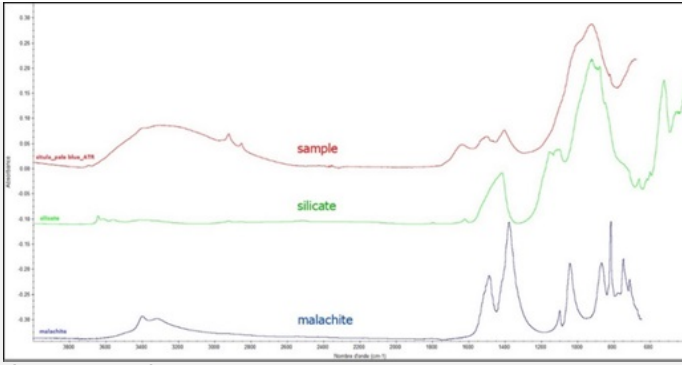
Fig. 14: FTIR spectrum (ATR mode) of the inner blue layer compared to the silicate and malachite standard spectrum. Method of analysis: FTIR spectroscopy, HE- Arc CR,

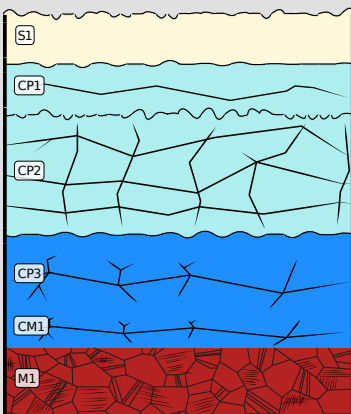
There are 2 stratigraphies (Fig. 5 corresponding to the interior face of the situla and Fig. 6 to its exterior face). The strata are similar in composition but their coding is different: CP1 to CP3 in Fig. 5 correspond to CP3 to CP5 in Fig. 6. Since the stratigraphy of Fig. 6 is more complete, the composition of each of its strata is given below.

Fig. 5: Stratigraphic representation of the sample taken from the detached fragment of the situla in cross-section (dark field) using the MiCorr application. The characteristics of the strata are only accessible by clicking on the drawing that redirects you to the search tool by stratigraphy representation. This representation shows the exterior face and can be compared to Fig. 10 (bottom red rectangle), Credit HE-Arc CR, M-J.Scholl.

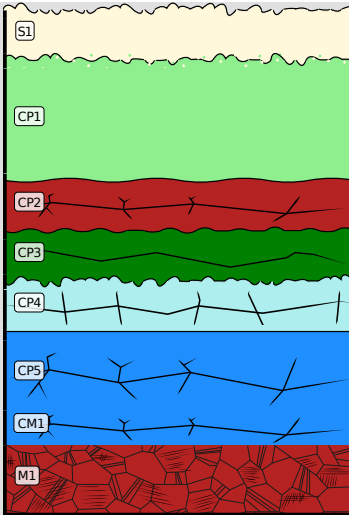
Fig. 6: Stratigraphic representation of the sample taken from the detached fragment of the situla in cross-section (dark field) using the MiCorr application. The characteristics of the strata are only accessible by clicking on the drawing that redirects you to the search tool by stratigraphy representation. This representation shows the interior face and can be compared to Fig. 10 (top red rectangle), Credit HE-Arc CR, M-J.Scholl.

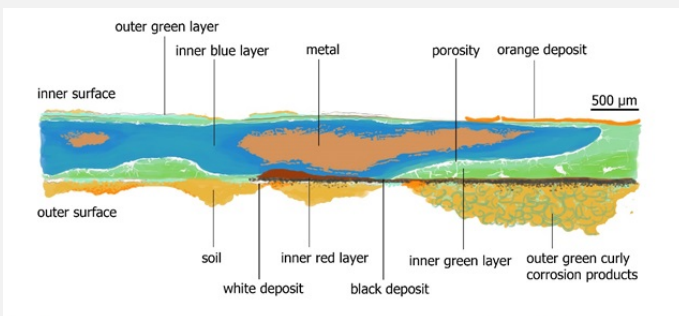
The schematic representation of corrosion layers of Fig. 3 integrating additional information (e and i within the coding correspond to strata in contact with the environment (e) and internal strata (i)) based on the analyses carried out is given in Fig. 16.

Fig. 16: Improved stratigraphic representation of the situla from visual observations and analyses,

The metal structure of this low-tin bronze shows extensive cold work and multiple annealing cycles with a final cold work. The total absence of inclusions highlights a highly developed knowledge in bronze metallurgy. The metal is much corroded. Transgranular corrosion is visible. The majority of the internal corrosion products are composed of copper carbonates that have replaced much of the metal. Curly malachite has developed in clusters on the outside of the surface. This pattern is characteristic of a long-term burial period. The presence of inner enriched Sn layers shows a decuprification phenomenon (dissolution of Cu). Because of the friable nature of the inner green layer that supports the limit of the original surface, as well as its cleavage with the blue layer underneath, the original surface has become very fragile. The corrosion is thought to be of type 1 according to Robbiola et al. 1998.
