SITULA EMT09-554.665 – TIN BRONZE – IRON AGE – SWITZERLAND

Artefact name	Situla EMT09-554.665
Authors	Christian. Degriigny (HE-Arc CR, Neuchâtel, Neuchâtel, Switzerland) & Marie-Jeanne. Scholl (HE-Arc CR, Neuchâtel, Neuchâtel, Switzerland) & Valentin. Boissonnas (HE-Arc CR, Neuchâtel, Neuchâtel, Switzerland)
Url	/artefacts/692/

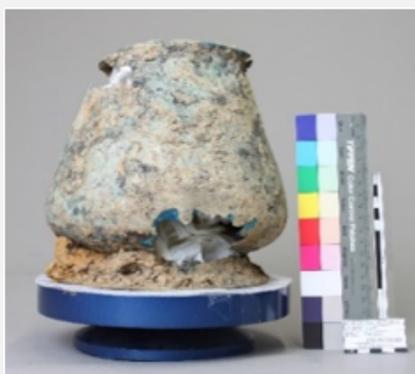
Fig. 1: Situla (Archeodunum (Gollion), 2009) inverted as found in situ,

Description of the artefact	Situla (Fig. 1) covered with blue-green corrosion products and sediments. Attached to two riveted iron loops is an iron handle terminating in two swan heads (not shown here). Dimensions of the main body: Hmax = 340mm, Ømax = 220mm.
Type of artefact	Situla
Origin	Mormont sanctuary, La Sarraz, Vaud, Switzerland
Recovering date	Excavated in 2011
Chronology category	Iron Age
chronology tpq	<input type="text" value="140"/> B.C. ▾
chronology taq	<input type="text" value="30"/> B.C. ▾
Chronology comment	La Tène D
Burial conditions / environment	Soil
Artefact location	Musée cantonal d'archéologie et d'histoire, Lausanne, Vaud
Owner	Musée cantonal d'archéologie et d'histoire, Lausanne, Vaud
Inv. number	EMT09/554.665

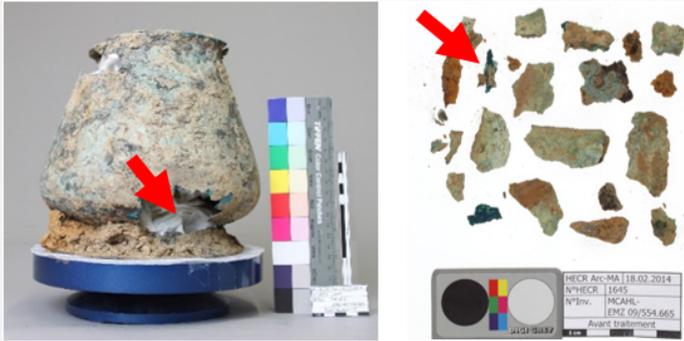
Fig. 2: Location of sampling area and sample selected from detached fragments,

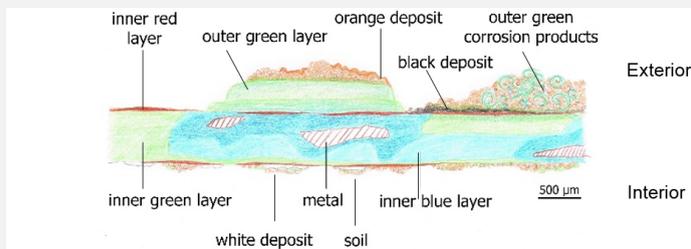
Fig. 3: Stratigraphic representation of the situla in cross-section by macroscopic observation,

S: soil (sediment)
D1: black deposit
D2: orange deposit
D3: white deposit
CP1e: outer green corrosion products (might be curly)
CP2i: inner red layer
CP3i: outer green layer
CP4i: inner green layer
CP5i: inner blue layer
M: metal
Credit HE-Arc CR, M-J.Scholl.

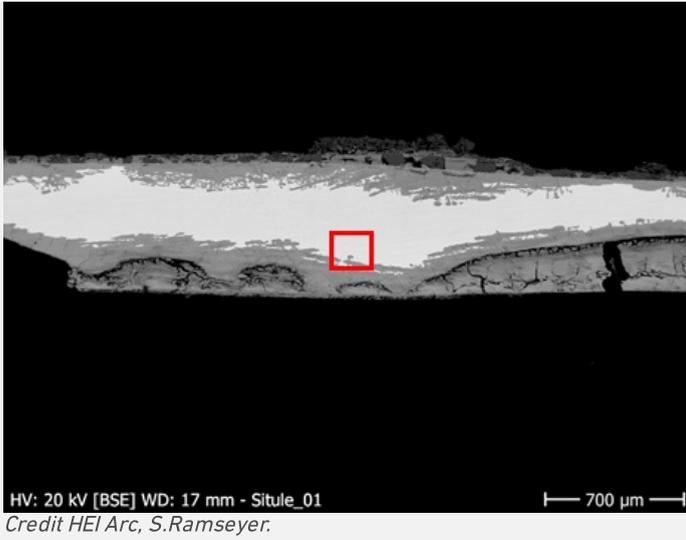
The remaining metal is a dense tin bronze (Fig. 7, Table 1), showing no inclusion. In bright field, the etched alloy shows a structure principally consisting of polygonal alpha phase grains (Fig. 8). Some of the grains include twin lines (Fig. 9). The presence of strain lines (slip lines) indicates a final cold work without annealing (Fig. 9).

Fig. 7: SEM image, BSE-mode, of the metal sample from Fig. 4. Area of Fig. 8 is marked by a red square,

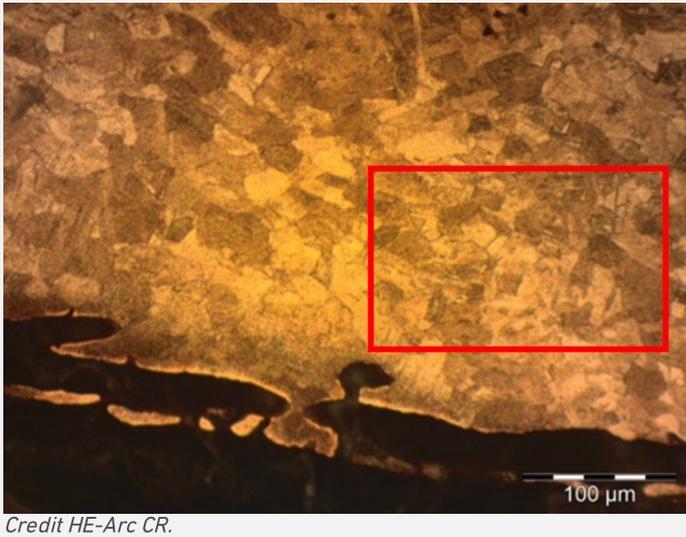
Fig. 8: Micrograph of the metal structure from Fig. 7 (detail), etched, bright field, 50x. The alpha phase of the alloy shows polygonal grains. Area of Fig. 9 is marked by a red rectangle,

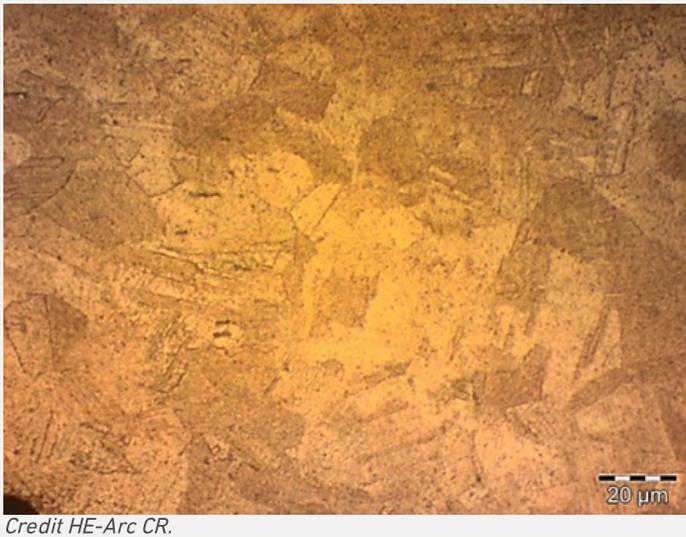
Fig. 9: Micrograph of the selected area of Fig. 8, etched, bright field, 500x. The grains show both twin and strain lines,

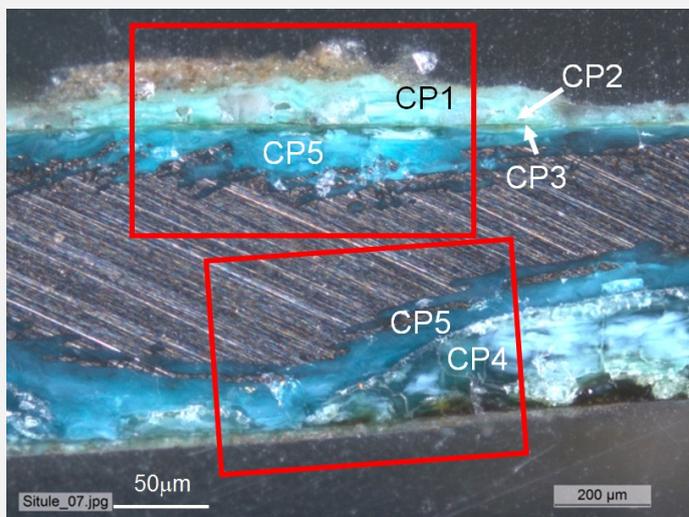
Table 2: Chemical composition of the corrosion crust from Fig. 10. SEM-EDS, Lab of Electronic Microscopy and Microanalysis, IMA (Néode) (+++: high concentration, ++ medium concentration, + low concentration, nd: not-detected).

Fig. 10: Micrograph of the metal sample from Fig. 4, unetched, dark field, 50x. Areas of Fig. 11 (bottom, corresponding to the stratigraphy of Fig. 5) and Figs. 12 and 13 (top, corresponding to the stratigraphy of Fig. 6) are marked by a rectangle. Codes are those of Fig. 6.

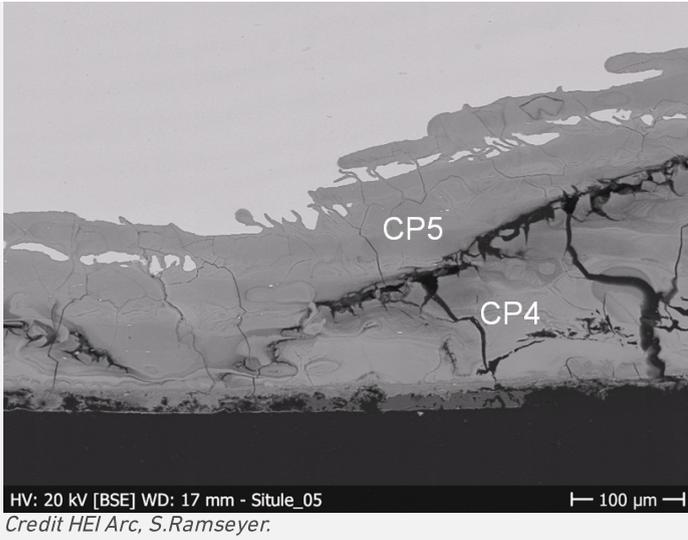
The corrosion crust is heterogeneous and has in places completely replaced the metal. The metal – corrosion products interface is irregular due to transgranular corrosion (Figs 7-8). In most cases, the corrosion crust can be divided in three main layers: an inner compact blue layer directly on the metal core (CP5, Figs. 6, 10 and 11 and CP3, Fig. 5). In areas of extensive corrosion this blue layer coexists with a friable green layer (CP4, Figs. 6, 10 and 11 and CP2, Fig. 5). Depending on the area either a very fine dark green (CP3, Fig. 6 and Fig. 10) or red corrosion layer (CP2, Fig. 6 and Fig. 10) marks the limit of the original surface. It is followed by an external fourth layer, consisting of friable and sometimes curly pale green corrosion products intermingled with soil products (CP1, Fig. 6 and Fig. 10 and 13). In heavily worked and fragile parts of the object a cleavage between the inner layers of blue and green corrosion is present, rendering the green corrosion vulnerable to loss (Fig. 11).

Fig. 11: SEM image, BSE-mode of the metal sample from Fig. 10 (detail) showing cleavage between the inner blue (CP5) and green (CP4) layers of Fig. 6,

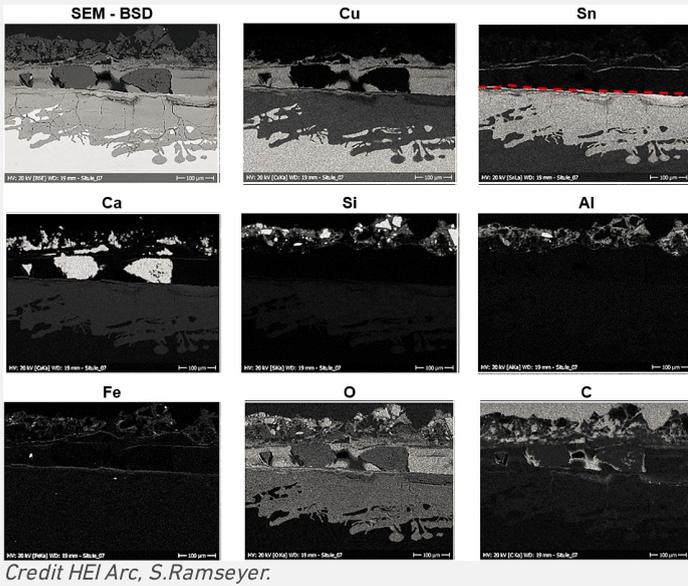
The inner layers (CP3-CP5) are Sn and O-rich and depleted in Cu (Table 2). The outer layers (CP1 and CP2) are Cu and O-rich, contain no Sn, and are contaminated with Ca, Si, Al and Fe coming from the soil (Fig. 12). The colour of the corrosion crust varies according to the content of Sn (the more Sn, the darker green or blue the corrosion). FTIR on the inner blue (CP5 and Fig. 14) and outer green (CP1 and Fig. 15) layers were difficult to interpret. Only malachite could be identified in both cases. XRD spectra could not be interpreted because of the deficiency of peaks.

Fig. 12: SEM image, SE-mode, and elemental chemical distribution of the selected area of Fig. 10. In red: the limit of the original surface highlighted by the enriched tin layer. Method of examination: SEM-EDS, Lab of Electronic Microscopy and Microanalysis, IMA (Néode), HEI Arc,

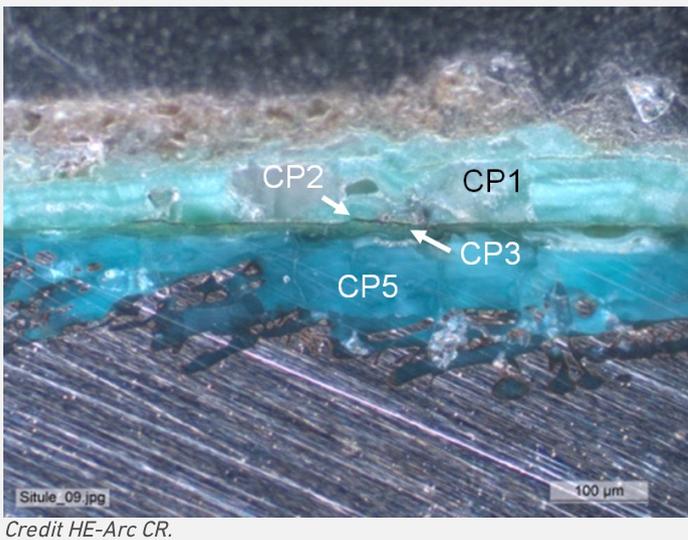
The limit of the original surface is well defined (interface of CP1 and CP2) but due to the fragility of the inner corrosion layers it was difficult to uncover.

Fig. 13: Micrograph of the metal / corrosion interface (detail of Fig. 10) unetched, dark field, 100x. The outer layer (CP1 of Fig. 6) incorporates soil material and the thin dark layer (CP2 of Fig. 6) highlights the limit of the original surface,

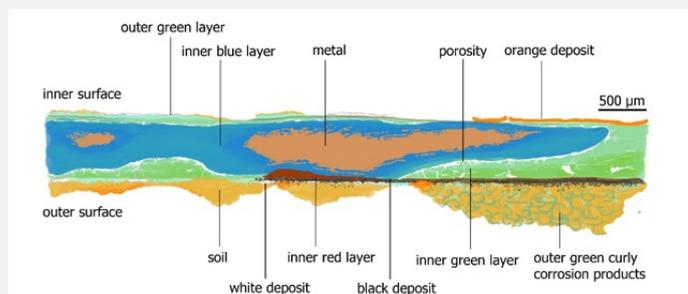
Fig. 16: Improved stratigraphic representation of the situla from visual observations and analyses,

Strata	Composition
Soil (S)	Ca, Si, Al, Fe
Black deposit (D1)	C
Orange deposit (D2)	Ferrous oxides
White deposit (D3)	Ca
Outer green curly corrosion product (CP1e)	Copper carbonates (curly malachite)
Inner red (CP2i)	Copper oxide (cuprite ?)
Outer green layer (CP3i)	Copper carbonates (malachite)
Inner green layer (CP4i)	Copper carbonates (?) + Sn
Inner blue layer (CP5i)	Copper carbonates (?) + Sn
Remnant metal phase (M)	Bronze (90%Cu, 10% Sn)
