SITULA EMT09-554.665 – TIN BRONZE – IRON AGE – SWITZERLAND

Artefact name	Situla EMT09-554.665
Authors	Christian. Degriigny (HE-Arc CR, Neuchâtel, Neuchâtel, Switzerland) & Marie-Jeanne. Scholl (HE-Arc CR, Neuchâtel, Neuchâtel, Switzerland) & Valentin. Boissonnas (HE-Arc CR, Neuchâtel, Neuchâtel, Switzerland)
Url	/artefacts/692/

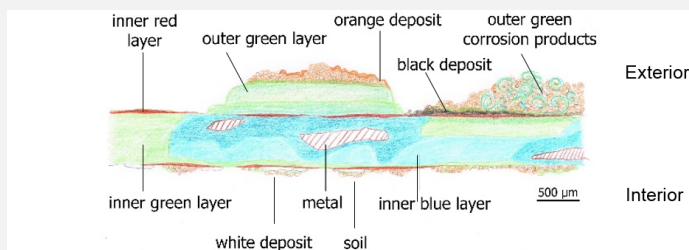
Fig. 3: Stratigraphic representation of the situla in cross-section by macroscopic observation,

S: soil (sediment)
D1: black deposit
D2: orange deposit
D3: white deposit
CP1e: outer green corrosion products (might be curly)
CP2i: inner red layer
CP3i: outer green layer
CP4i: inner green layer
CP5i: inner blue layer
M: metal
Credit HE-Arc CR, M-J.Scholl.

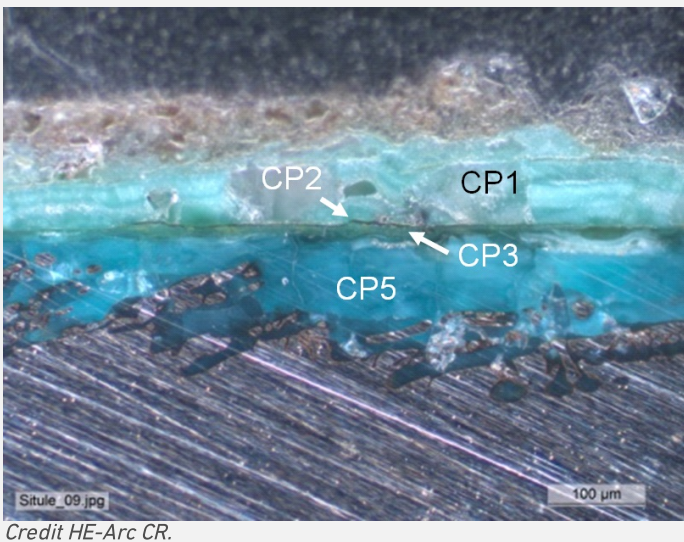
The limit of the original surface is well defined (interface of CP1 and CP2) but due to the fragility of the inner corrosion layers it was difficult to uncover.

Fig. 13: Micrograph of the metal / corrosion interface (detail of Fig. 10) unetched, dark field, 100x. The outer layer (CP1 of Fig. 6) incorporates soil material and the thin dark layer (CP2 of Fig. 6) highlights the limit of the original surface,

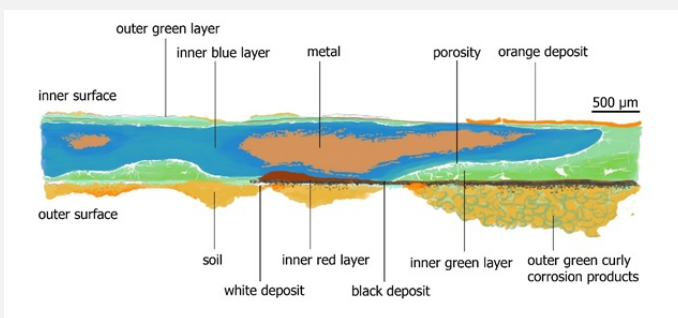
Fig. 16: Improved stratigraphic representation of the situla from visual observations and analyses,

Strata	Composition
Soil (S)	Ca, Si, Al, Fe
Black deposit (D1)	C
Orange deposit (D2)	Ferrous oxides
White deposit (D3)	Ca
Outer green curly corrosion product (CP1e)	Copper carbonates (curly malachite)
Inner red (CP2i)	Copper oxide (cuprite ?)
Outer green layer (CP3i)	Copper carbonates (malachite)
Inner green layer (CP4i)	Copper carbonates (?) + Sn
Inner blue layer (CP5i)	Copper carbonates (?) + Sn
Remnant metal phase (M)	Bronze (90%Cu, 10% Sn)

The metal structure of this low-tin bronze shows extensive cold work and multiple annealing cycles with a final cold work. The total absence of inclusions highlights a highly developed knowledge in bronze metallurgy. The metal is much corroded. Transgranular corrosion is visible. The majority of the internal corrosion products are composed of copper carbonates that have replaced much of the metal. Curly malachite has developed in clusters on the outside of the surface. This pattern is characteristic of a long-term burial period. The presence of inner enriched Sn layers shows a decuprification phenomenon (dissolution of Cu). Because of the friable nature of the inner green layer that supports the limit of the original surface, as well as its cleavage with the blue layer underneath, the original surface has become very fragile. The corrosion is thought to be of type 1 according to Robbiola et al. 1998.
