SITULA EMT09-554.665 – TIN BRONZE – IRON AGE – SWITZERLAND

Artefact name	Situla EMT09-554.665
Authors	Christian. Degriigny (HE-Arc CR, Neuchâtel, Neuchâtel, Switzerland) & Marie-Jeanne. Scholl (HE-Arc CR, Neuchâtel, Neuchâtel, Switzerland) & Valentin. Boissonnas (HE-Arc CR, Neuchâtel, Neuchâtel, Switzerland)
Url	/artefacts/692/

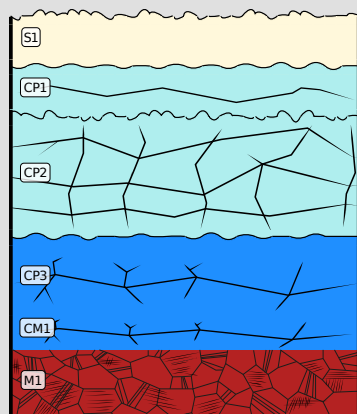
There are 2 stratigraphies (Fig. 5 corresponding to the interior face of the situla and Fig. 6 to its exterior face). The strata are similar in composition but their coding is different: CP1 to CP3 in Fig. 5 correspond to CP3 to CP5 in Fig. 6. Since the stratigraphy of Fig. 6 is more complete, the composition of each of its strata is given below.

Fig. 5: Stratigraphic representation of the sample taken from the detached fragment of the situla in cross-section (dark field) using the MiCorr application. The characteristics of the strata are only accessible by clicking on the drawing that redirects you to the search tool by stratigraphy representation. This representation shows the exterior face and can be compared to Fig. 10 (bottom red rectangle), Credit HE-Arc CR, M-J.Scholl.

Fig. 6: Stratigraphic representation of the sample taken from the detached fragment of the situla in cross-section (dark field) using the MiCorr application. The characteristics of the strata are only accessible by clicking on the drawing that redirects you to the search tool by stratigraphy representation. This representation shows the interior face and can be compared to Fig. 10 (top red rectangle), Credit HE-Arc CR, M-J.Scholl.

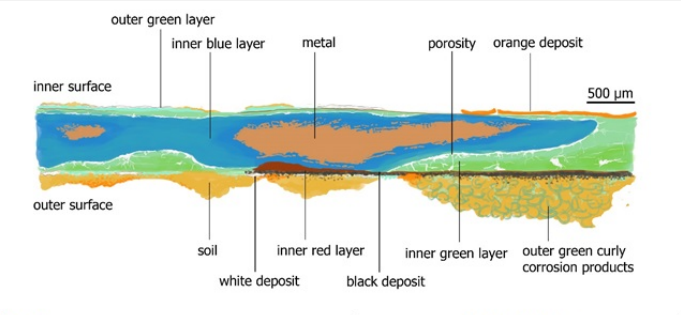
The schematic representation of corrosion layers of Fig. 3 integrating additional information (e and i within the coding correspond to strata in contact with the environment (e) and internal strata (i)) based on the analyses carried out is given in Fig. 16.

Fig. 16: Improved stratigraphic representation of the situla from visual observations and analyses,

Strata	Composition
Soil (S)	Ca, Si, Al, Fe
Black deposit (D1)	C
Orange deposit (D2)	Ferrous oxides
White deposit (D3)	Ca
Outer green curly corrosion product (CP1e)	Copper carbonates (curly malachite)
Inner red (CP2i)	Copper oxide (cuprite ?)
Outer green layer (CP3i)	Copper carbonates (malachite)
Inner green layer (CP4i)	Copper carbonates (?) + Sn
Inner blue layer (CP5i)	Copper carbonates (?) + Sn
Remnant metal phase (M)	Bronze (90%Cu, 10% Sn)
