SITULA EMT09-554.665 - TIN BRONZE - IRON AGE - SWITZERLAND

Artefact name	Situla EMT09-554.665
Authors	Christian. Degriigny (HE-Arc CR, Neuchâtel, Neuchâtel, Switzerland) & Marie-Jeanne. Scholl (HE-Arc CR, Neuchâtel, Neuchâtel, Switzerland) & Valentin. Boissonnas (HE-Arc CR, Neuchâtel, Neuchâtel, Switzerland)
Url	/artefacts/692/

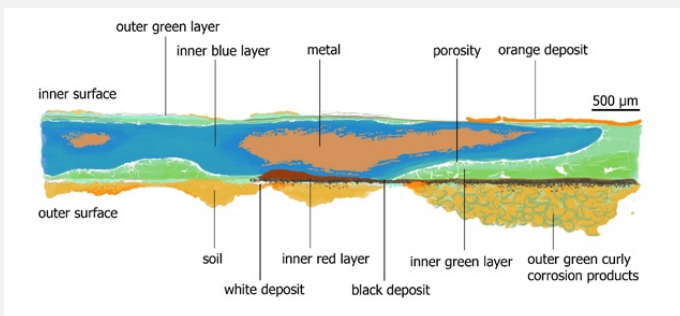
Fig. 16: Improved stratigraphic representation of the situla from visual observations and analyses,

Strata	Composition
Soil (S)	Ca, Si, Al, Fe
Black deposit (D1)	C
Orange deposit (D2)	Ferrous oxides
White deposit (D3)	Ca
Outer green curly corrosion product (CP1e)	Copper carbonates (curly malachite)
Inner red (CP2i)	Copper oxide (cuprite ?)
Outer green layer (CP3i)	Copper carbonates (malachite)
Inner green layer (CP4i)	Copper carbonates (?) + Sn
Inner blue layer (CP5i)	Copper carbonates (?) + Sn
Remnant metal phase (M)	Bronze (90%Cu, 10% Sn)
