SITULA EMT09/554.665 – TIN BRONZE – IRON AGE – SWITZERLAND

Artefact name	Situla EMT09/554.665
Authors	Christian. Degriigny (HE-Arc CR, Neuchâtel, Neuchâtel, Switzerland) & Marie-Jeanne. Scholl (HE-Arc CR, Neuchâtel, Neuchâtel, Switzerland) & Valentin. Boissonnas (HE-Arc CR, Neuchâtel, Neuchâtel, Switzerland)
Url	/artefacts/692/

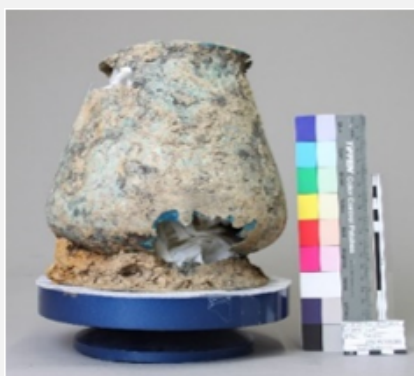
Fig. 1: Situla (Archeodunum (Gollion), 2009) inverted as found in situ,

Description of the artefact	Situla (Fig. 1) covered with blue-green corrosion products and sediments. Attached to two riveted iron loops is an iron handle terminating in two swan heads (not shown here). Dimensions of the main body: Hmax = 340mm, Ømax = 220mm.
Type of artefact	Situla
Origin	Mormont sanctuary, La Sarraz, Vaud, Switzerland
Recovering date	Excavated in 2011
Chronology category	Iron Age
chronology tpq	140 B.C. ▼
chronology taq	30 B.C. ▼
Chronology comment	La Tène D
Burial conditions / environment	Soil
Artefact location	Musée cantonal d'archéologie et d'histoire, Lausanne, Vaud
Owner	Musée cantonal d'archéologie et d'histoire, Lausanne, Vaud
Inv. number	EMT09/554.665
Recorded conservation data	Not conserved

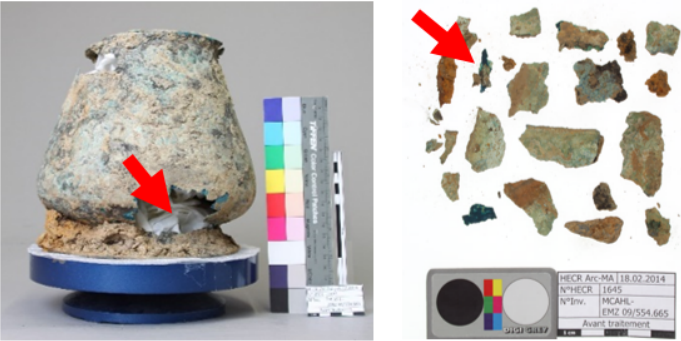
Fig. 2: Location of sampling area and sample selected from detached fragments,

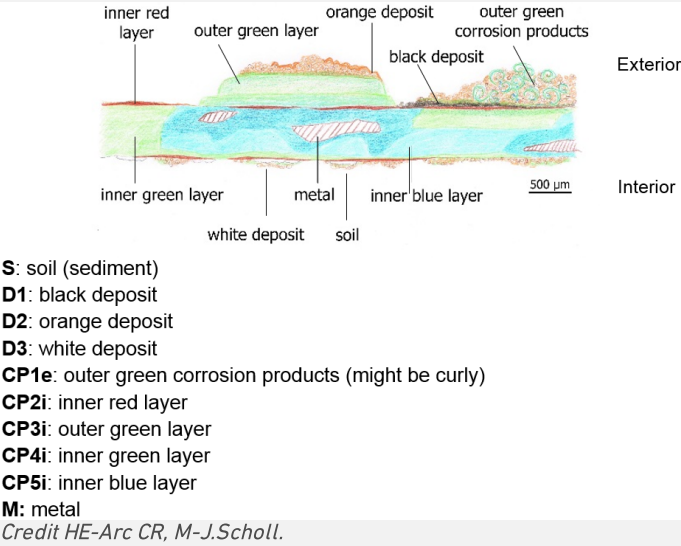
The schematic representation below gives an overview of the corrosion layers encountered on the situla from a first visual macroscopic observation (additional e and i within the coding correspond to strata in contact with the environment (e) and internal strata (i)).

Fig. 3: Stratigraphic representation of the situla in cross-section by macroscopic observation,

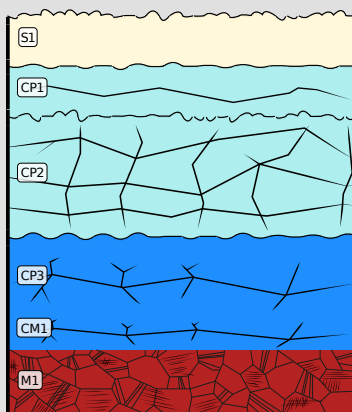
There are 2 stratigraphies (Fig. 5 corresponding to the interior face of the situla and Fig. 6 to its exterior face). The strata are similar in composition but their coding is different: CP1 to CP3 in Fig. 5 correspond to CP3 to CP5 in Fig. 6. Since the stratigraphy of Fig. 6 is more complete, the composition of each of its strata is given below.

Fig. 5: Stratigraphic representation of the sample taken from the detached fragment of the situla in cross-section (dark field) using the MiCorr application. The characteristics of the strata are only accessible by clicking on the drawing that redirects you to the search tool by stratigraphy representation. This representation shows the exterior face and can be compared to Fig. 10 (bottom red rectangle), Credit HE-Arc CR, M-J.Scholl.

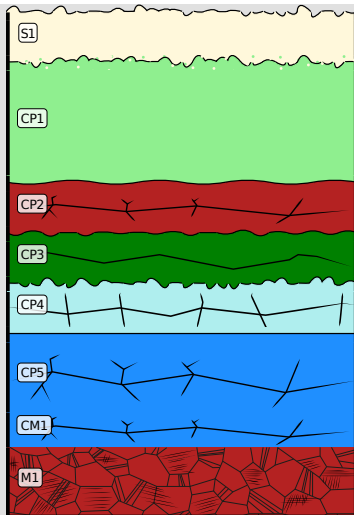
Fig. 6: Stratigraphic representation of the sample taken from the detached fragment of the situla in cross-section (dark field) using the MiCorr application. The characteristics of the strata are only accessible by clicking on the drawing that redirects you to the search tool by stratigraphy representation. This representation shows the interior face and can be compared to Fig. 10 (top red rectangle), Credit HE-Arc CR, M-J.Scholl.
