SITULA EMT09-554.665 – TIN BRONZE – IRON AGE – SWITZERLAND

Artefact name Situla EMT09-554.665

Authors Christian. Degriigny (HE-Arc CR, Neuchâtel, Neuchâtel, Switzerland) & Marie-Jeanne. Scholl (HE-Arc CR, Neuchâtel, Neuchâtel, Switzerland) & Valentin. Boissonnas (HE-Arc CR, Neuchâtel, Neuchâtel, Switzerland)

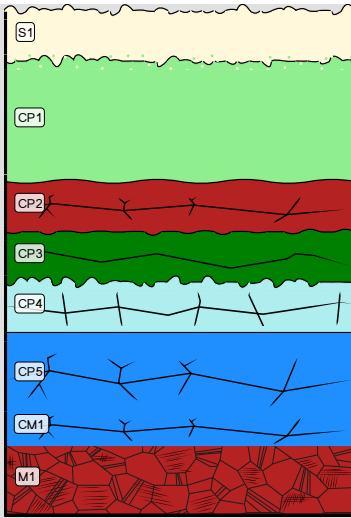
There are 2 stratigraphies (Fig. 5 corresponding to the interior face of the situla and Fig. 6 to its exterior face). The strata are similar in composition but their coding is different: CP1 to CP3 in Fig. 5 correspond to CP3 to CP5 in Fig. 6. Since the stratigraphy of Fig. 6 is more complete, the composition of each of its strata is given below.

Fig. 6: Stratigraphic representation of the sample taken from the detached fragment of the situla in cross-section (dark field) using the MiCorr application. The characteristics of the strata are only accessible by clicking on the drawing that redirects you to the search tool by stratigraphy representation. This representation shows the interior face and can be compared to Fig. 10 (top red rectangle), Credit HE-Arc CR, M-J.Scholl.

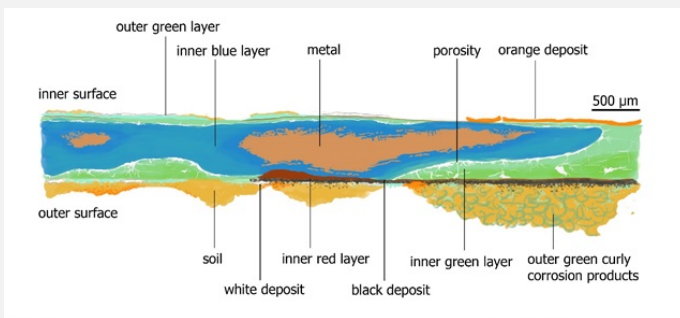
Fig. 16: Improved stratigraphic representation of the situla from visual observations and analyses,

Strata	Composition
Soil (S)	Ca, Si, Al, Fe
Black deposit (D1)	C
Orange deposit (D2)	Ferrous oxides
White deposit (D3)	Ca
Outer green curly corrosion product (CP1e)	Copper carbonates (curly malachite)
Inner red (CP2i)	Copper oxide (cuprite ?)
Outer green layer (CP3i)	Copper carbonates (malachite)
Inner green layer (CP4i)	Copper carbonates (?) + Sn
Inner blue layer (CP5i)	Copper carbonates (?) + Sn
Remnant metal phase (M)	Bronze (90%Cu, 10% Sn)

The metal structure of this low-tin bronze shows extensive cold work and multiple annealing cycles with a final cold work. The total absence of inclusions highlights a highly developed knowledge in bronze metallurgy. The metal is much corroded. Transgranular corrosion is visible. The majority of the internal corrosion products are composed of copper carbonates that have replaced much of the metal. Curly malachite has developed in clusters on the outside of the surface. This pattern is characteristic of a long-term burial period. The presence of inner enriched Sn layers shows a decuprification phenomenon (dissolution of Cu). Because of the friable nature of the inner green layer that supports the limit of the original surface, as well as its cleavage with the blue layer underneath, the original surface has become very fragile. The corrosion is thought to be of type 1 according to Robbiola et al. 1998.
