CORRODED METAL SHEET FN 655.13.01 – FE ALLOY – MODERN TIMES – SWITZERLAND

Artefact name	Corroded metal sheet FN 655.13.01
Authors	Marianne. Senn (EMPA, Dübendorf, Zurich, Switzerland) & Christian. Degrieny (HE-Arc CR, Neuchâtel, Neuchâtel, Switzerland)
Url	/artefacts/696/

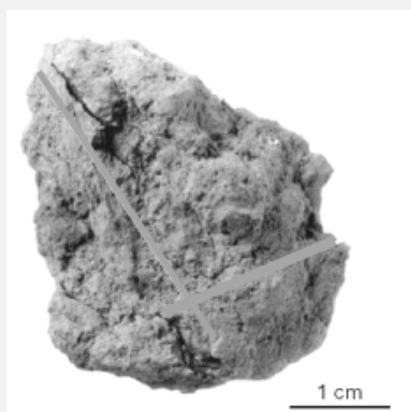
Fig. 1: Metal sheet (after Senn Bischofberger 2005, 137),

Description of the artefact	Metal (iron-based) sheet with middle rib. The shape is no longer discernible (Fig. 1). The metal is covered by a thick corrosion crust. Dimensions: L = 4.5cm; WT = 35g.
Type of artefact	Iron (and steel) sheet
Origin	Steinmöri, Neftenbach / Dorf Neftenbach, Zurich, Switzerland
Recovering date	Excavation of the Roman villa, 1986-1990, phase S2, StbII.2 (2nd/3rd century AD)
Chronology category	Modern Times
chronology tpq	1900 A.D. ▼
chronology taq	2000 A.D. ▼
Chronology comment	Product of the 20th century AD introduced accidentally into a Roman layer
Burial conditions / environment	Soil
Artefact location	Kantonsarchäologie, Dübendorf, Zurich
Owner	Kantonsarchäologie, Dübendorf, Zurich

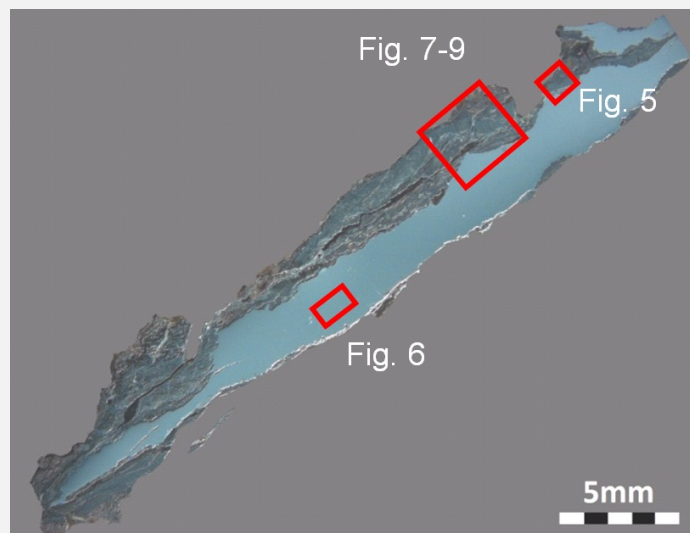
Fig. 3: Micrograph of the cross-section of the iron-based sheet showing the location of Figs. 5 to 9,

The corrosion is massive and large parts of the outer corrosion layers have been lost during the sample preparation. The heavily cracked corrosion crust represents about one third of the thickness of the sample (Fig. 3) and is located on one side of the metal (the rest having been lost during the cutting process). It does not show well defined layers. Despite this, three areas can be distinguished (Figs. 7 and 8). Adhering to the metal (area 1), we find an orange-red-brown layer enriched in Cl (CP3 in Fig. 4, Fig. 9

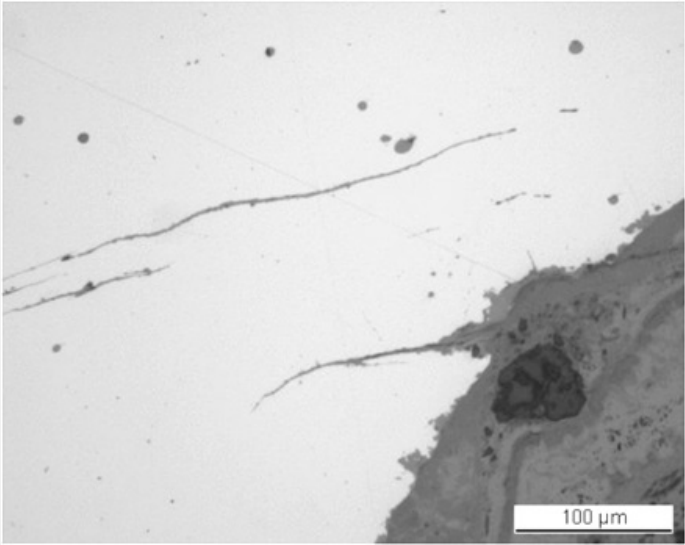
The remaining metal is an iron containing elevated (more than 1g/kg) concentrations of Co and Ni (Table 1), small round slag inclusions and cracks resulting from corrosion and deformation (Fig. 5). The composition of the round, elongated slag inclusions is similar to wüstite-FeO (Table 2). Iron reduced in the direct smelting process never contains such pure compounds and only FeO inclusions. In modern steels FeO occurs in low carbon alloys and Armco-iron (Schumann 1991, 474). After etching, the cross-section shows a heavily deformed ferritic microstructure from cold working (Fig. 6). The cracks have the same orientation as the deformation. The average hardness of the metal is HV1 195.

Fig. 5: Micrograph of metal sample from Fig. 3 (inverted picture, detail), unetched, bright field. In white the metal with round slag inclusions as well as cracks filled with corrosion products,

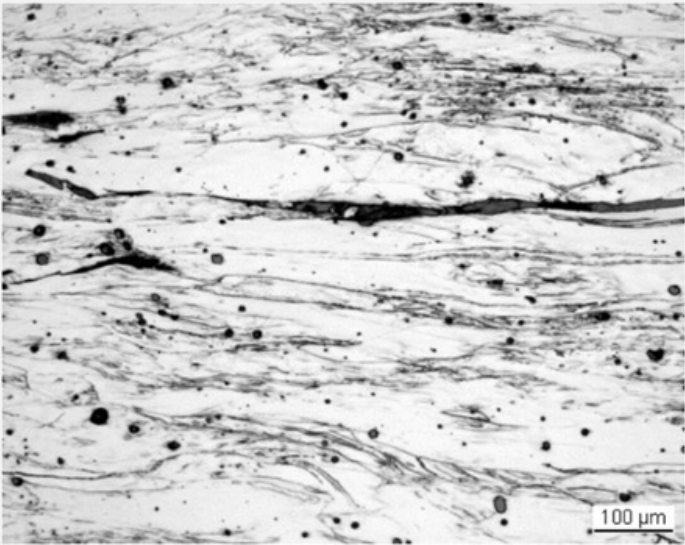
Fig. 6: Micrograph of metal sample from Fig. 3 (detail), etched, bright field. The heavily cold worked metal shows elongated grains with nearly invisible grain boundaries and cracks parallel to the grains,

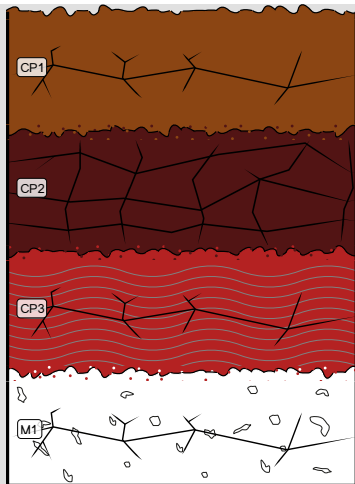
and Table 3). The dark or violet middle area 2 is richer in Fe (CP2 in Fig. 4). The outer area 3 is red-brown (CP1 in Fig. 4) and strongly contaminated by soil material (rock fragment inclusion and elements like Si, Al, P etc.). This layer is enriched in O (Fig. 9).

Fig. 4: Stratigraphic representation of the iron-based sheet in cross-section (dark field) using the MiCorr application. The characteristics of the strata are only accessible by clicking on the drawing that redirects you to the search tool by stratigraphy representation. This representation can be compared to Figs. 7 and 8, Credit HE-Arc CR.

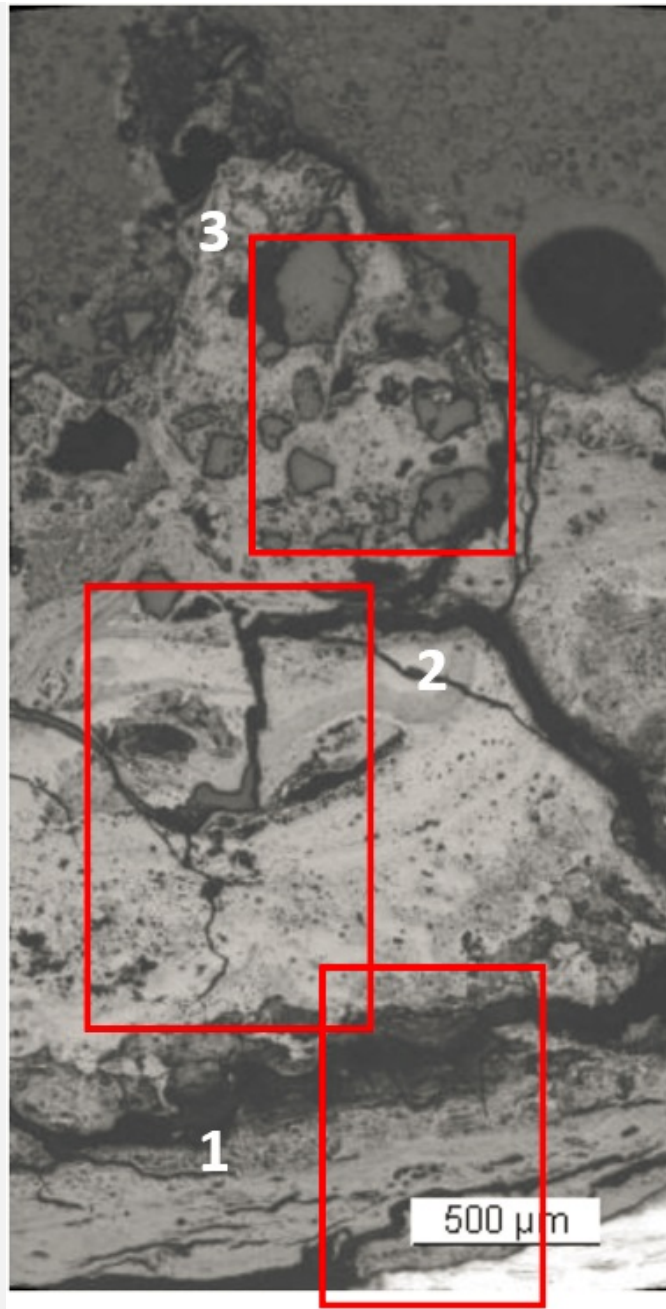
Fig. 7: Micrograph of the corrosion layer from Fig. 3 showing the metal - corrosion crust interface (detail, rotated by 45°) and corresponding to the stratigraphy of Fig. 4, unetched, bright field. The areas 1 (for CP3), 2 (for CP2) and 3 (for CP3) selected for elemental chemical distribution (Fig. 9) are marked by red rectangles,

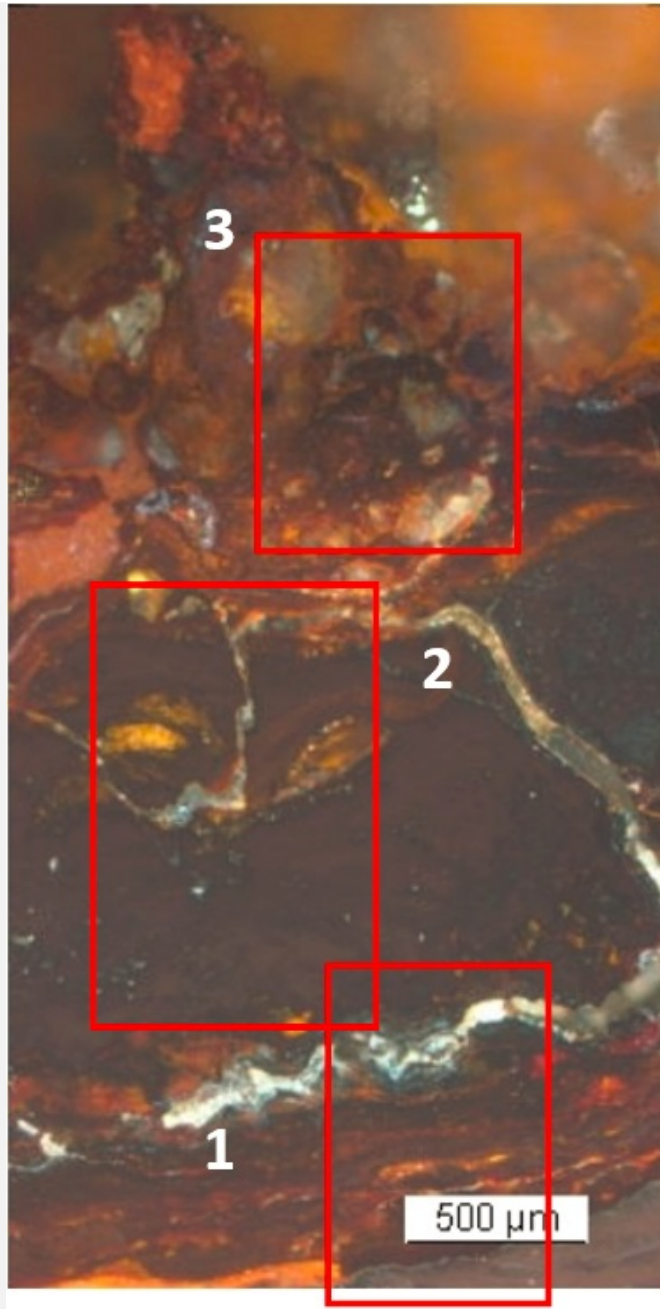
Fig. 8: Micrograph (same as Fig.7) and corresponding to the stratigraphy of Fig. 4, polarised light. The inner layer (CP3) is red-brown, area 2 is brown-violet (CP2) and the outer pale brown area contains rock fragment inclusions (CP1),

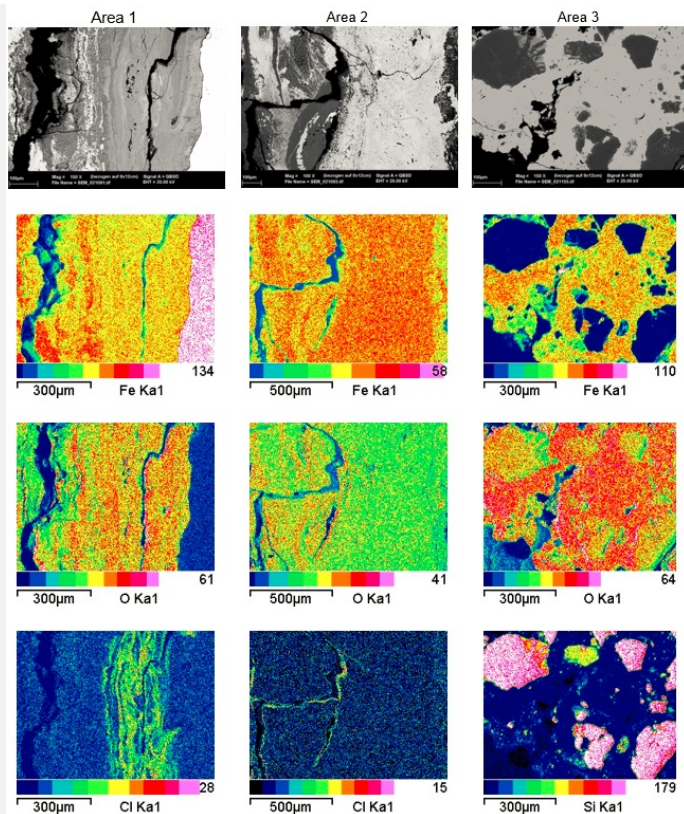
Fig. 9: SEM images, BSE-mode, and elemental chemical distribution of the selected areas from Figs. 7 and 8 (reversed picture rotated by 270°, details). First column: mapping on area 1 (CP3) where an inner layer enriched in Cl appears near the metal surface. 2nd column: area 2 (CP2) where iron oxides prevail. 3rd column: area 3 (CP1) where the outer O-rich layer includes rock fragments rich in Si. Method of examination: SEM/EDS, Lab. Anal. Chem. Empa,

This iron-based sheet is entirely cold worked and hard compared to an annealed metal. The corrosion is massive and masks the shape of the object. The presence of Cl adjacent to the metal surface indicates that the corrosion front is potentially active. The very thick top corrosion layers may have slowed down the corrosion. The object was mentioned as being Roman in Senn Bischofberger 2005, however the chemical composition of the slag inclusions shows that it is a product of the 20th century AD which has been accidentally introduced into a Roman layer.
