CORRODED METAL SHEET FN 655.13.01 – FE ALLOY – MODERN TIMES – SWITZERLAND

Artefact name	Corroded metal sheet FN 655.13.01
Authors	Marianne. Senn (EMPA, Dübendorf, Zurich, Switzerland) & Christian. Degrigny (HE-Arc CR, Neuchâtel, Neuchâtel, Switzerland)
Url	/artefacts/696/

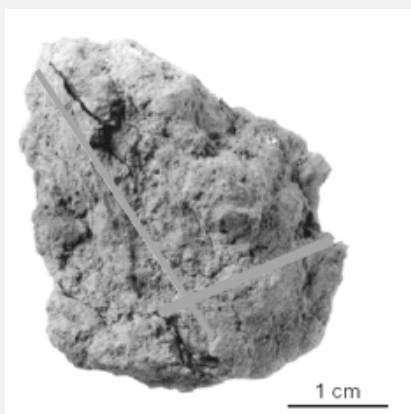
Fig. 1: Metal sheet (after Senn Bischofberger 2005, 137),

Description of the artefact	Metal (iron-based) sheet with middle rib. The shape is no longer discernible (Fig. 1). The metal is covered by a thick corrosion crust. Dimensions: L = 4.5cm; WT = 35g.
Type of artefact	Iron (and steel) sheet
Origin	Steinmöri, Neftenbach / Dorf Neftenbach, Zurich, Switzerland
Recovering date	Excavation of the Roman villa, 1986-1990, phase S2, Stbl.2 (2nd/3rd century AD)
Chronology category	Modern Times
chronology tpq	<input type="text" value="1900"/> A.D. ▾
chronology taq	<input type="text" value="2000"/> A.D. ▾
Chronology comment	Product of the 20th century AD introduced accidentally into a Roman layer
Burial conditions / environment	Soil
Artefact location	Kantonsarchäologie, Dübendorf, Zurich
Owner	Kantonsarchäologie, Dübendorf, Zurich

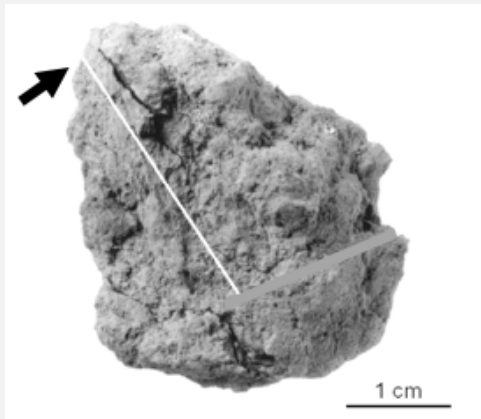
Fig. 2: Location of sampling area,

Description of sample	A longitudinal cut has been made through the sheet (Fig. 2). Large parts of the corrosion crust fell off during sampling (Fig. 3).
Alloy	Fe Alloy
Technology	Forged with final cold work
Lab number of sample	NEF 655
Sample location	Empa (Marianne Senn)
Responsible institution	Kantonsarchäologie, Dübendorf, Zurich
Date and aim of sampling	2000, metallography

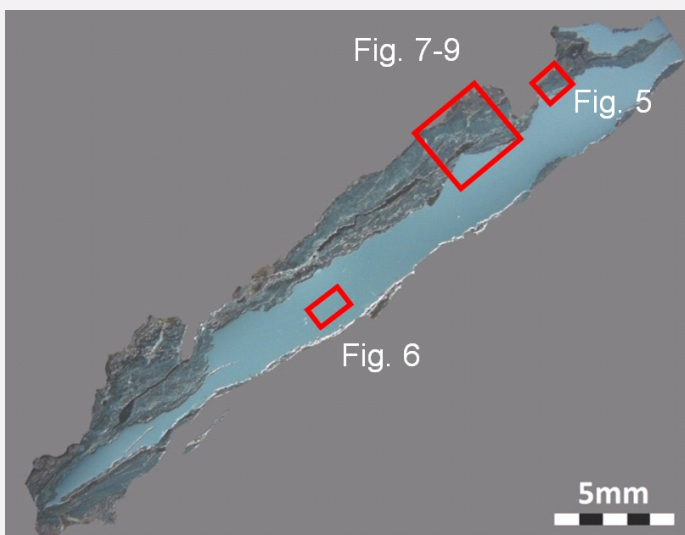
Fig. 3: Micrograph of the cross-section of the iron-based sheet showing the location of Figs. 5 to 9,

The corrosion is massive and large parts of the outer corrosion layers have been lost during the sample preparation. The heavily cracked corrosion crust represents about one third of the thickness of the sample (Fig. 3) and is located on one side of the metal (the rest having been lost during the cutting process). It does not show well defined layers. Despite this, three areas can be distinguished (Figs. 7 and 8). Adhering to the metal (area 1), we find an orange-red-brown layer enriched in Cl (CP3 in Fig. 4, Fig. 9 and Table 3). The dark or violet middle area 2 is richer in Fe (CP2 in Fig. 4). The outer area 3 is red-brown (CP1 in Fig. 4) and strongly contaminated by soil material (rock fragment inclusion and elements like Si, Al, P etc.). This layer is enriched in O (Fig. 9).

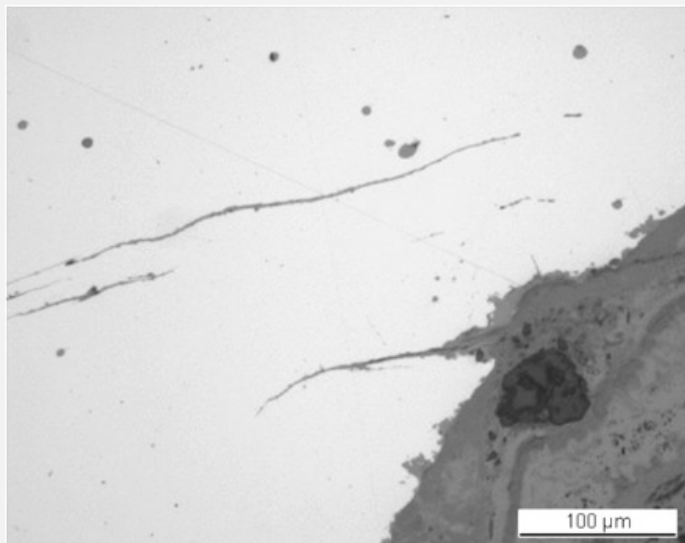
The remaining metal is an iron containing elevated (more than 1g/kg) concentrations of Co and Ni (Table 1), small round slag inclusions and cracks resulting from corrosion and deformation (Fig. 5). The composition of the round, elongated slag inclusions is similar to wüstite-FeO (Table 2). Iron reduced in the direct smelting process never contains such pure compounds and only FeO inclusions. In modern steels FeO occurs in low carbon alloys and Armco-iron (Schumann 1991, 474). After etching, the cross-section shows a heavily deformed ferritic microstructure from cold working (Fig. 6). The cracks have the same orientation as the deformation. The average hardness of the metal is HV1 195.

Fig. 5: Micrograph of metal sample from Fig. 3 (inverted picture, detail), unetched, bright field. In white the metal with round slag inclusions as well as cracks filled with corrosion products,

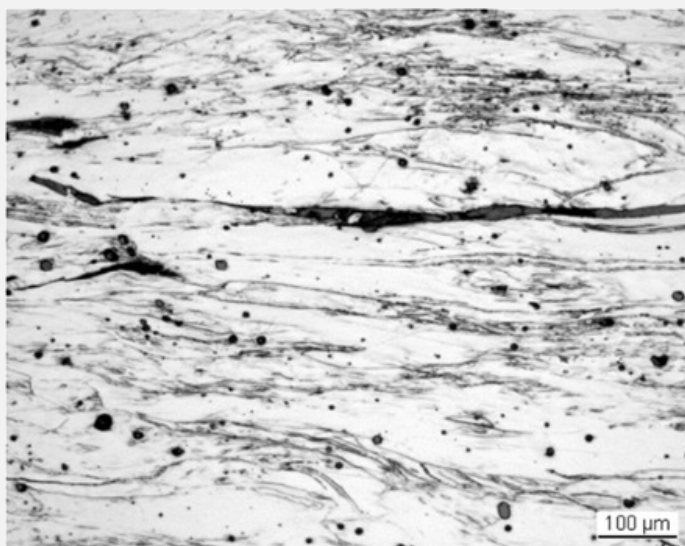
Fig. 6: Micrograph of metal sample from Fig. 3 (detail), etched, bright field. The heavily cold worked metal shows elongated grains with nearly invisible grain boundaries and cracks parallel to the grains,

Microstructure	Heavily deformed ferritic microstructure
First metal element	Fe
Other metal elements	Co, Ni

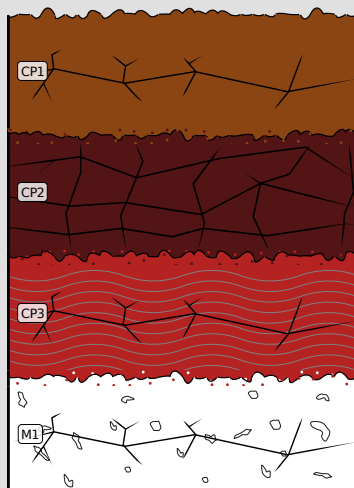
Fig. 4: Stratigraphic representation of the iron-based sheet in cross-section (dark field) using the MiCorr application. The characteristics of the strata are only accessible by clicking on the drawing that redirects you to the search tool by stratigraphy representation. This representation can be compared to Figs. 7 and 8, Credit HE-Arc CR.

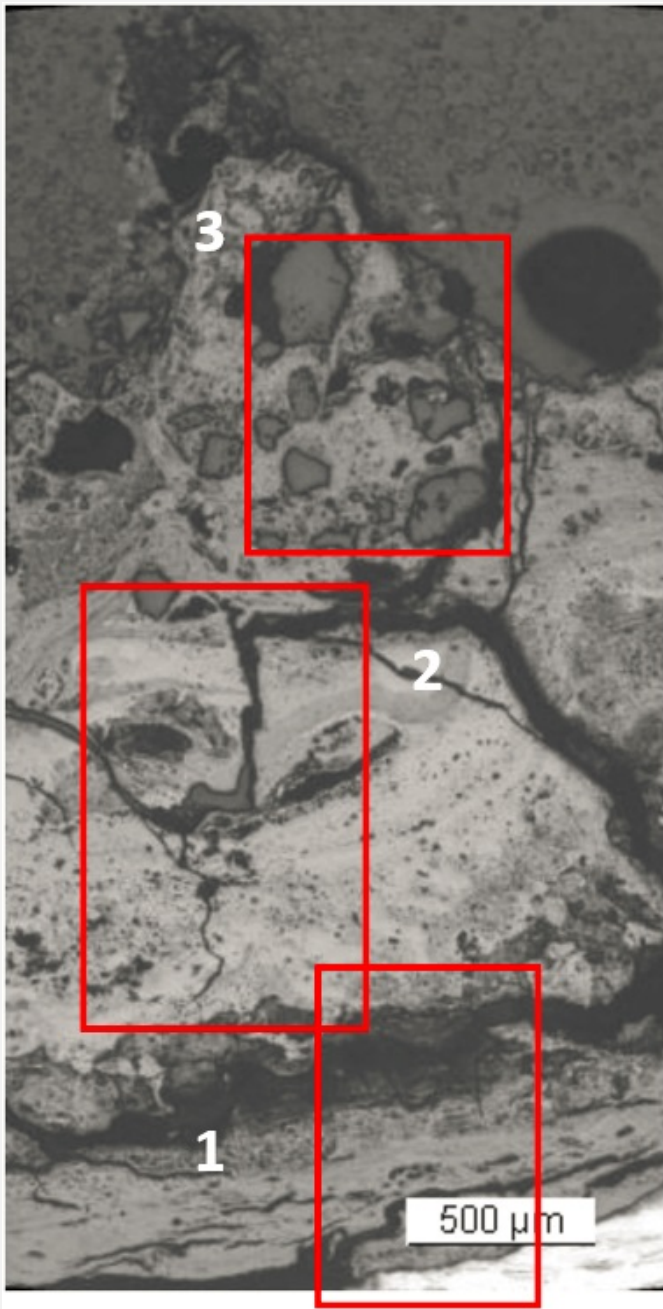
Fig. 7: Micrograph of the corrosion layer from Fig. 3 showing the metal - corrosion crust interface (detail, rotated by 45°) and corresponding to the stratigraphy of Fig. 4, unetched, bright field. The areas 1 (for CP3), 2 (for CP2) and 3 (for CP3) selected for elemental chemical distribution (Fig. 9) are marked by red rectangles,

Fig. 8: Micrograph (same as Fig.7) and corresponding to the stratigraphy of Fig. 4, polarised light. The inner layer (CP3) is red-brown, area 2 is brown-violet (CP2) and the outer pale brown area contains rock fragment inclusions (CP1),

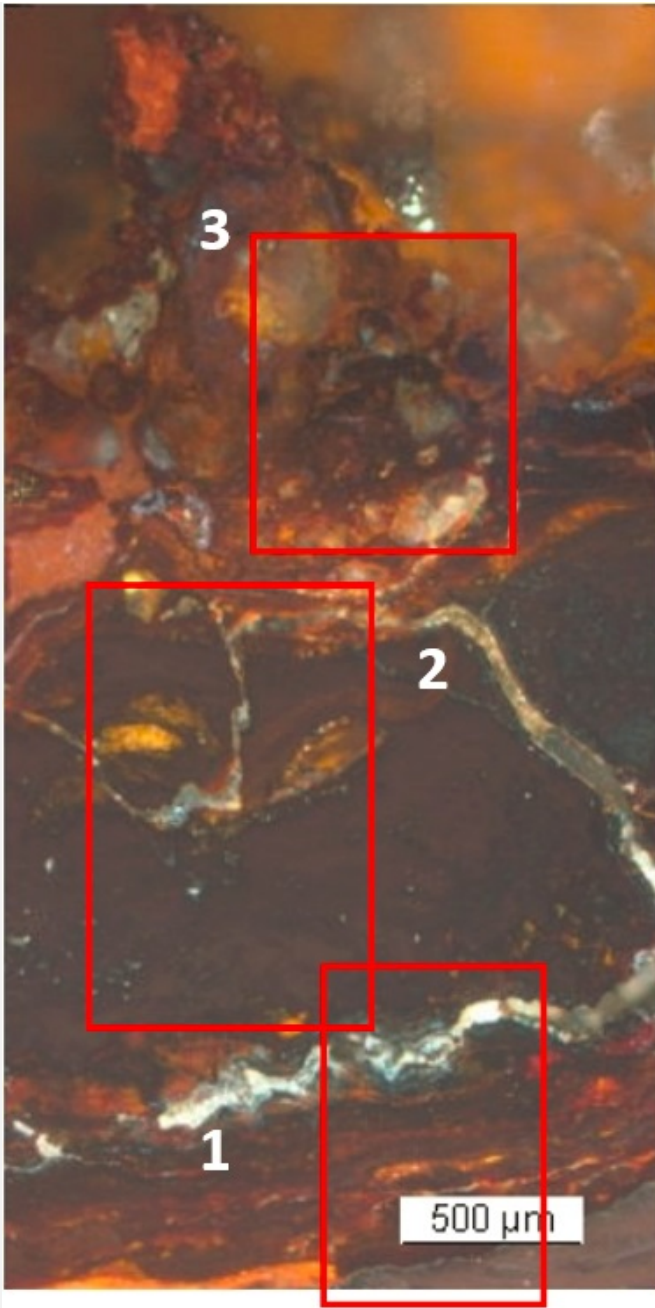
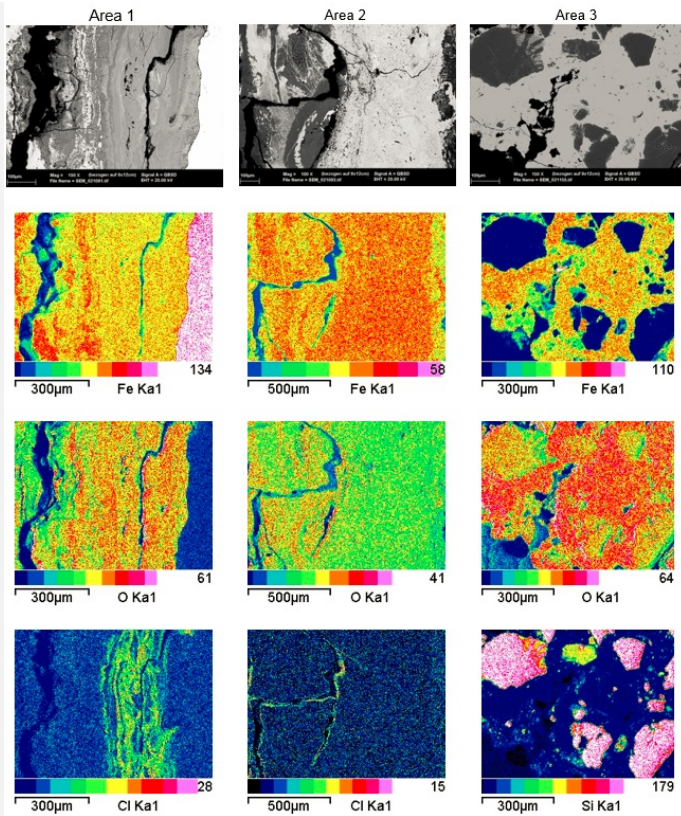
Fig. 9: SEM images, BSE-mode, and elemental chemical distribution of the selected areas from Figs. 7 and 8 (reversed picture rotated by 270°, details). First column: mapping on area 1 (CP3) where an inner layer enriched in Cl appears near the metal surface. 2nd column: area 2 (CP2) where iron oxides prevail. 3rd column: area 3 (CP1) where the outer O-rich layer includes rock fragments rich in Si. Method of examination: SEM/EDS, Lab. Anal. Chem. Empa,

This iron-based sheet is entirely cold worked and hard compared to an annealed metal. The corrosion is massive and masks the shape of the object. The presence of Cl adjacent to the metal surface indicates that the corrosion front is potentially active. The very thick top corrosion layers may have slowed down the corrosion. The object was mentioned as being Roman in Senn Bischofberger 2005, however the chemical composition of the slag inclusions shows that it is a product of the 20th century AD which has been accidentally introduced into a Roman layer.
