CHISEL POINT DEV 995 1069 PR – EUTECTOID TO HYPEREUTECTOID STEEL – EARLY MEDIEVAL TIMES – SWITZERLAND

Artefact name Chisel point DEV 995 1069 PR

Authors Marianne. Senn (EMPA, Dübendorf, Zurich, Switzerland) & Christian. Degryny (HE-Arc CR, Neuchâtel, Neuchâtel, Switzerland)

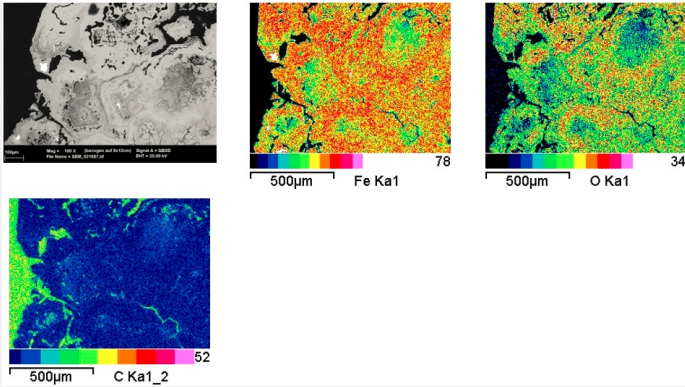
Table 3: Chemical composition (mass %) of the corrosion crust (from Figs. 11-14). Method of analysis: SEM/EDS, Laboratory of Analytical Chemistry, Empa.

Fig. 13: SEM image, BSE-mode, and elemental chemical distribution of the selected area from Fig. 11 (rotated by 45°). Method of examination: SEM/EDS, Laboratory of Analytical Chemistry, Empa,

Fig. 14: SEM image, BSE-mode, and elemental chemical distribution of the selected area from Fig. 11 (rotated by 45°). Method of examination: SEM/EDS, Laboratory of Analytical Chemistry, Empa,

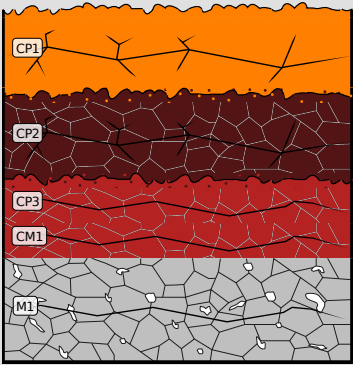
Fig. 4: Stratigraphic representation of the chisel point in cross-section (dark field) using the MiCorr application. The characteristics of the strata are only accessible by clicking on the drawing that redirects you to the search tool by stratigraphy representation. This representation can be compared to Fig. 11, Credit HE-Arc CR.
