CHISEL POINT DEV 995 1069 PR – EUTECTOID TO HYPEREUTECTOID STEEL – EARLY MEDIEVAL TIMES – SWITZERLAND

Artefact name	Chisel point DEV 995 1069 PR
Authors	Marianne. Senn (EMPA, Dübendorf, Zurich, Switzerland) & Christian. Degrieny (HE-Arc CR, Neuchâtel, Neuchâtel, Switzerland)
Url	/artefacts/700/

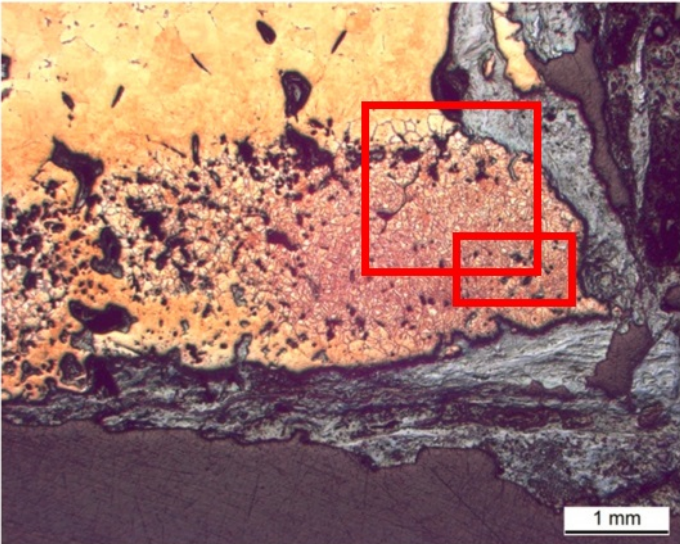
The remaining metal is a eutectoid to hypereutectoid steel (C 0.8-1 mass%) with cracks and porosity (Figs. 5 and 6). Its composition is given in Table 1 (except Fe). Of the trace elements, only Ni reaches a medium concentration (Ni 0.07 mass%). The composition and the high Ni/Co ratio are atypical for iron worked in smithies of the settlement at Develier-Courtételle JU, CH. The few slag inclusions and their chemical composition confirm this (Table 2). The slag is rich in CaO whereas the pisolithic or bean ore worked in the Central Jura smelting district is rich in Al₂O₃. The slag inclusions cannot be smithing slag because the artefact is formed from one piece of metal. The slag probably incorporated while refining the bloom or during the bloom smelting process. The ore from which this metal was smelted cannot yet be identified. Intergranular corrosion has developed, penetrating into the metal structure (Fig. 6). The etched metal shows a dominant martensitic structure, typical of quench hardened steel (Figs. 5, 7, 8 and 9). The characteristic forms of the martensite are non-organised needles (Fig. 8). In restricted areas bainite nodules occur (Figs. 7 and 8). In the centre of the point, hypereutectoid steel is composed of cementite in the grain boundaries and in needle like shapes within the grains (Fig. 10). Hypereutectoid regions also occur in the centre of the shaft and on its left surface (Fig. 5). Here the hypereutectoid steel is composed of martensite and cementite in the grain boundaries and in needle form within the grains (Figs. 6 and 9). Nevertheless, most of the chisel is dominated by eutectoid steel. The average hardness of the quench hardened eutectoid steel is about HV1 690. In the bainite nodules the average hardness drops to about HV1 350, the martensite has an average hardness of HV1 750.

Fig. 5: Micrograph of the metal sample from Fig. 3 (inverted picture, detail), etched, bright field. The metal contains porosity and cracks (in black). The micrographs of Figs. 6 and 9 are marked by the top and bottom rectangles respectively,

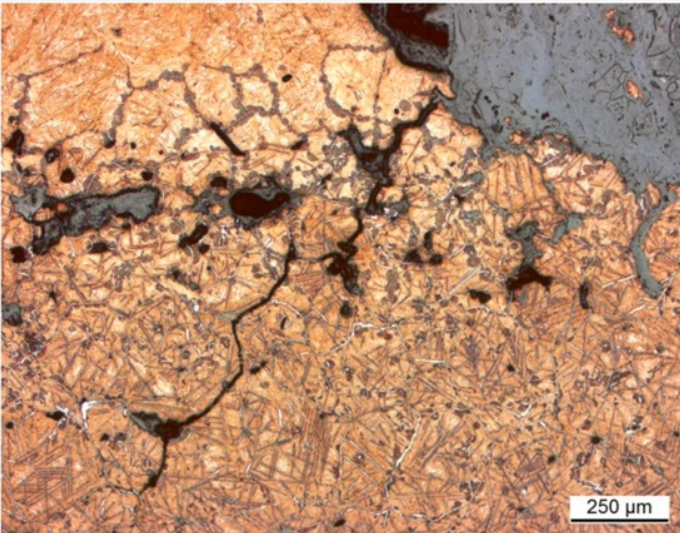
Fig. 6: Micrograph of the metal sample, detail from Fig. 5, etched, bright field. We observe martensite (in orange), cementite (in grey), porosity and intergranular cracks (in black) and corrosion,

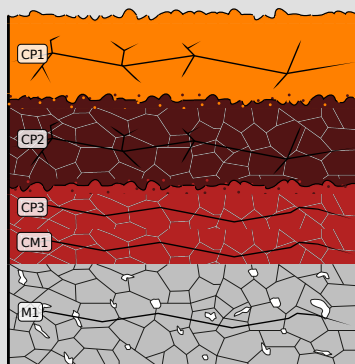
Fig. 4: Stratigraphic representation of the chisel point in cross-section (dark field) using the MiCorr application. The characteristics of the strata are only accessible by clicking on the drawing that redirects you to the search tool by stratigraphy representation. This representation can be compared to Fig. 11, Credit HE-Arc CR.
