# CHISEL POINT DEV 995/1069 PR – EUTECTOID TO HYPEREUTECTOID STEEL – EARLY MEDIEVAL TIMES – SWITZERLAND

| Artefact name | Chisel point DEV 995/1069 PR |
| Authors | Marianne. Senn (EMPA, Dübendorf, Zurich, Switzerland) & Christian. Degrieny (HE-Arc CR, Neuchâtel, Neuchâtel, Switzerland) |

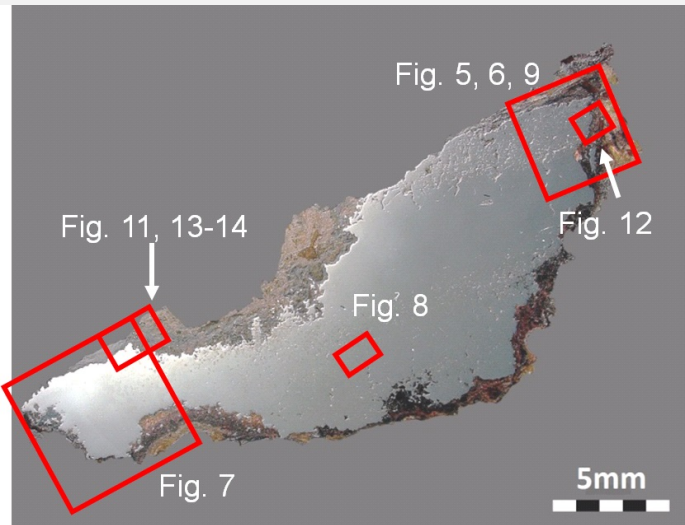
Fig. 3: Micrograph of the cross-section of the chisel point showing the location of Figs. 5 to 9 and 11 to 14,

A longitudinal cut from a chisel point (Figs. 2 and 3) undertaken after restoration. Dimensions: L = 30mm; W = 11mm (approximately).

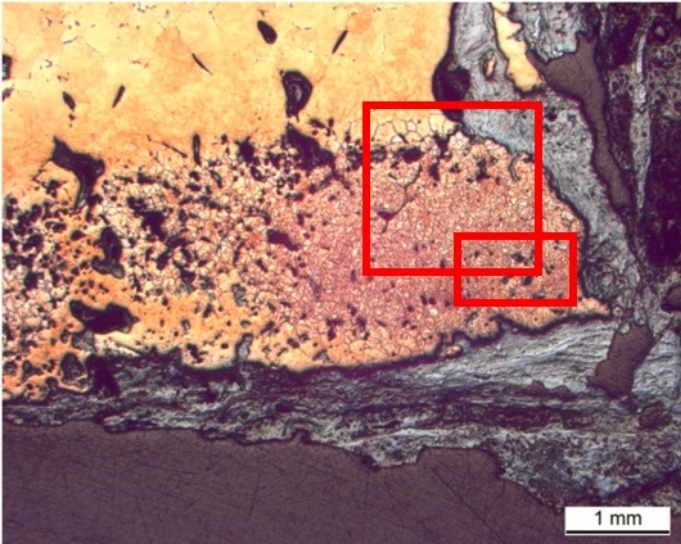
The remaining metal is a eutectoid to hypereutectoid steel (C 0.8-1 mass%) with cracks and porosity (Figs. 5 and 6). Its composition is given in Table 1 (except Fe). Of the trace elements, only Ni reaches a medium concentration (Ni 0.07 mass%). The composition and the high Ni/Co ratio are atypical for iron worked in smithies of the settlement at Develier-Courtételle JU, CH. The few slag inclusions and their chemical composition confirm this (Table 2). The slag is rich in CaO whereas the pisolithic or bean ore worked in the Central Jura smelting district is rich in Al<sub>2</sub>O<sub>3</sub>. The slag inclusions cannot be smithing slag because the artefact is formed from one piece of metal. The slag probably incorporated while refining the bloom or during the bloom smelting process. The ore from which this metal was smelted cannot yet be identified. Intergranular corrosion has developed, penetrating into the metal structure (Fig. 6). The etched metal shows a dominant martensitic structure, typical of quench hardened steel (Figs. 5, 7, 8 and 9). The characteristic forms of the martensite are non-organised needles (Fig. 8). In restricted areas bainite nodules occur (Figs. 7 and 8). In the centre of the point, hypereutectoid steel is composed of cementite in the grain boundaries and in needle like shapes within the grains (Fig. 10). Hypereutectoid regions also occur in the centre of the shaft and on its left surface (Fig. 5). Here the hypereutectoid steel is composed of martensite and cementite in the grain boundaries and in needle form within the grains (Figs. 6 and 9). Nevertheless, most of the chisel is dominated by eutectoid steel. The average hardness of the quench hardened eutectoid steel is about HV1 690. In the bainite nodules the average hardness drops to about HV1 350, the martensite has an average hardness of HV1 750.

Fig. 5: Micrograph of the metal sample from Fig. 3 (inverted picture, detail), etched, bright field. The metal contains porosity and cracks (in black). The micrographs of Figs. 6 and 9 are marked by the top and bottom rectangles respectively,

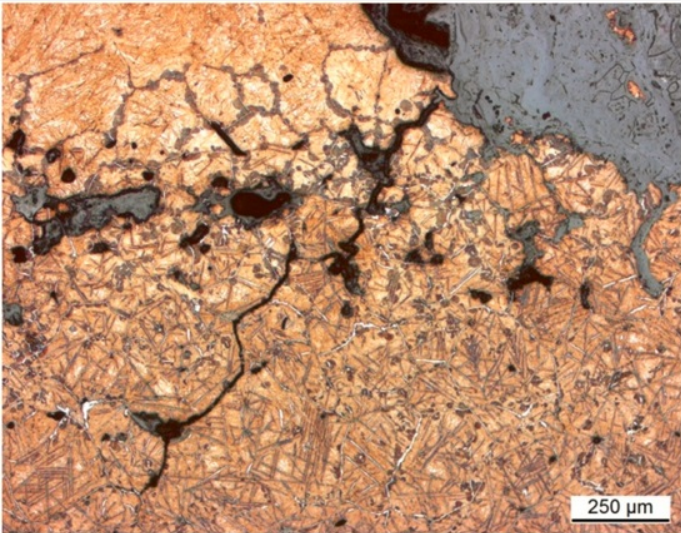
Fig. 6: Micrograph of the metal sample, detail from Fig. 5, etched, bright field. We observe martensite (in orange), cementite (in grey), porosity and intergranular cracks (in black) and corrosion,

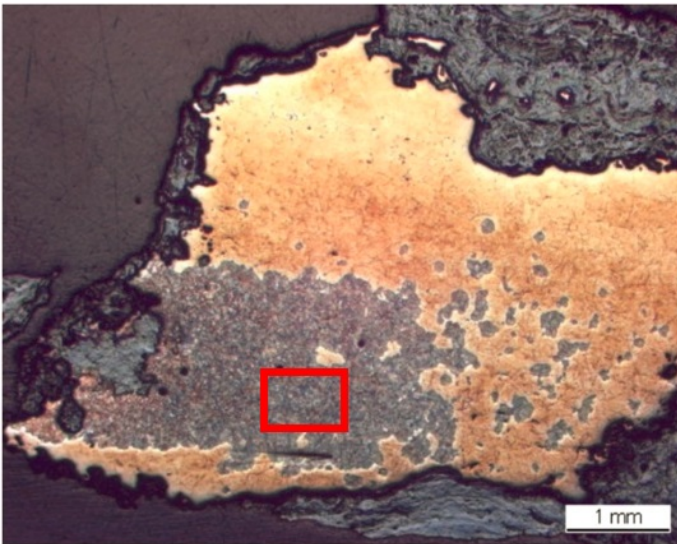
Fig. 7: Micrograph of the metal sample from Fig. 3 (inverted picture, detail), etched, bright field. We observe the metal with martensite (orange) and bainite nodules (blue). The micrograph of Fig. 10 is marked by a rectangle,

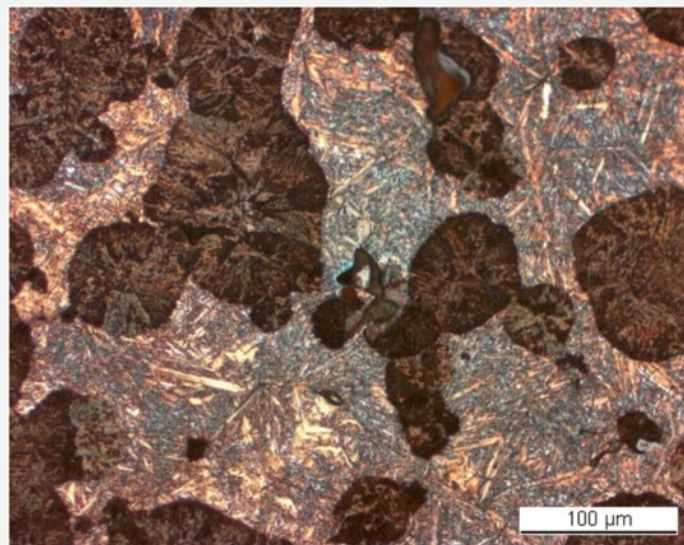
Fig. 8: Micrograph of the metal sample from Fig. 3 (detail), etched, bright field. We observe dark bainite nodules combined with martensite needles,

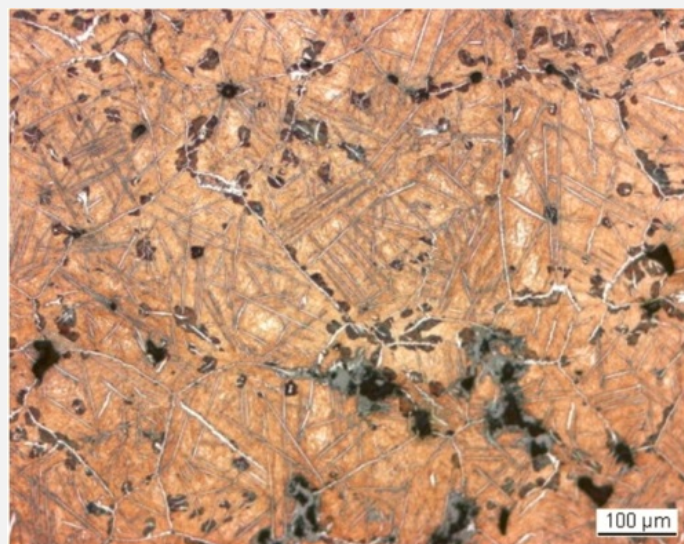
Fig. 9: Micrograph of the metal sample, detail from Fig. 5, etched, bright field. Hypereutectoid steel with a structure of cementite in white in the grain boundaries and in needle form combined with martensite (pink). Some bainite occurs around the grain boundaries,

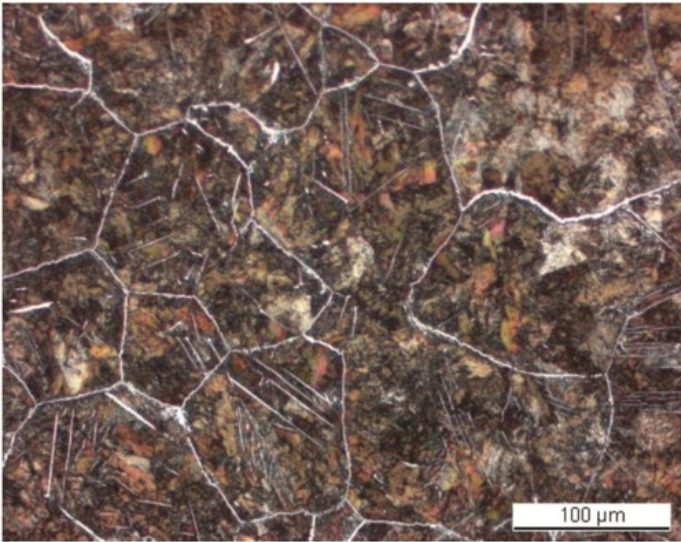
Fig. 10: Micrograph of the metal sample, detail from Fig. 7, etched, bright field. Hypereutectoid steel with a structure of cementite in white in the grain boundaries and in needle form combined with bainite (dark),

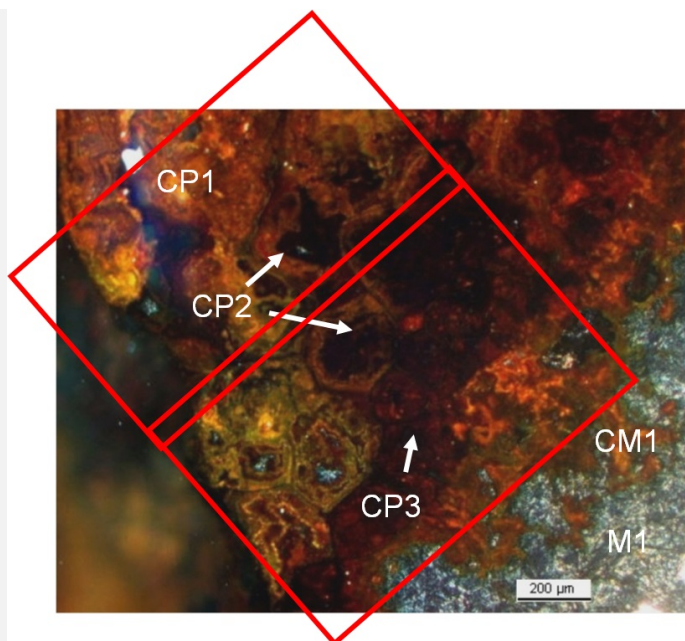
The metal is heavily corroded and the thickness of the corrosion crust is irregular, but averages about 0.5mm. The corrosion products enclose different ghost structures: the corrosion crust has preserved the shape of polygonal grains (Figs. 11 and 13) and cementite needles (Fig. 12). Under polarised light, the corrosion products at the metal - corrosion crust interface are dark-red and form an inner S-rich layer (CP3, Figs. 11 and 13). Cl occurs locally (CP3) and C is present in layers CP2 and CP3 (Fig. 13). The outer layer of the corrosion products (CP1) is orange and contains more O than the inner layer CP3 (Figs. 11 and 14).

Fig. 11: Micrograph showing the metal - corrosion crust interface from Fig. 3 (rotated by 270°, detail) and corresponding to the stratigraphy of Fig. 4, unetched, polarised light. Polygonal grains are visible as ghost structure in the corrosion crust. The selected areas for elemental chemical distribution (Figs. 13 and 14) are marked by two rectangles (bottom: Fig. 13 and top: Fig. 14),

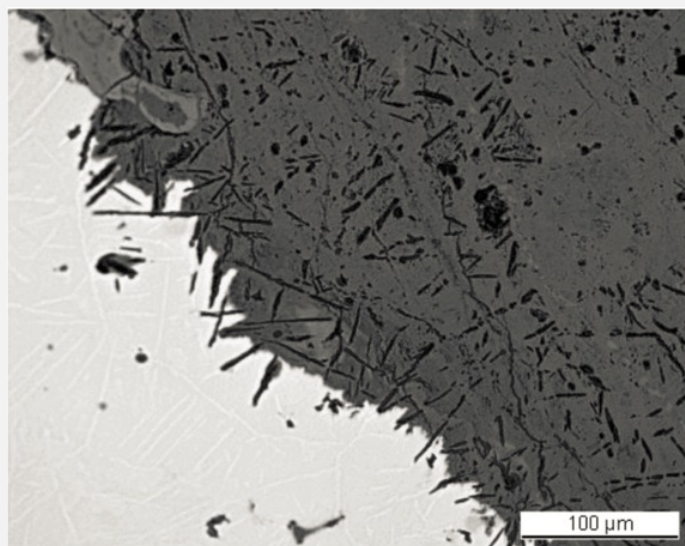
Fig. 12: Micrograph showing the metal - corrosion crust interface from Fig. 3 (detail), unetched, bright field. The cementite is visible as white needles in the metal and its ghost structure as black needles in the corrosion crust,

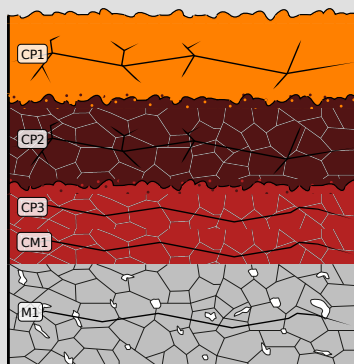
Fig. 4: Stratigraphic representation of the chisel point in cross-section (dark field) using the MiCorr application. The characteristics of the strata are only accessible by clicking on the drawing that redirects you to the search tool by stratigraphy representation. This representation can be compared to Fig. 11, Credit HE-Arc CR.
