# FITTING ON BACK PANEL OF A MILITARY CARRIAGE – THOMAS STEEL – MODERN TIMES – SWITZERLAND

| <b>Artefact name</b> | Fitting on back panel of a military carriage |
| <b>Authors</b> | Marianne. Senn (EMPA, Dübendorf, Zurich, Switzerland) & Christian. Degryny (HE-Arc CR, Neuchâtel, Neuchâtel, Switzerland) |

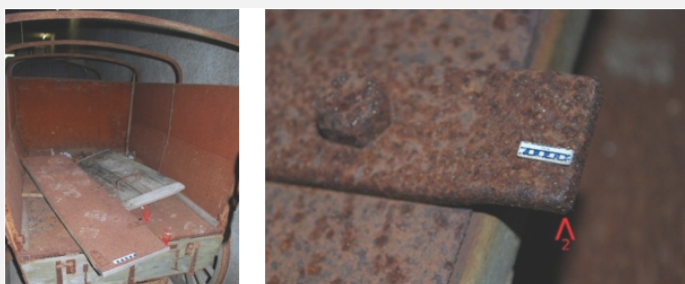
Fig. 1: Fitting on back panel of a military carriage (©Tarchini),

| <b>Description of the artefact</b> | Fitting on back panel, first exposed outdoors, later indoors (Fig. 1). Uniform corrosion and pitting corrosion are visible. |

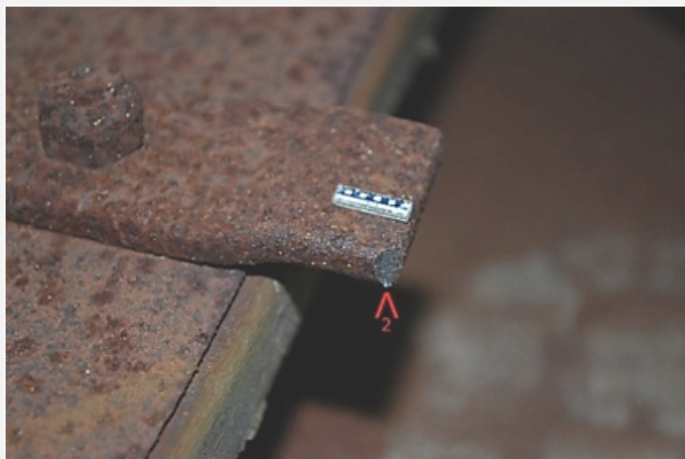
Fig. 2: Location of sampling area,

| <b>Description of sample</b> | This sample is a cut from the corner of one of the two fittings on the back panel (Fig. 2). The metal is covered by a thin corrosion layer (Fig. 3). |

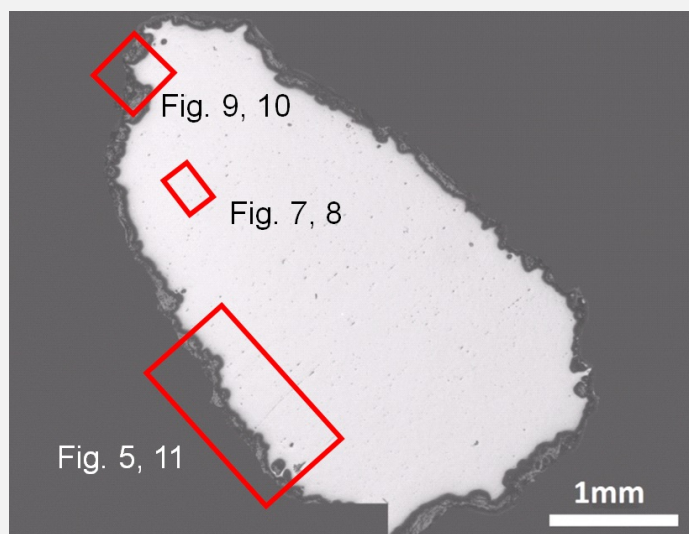
Fig. 3: Micrograph of the cross-section of the sample taken from the fitting showing the location of Figs. 5 and 7 to 11,

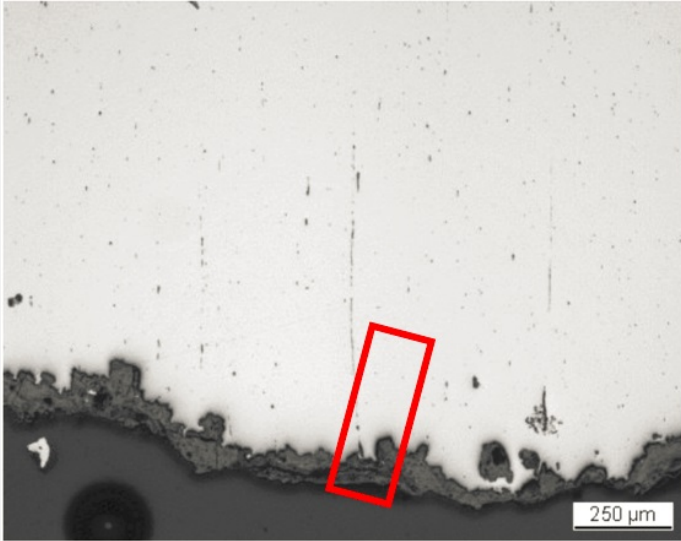
The remaining metal is a Mn-rich soft steel (C content around 0.1 mass%) containing manganese sulphide inclusions with a varying Fe content (Tables 1 and 2). The numerous inclusions form parallel rows (Fig. 5). This orientation is typical for hot rolled metal. After etching with Oberhoffer's reagent, three main welding seams (P-rich) become visible (Fig. 6). Near the surface they are also outlined by corrosion (Figs. 5 and 11). After nital etching, the metal shows a ferritic structure with tertiary cementite and lamellar pearlite at the grain boundaries (Figs. 7 and 8). The grains are small with an ASTM grain size of 10 and are recrystallized due to annealing after hot rolling. The average hardness of the metal is HV1 165. The hardness is slightly high for such a structure and this is due to the Mn content of the metal. The chemical composition, especially the Mn content and the presence of carbo-nitrides (not analysed here), is typical for Thomas steel.

Fig. 5: Micrograph of the metal sample from Fig. 3 (rotated by 270°, detail), unetched, bright field. We observe the metal including welding seams outlined by corrosion products and MnS inclusions. The area selected for elemental chemical distribution (Fig. 11) is marked by a red rectangle,

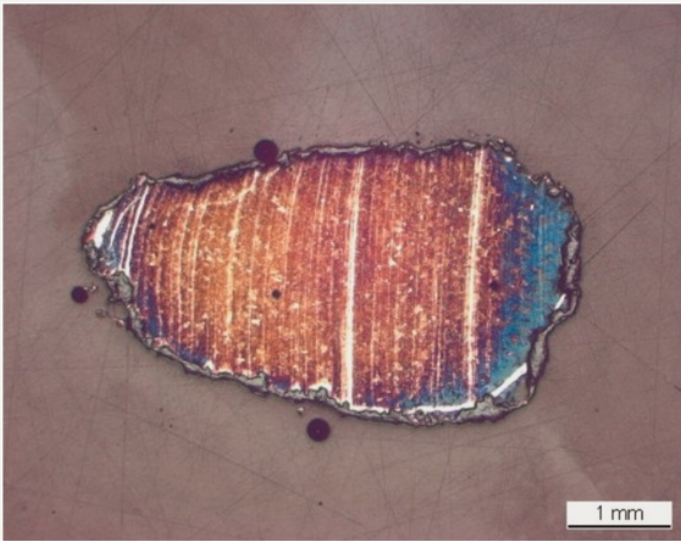
Fig. 6: Micrograph of the metal sample from Fig. 3, etched with Oberhoffer's reagent, bright field. We observe three P-rich welding seams in white,

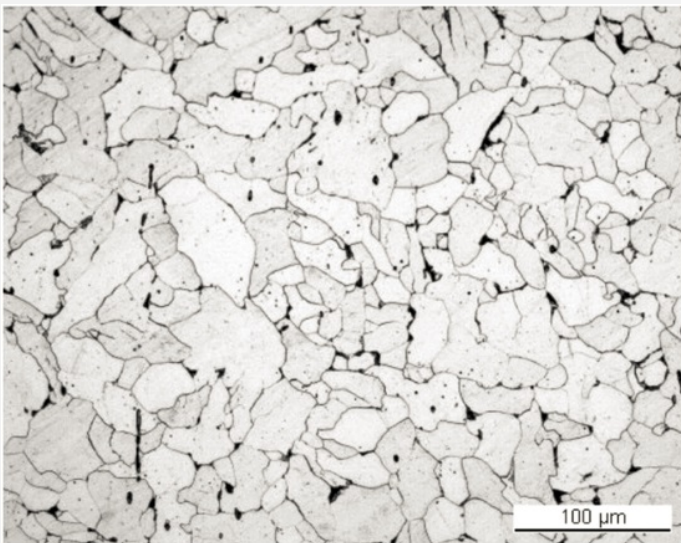
Fig. 7: Micrograph of the metal sample, nital etched, bright field. We observe tertiary cementite (black) on the grain boundaries,

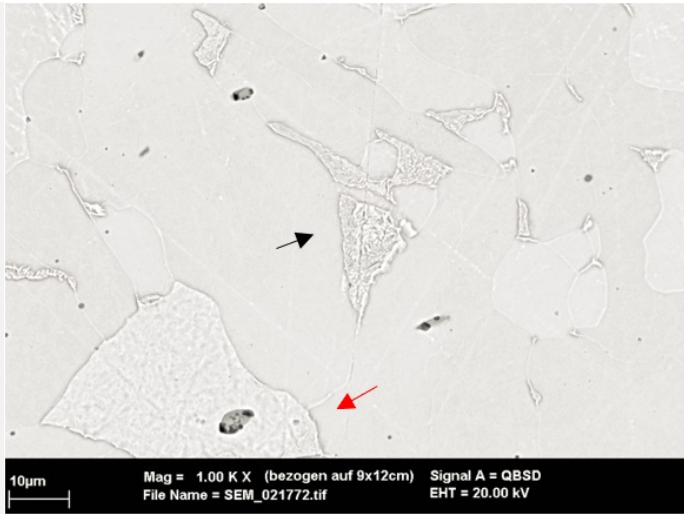
Fig. 8: SEM image of the metal sample from Fig. 3 (detail), BSE-mode, nital etched, bright field. The white ferrite grains contain lamellar pearlite (black arrow) and lenticular grey MnS inclusions (red arrow) in between the grain boundaries,

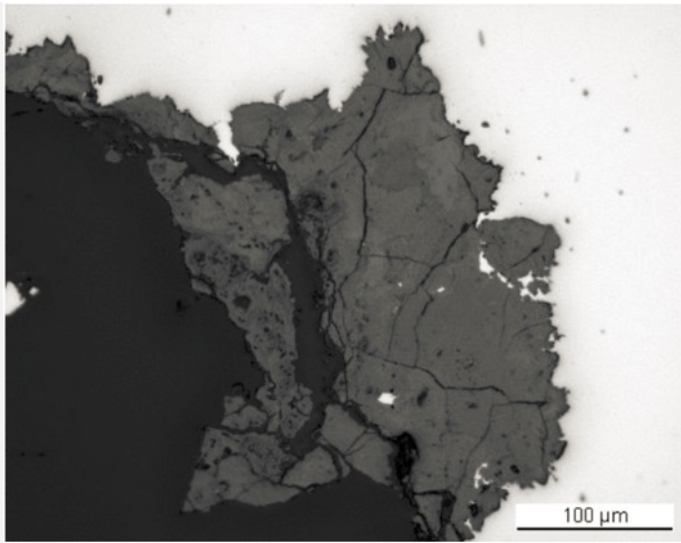
The average thickness of the corrosion products is about 80µm (Figs. 5 and 9). In bright field they appear grey, marbled and heavily cracked (Fig. 9). Under polarised light, the corrosion products appear orange to dark-brown (Fig. 10). At the metal - corrosion products interface they are dark-brown (CP3). The middle part (CP2) is red-orange and the outer part is bright orange (CP1). The elemental mapping of the corrosion layers shows no distinctive stratification, but areas near the metal - corrosion crust interface (CP3) as well as the top surface of the corrosion layer (CP1) seem to have a lower O content (Fig. 11). The O content indicates the presence of iron hydroxides (Table 3). Soil materials (such as rock fragments and dust) are found in the welding seams near the surface.

Fig. 9: Micrograph showing the metal - corrosion crust interface from Fig. 3 (rotated by 270°, detail), unetched, bright field. We observe in white the metal, in grey the corrosion products and in black the resin,

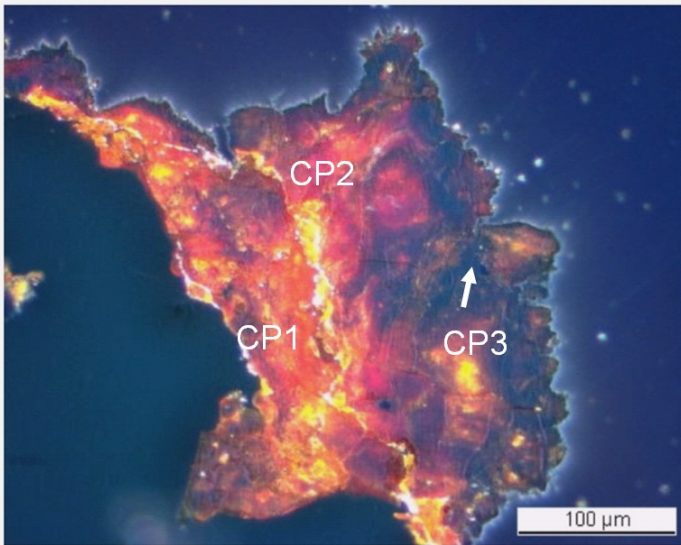
Fig. 10: Micrograph showing the metal - corrosion crust (same as Fig. 9) and corresponding to the stratigraphy of Fig. 4, unetched, polarised light. The corrosion products are dark-brown at the metal - corrosion crust interface and red-orange on the outside,

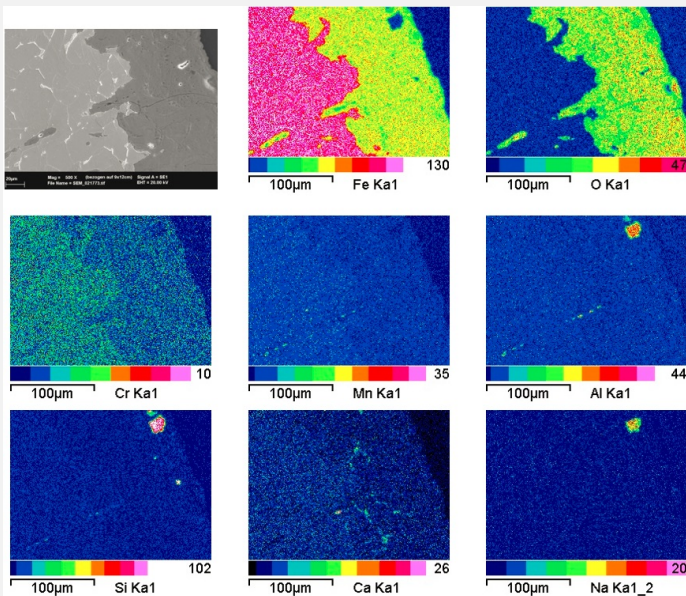
Table 3: Chemical composition (mass %) of the corrosion layer (from Fig. 11). Method of analysis: SEM/EDS, Laboratory of Analytical Chemistry, Empa.

Fig. 11: SEM image, BSE-mode, and elemental chemical distribution of the selected area from Fig. 5 (rotated by 270°, detail). Method of examination: SEM/EDS, Laboratory of Analytical Chemistry, Empa.

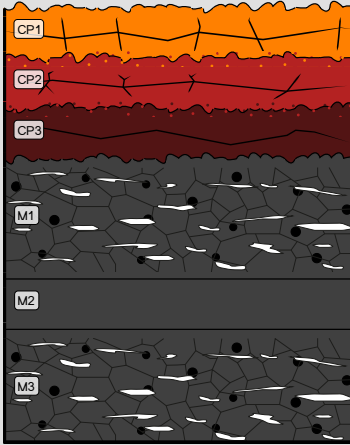
Fig. 4: Stratigraphic representation of the sample taken from the fitting in cross-section (dark field) using the MiCorr application. The characteristics of the strata are only accessible by clicking on the drawing that redirects you to the search tool by stratigraphy representation. This representation showing for the metal part a welding seam (M2) can be compared to Fig. 10, Credit HE-Arc CR.
