# AIRCRAFT REAR FASTENING PLATE VHS-497 – AL ALLOY – MODERN TIMES

**Artefact name** Aircraft rear fastening plate VHS-497

**Authors** Marianne. Senn (EMPA, Dübendorf, Zurich, Switzerland) & Christian. Degrieny (HE-Arc CR, Neuchâtel, Neuchâtel, Switzerland)

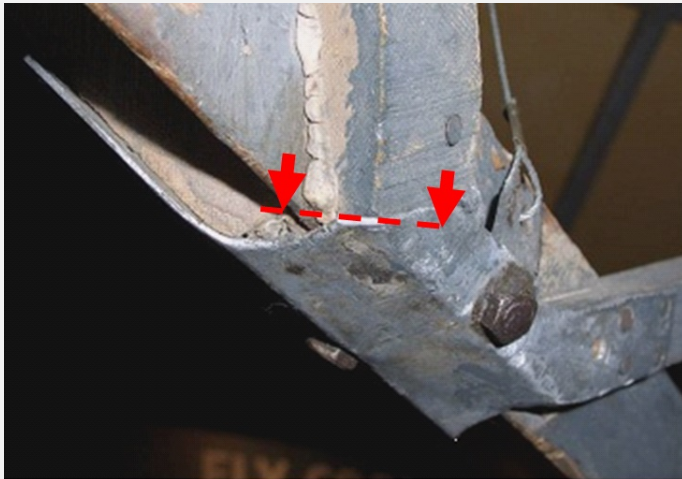
Fig. 2: Location of sampling area,

Sample cut from the corner of the fastening plate (Fig. 2). Dimensions: L = 4mm ; W = 1.2mm.

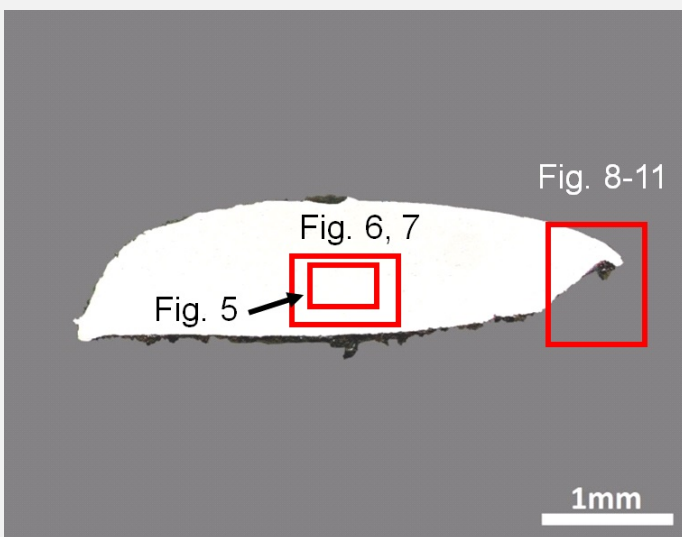
Fig. 3: Micrograph of the cross-section of the sample taken from the back fastening plate showing the location of Figs. 5 to 11,

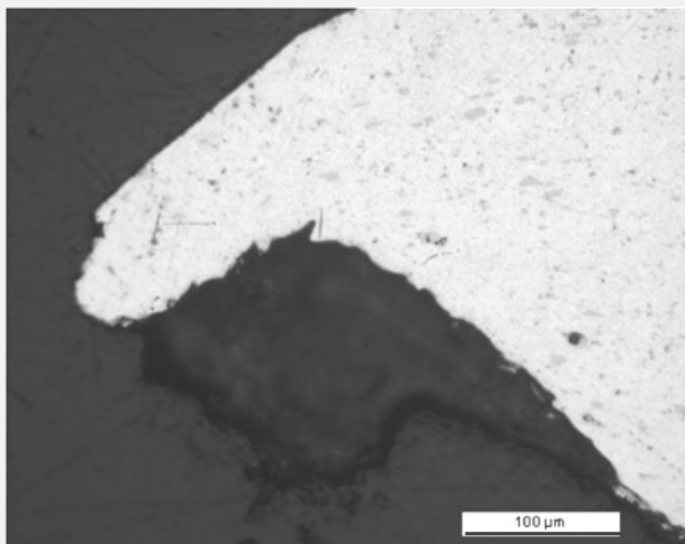
The metal is covered by a very thin corrosion layer (CP1). In addition to this, locally thicker adhering materials can be observed (NMM1, appearing as dark-grey area in Fig. 8). Under polarized light, they appear blue-brown (Fig. 9). Analysis by SEM-EDS indicates that the metal is, as expected, covered by a very thin Al and O-rich layer whereas the particles in the adherent material contain C, O, Si, Ca, Fe, Zn, S and even Ti (Figs. 10 and 11). The location of the adherent material and the presence of both Zn and Ti suggest that it is a residue of a paint coating.

Fig. 8: Micrograph showing the metal - adhering material interface from Fig. 3 (reversed picture, detail), unetched, bright field. We observe in white the metal matrix and dark-grey the adhering material,

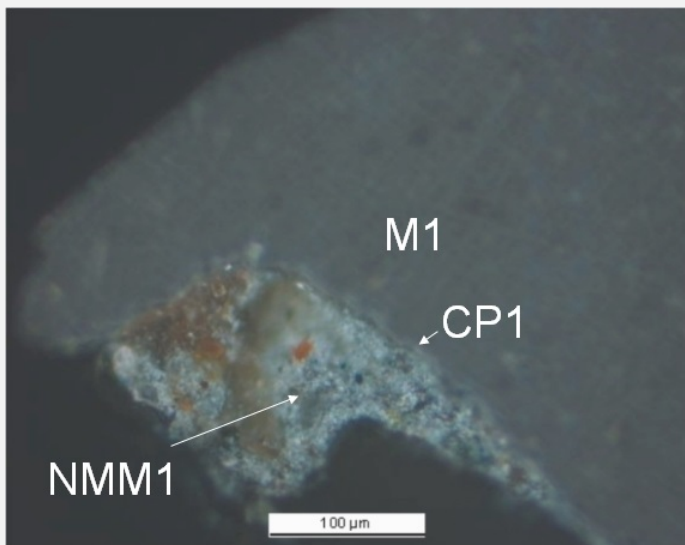
Fig. 9: Micrograph (same as Fig. 8) and corresponding to the stratigraphy of Fig. 4, unetched, polarised light. We observe in grey the metal matrix and blue-brown the adhering material,

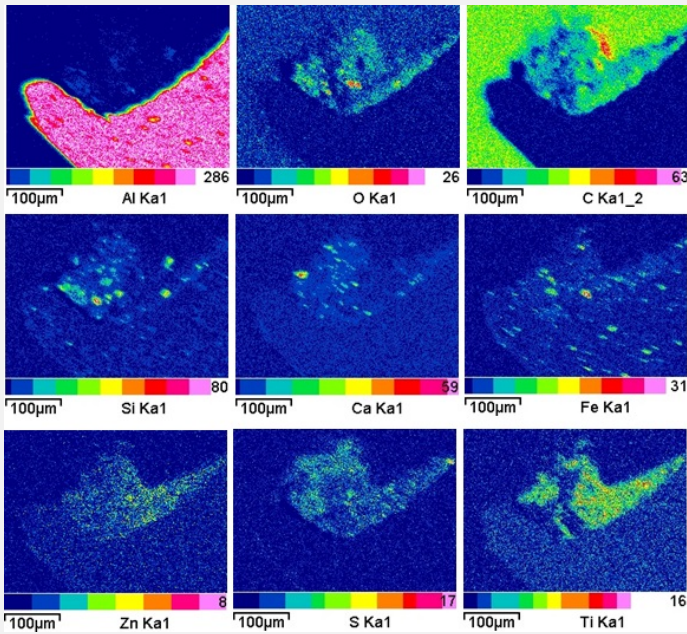
Fig. 11: Elemental chemical distribution of the selected area from Fig. 10. Method of examination: SEM/EDS, Laboratory of Analytical Chemistry, Empa,
