AIRCRAFT REAR FASTENING PLATE VHS-497 - AL ALLOY - MODERN TIMES

Artefact name Aircraft rear fastening plate VHS-497

Authors Marianne. Senn (EMPA, Dübendorf, Zurich, Switzerland) & Christian. Degrigny (HE-Arc CR, Neuchâtel, Neuchâtel, Switzerland)

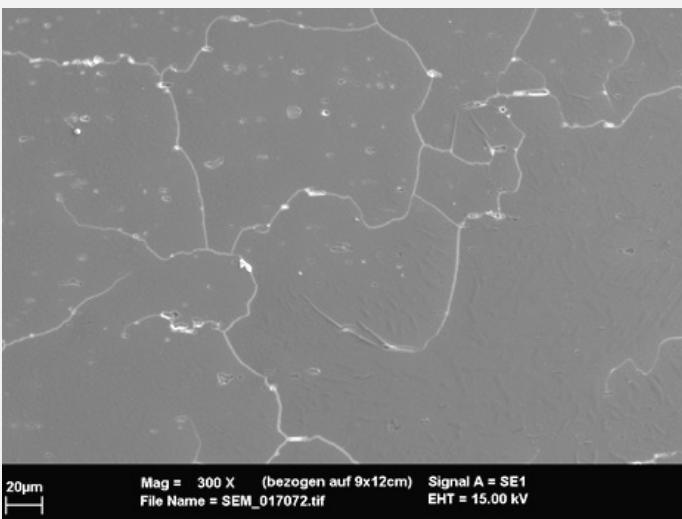
The metal is a relatively pure aluminium alloy with numerous inclusions (Table 1). From the chemical composition of the inclusions they can be interpreted as alpha-AlFeSi intermetallic compounds. In bright field we observe elongated inclusions indicating that the metal was rolled (Fig. 5). The alloy composition is similar to an unalloyed primary aluminium (Al content between 99 and 99.8 mass%). The O content reflects the immediate oxidation of the metal and is not part of the alloy. After etching the organisation of inclusions in rows is more easily seen (Fig. 6). The SEM image shows large grains formed after annealing (Fig. 7). The average hardness of the metal is HV1 40.

Fig. 7: SEM image of the metal sample from Fig. 3 (detail), SE-mode, etched. We observe the presence of large grains and numerous elongated inclusions,

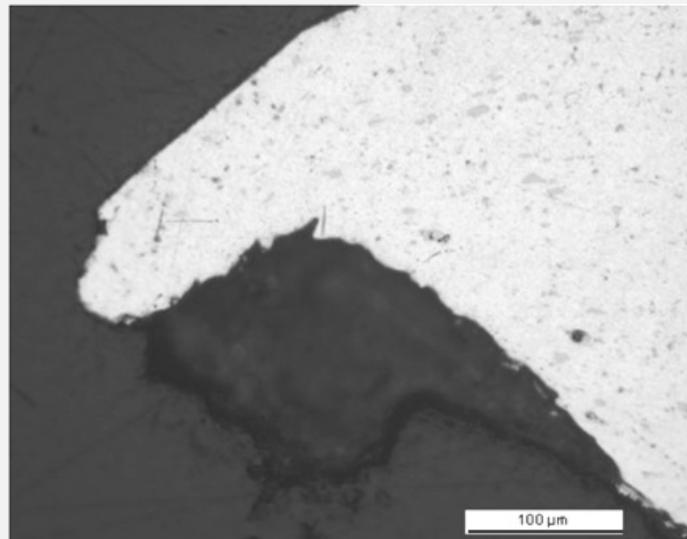
The metal is covered by a very thin corrosion layer (CP1). In addition to this, locally thicker adhering materials can be observed (NMM1, appearing as dark-grey area in Fig. 8). Under polarized light, they appear blue-brown (Fig. 9). Analysis by SEM-EDS indicates that the metal is, as expected, covered by a very thin Al and O-rich layer whereas the particles in the adherent material contain C, O, Si, Ca, Fe, Zn, S and even Ti (Figs. 10 and 11). The location of the adherent material and the presence of both Zn and Ti suggest that it is a residue of a paint coating.

Fig. 8: Micrograph showing the metal - adhering material interface from Fig. 3 (reversed picture, detail), unetched, bright field. We observe in white the metal matrix and dark-grey the adhering material,

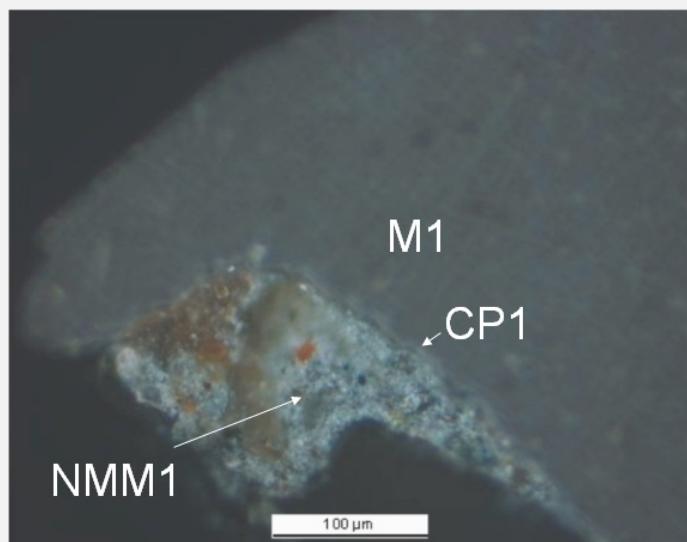
Fig. 9: Micrograph (same as Fig. 8) and corresponding to the stratigraphy of Fig. 4, unetched, polarised light. We observe in grey the metal matrix and blue-brown the adhering material,
