AIRCRAFT REAR FASTENING PLATE VHS-497 – AL ALLOY – MODERN TIMES

Artefact name Aircraft rear fastening plate VHS-497

Authors Marianne. Senn (EMPA, Dübendorf, Zurich, Switzerland) & Christian. Degrieny (HE-Arc CR, Neuchâtel, Neuchâtel, Switzerland)

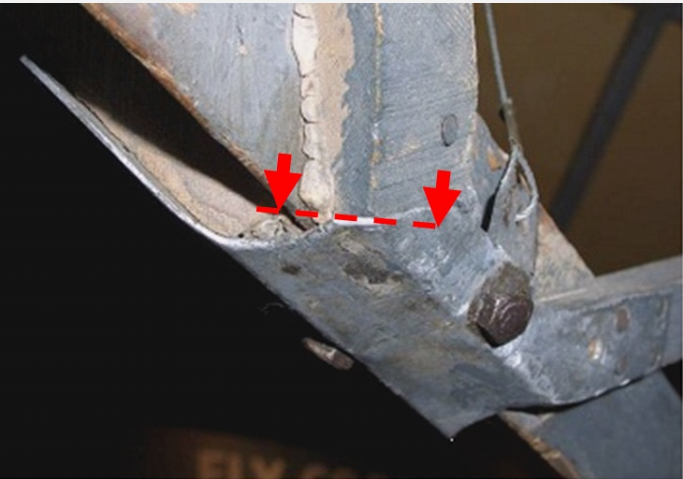
Fig. 2: Location of sampling area,

Sample cut from the corner of the fastening plate (Fig. 2). Dimensions: L = 4mm ; W = 1.2mm.

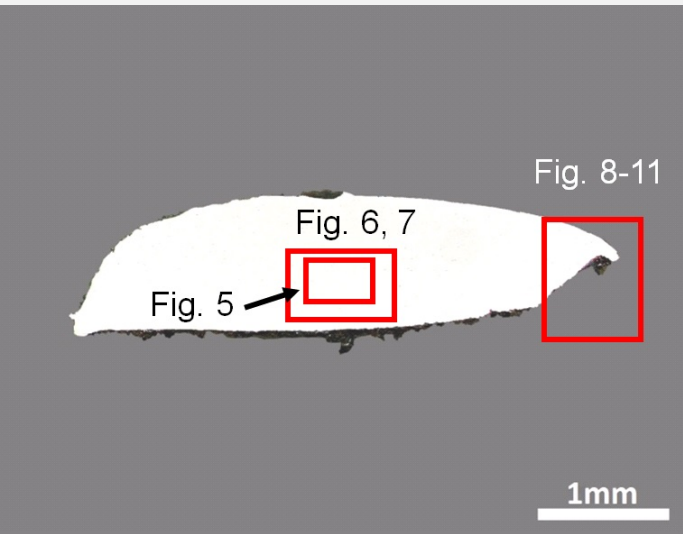
Fig. 3: Micrograph of the cross-section of the sample taken from the back fastening plate showing the location of Figs. 5 to 11,

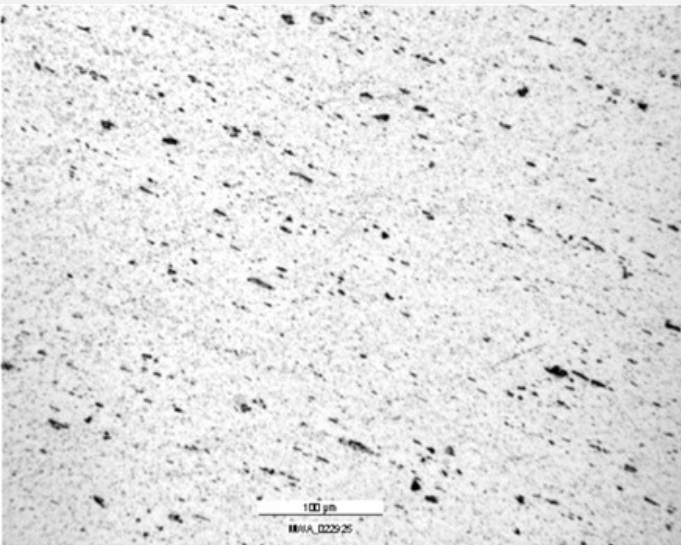
Fig. 6: Micrograph of the metal sample from Fig. 3 (detail), etched, bright field. The metal matrix is in white, the elongated inclusions in dark-grey and black,

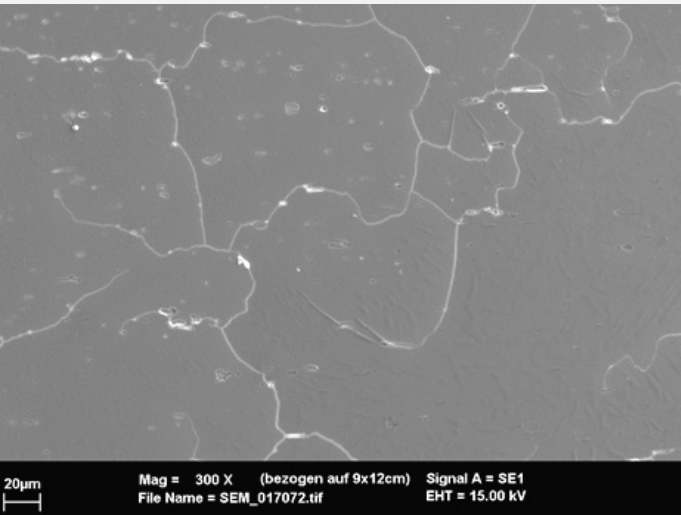
Fig. 7: SEM image of the metal sample from Fig. 3 (detail), SE-mode, etched. We observe the presence of large grains and numerous elongated inclusions,

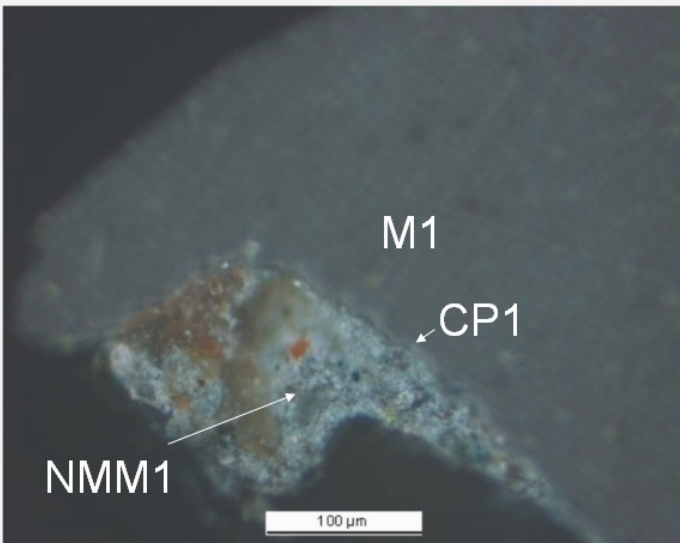
The metal is covered by a very thin corrosion layer (CP1). In addition to this, locally thicker adhering materials can be observed (NMM1, appearing as dark-grey area in Fig. 8). Under polarized light, they appear blue-brown (Fig. 9). Analysis by SEM-EDS indicates that the metal is, as expected, covered by a very thin Al and O-rich layer whereas the particles in the adherent material contain C, O, Si, Ca, Fe, Zn, S and even Ti (Figs. 10 and 11). The location of the adherent material and the presence of both Zn and Ti suggest that it is a residue of a paint coating.

Fig. 9: Micrograph (same as Fig. 8) and corresponding to the stratigraphy of Fig. 4, unetched, polarised light. We observe in grey the metal matrix and blue-brown the adhering material,

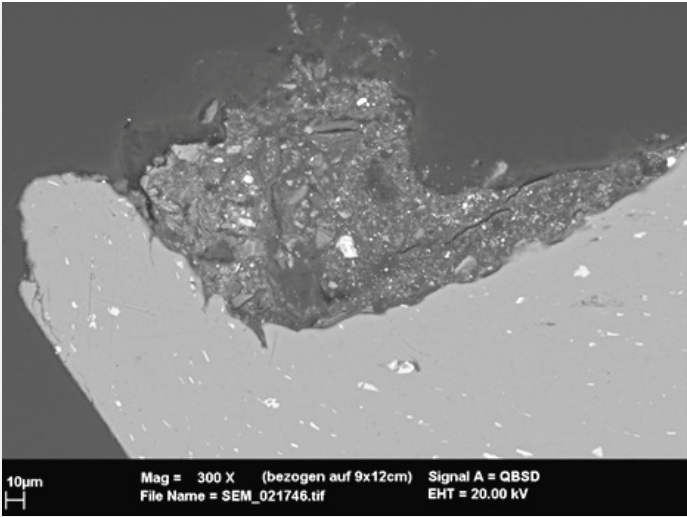
Fig. 10: SEM image (same as Fig. 8, inverted picture, detail), BSE-mode, unetched,

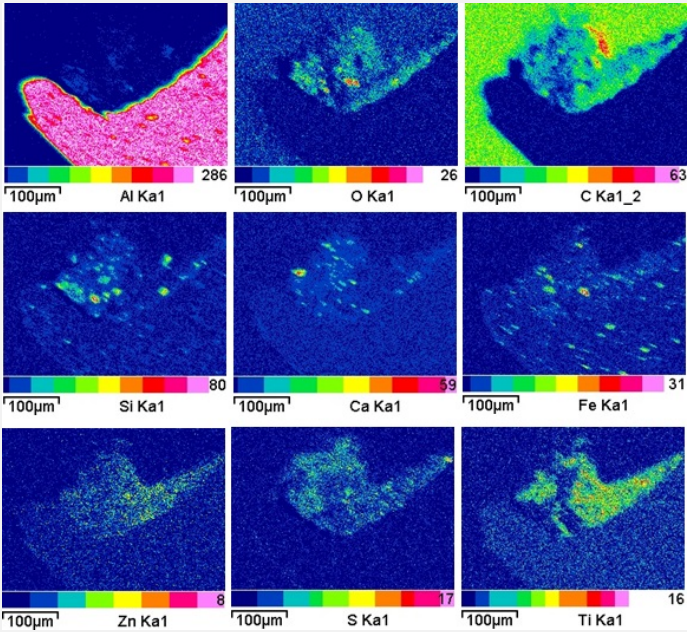
Fig. 11: Elemental chemical distribution of the selected area from Fig. 10. Method of examination: SEM/EDS, Laboratory of Analytical Chemistry, Empa,
