# AIRCRAFT FRONT FASTENING PLATE VHS-497 (2) – AL CU SN ZN SI ALLOY – MODERN TIMES

**Artefact name** Aircraft front fastening plate VHS-497 (2)

**Authors** Marianne. Senn (EMPA, Dübendorf, Zurich, Switzerland) & Christian. Degriigny (HE-Arc CR, Neuchâtel, Neuchâtel, Switzerland)

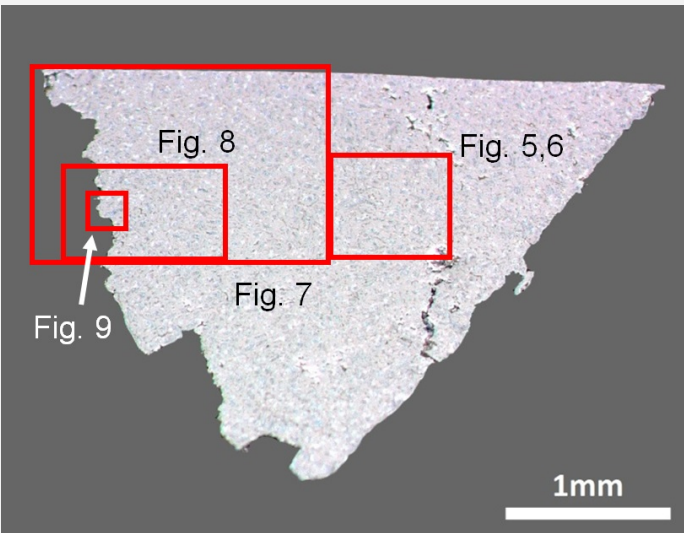
Fig. 3: Micrograph of the cross-section of the sample taken from the front fastening plate showing the location of Figs. 5 to 9,

| <b>Description of sample</b> | The top part has been cut during sampling (Fig. 2). The more regular right side is the plate surface and the irregular side is the broken edge (Fig. 3). Dimensions: L = 4mm ; W = 4mm. |

The metal is an aluminium alloy containing Cu, Sn, Zn and Si (Table 1). The unetched metal shows an as-cast structure consisting of the aluminium matrix with Sn (not soluble in Al) inclusions (Figs. 5 and 6), intermetallic compounds such as Al<sub>2</sub>Cu (Fig. 5, red arrows) and clusters of Al,Fe,Cu & Si phases (Fig. 5, black arrows). There are porosities in the metal (Figs. 3 and 5). The average hardness of the metal is HV1 80.

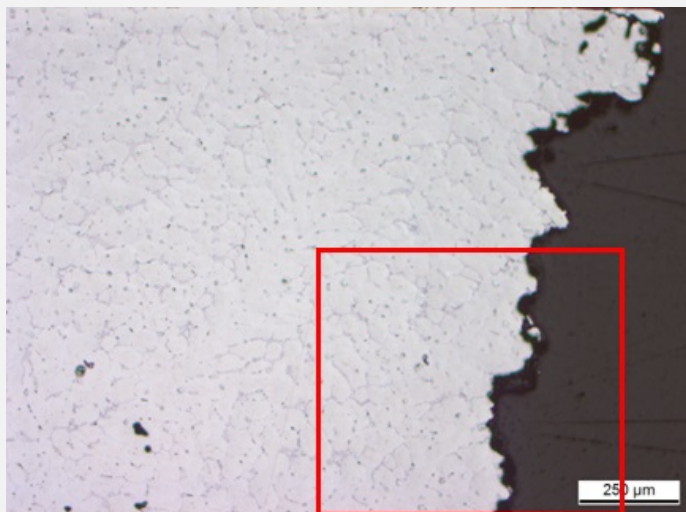
No corrosion layer can be seen on the metal surface (Figs. 3 and 7). Under polarized light small white and brown particles are visible on the broken edge (D1, Fig. 8). Their analysis reveals the presence of silica particles surrounded by dirt (Table 2 and Fig. 9). The metal surface is covered by a thin oxygen bearing skin (CP1, Fig. 9).

Table 2: Chemical composition (mass %) of the adhering particles to the metal surface (from Fig. 7). Method of analysis: SEM/EDS, Laboratory of Analytical Chemistry, Empa.

Fig. 7: Micrograph showing the metal - "corrosion products" interface from Fig. 3 (reversed picture, detail), unetched, bright field. We observe in white the metal matrix, in dark-grey Al,Fe, Si & Cu phase and light-grey Al<sub>2</sub>Cu intermetallic compounds. The micrograph of Fig. 8 is marked by a rectangle,

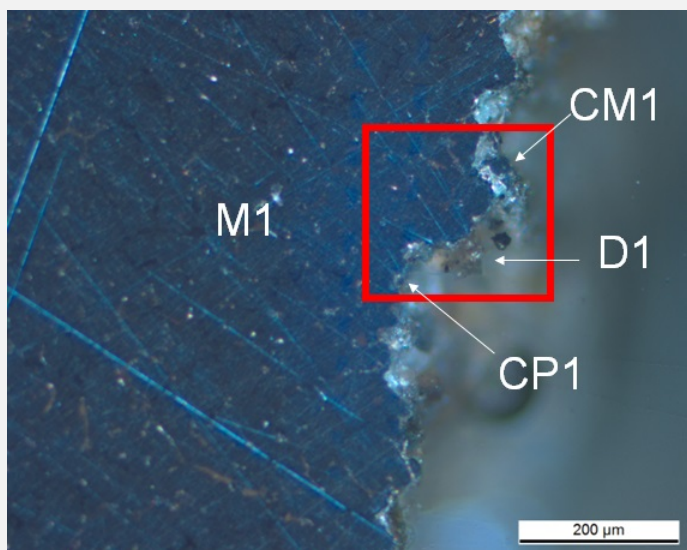
Fig. 8: Micrograph from Fig. 7 (detail) and corresponding to the stratigraphy of Fig. 4, unetched, polarised light. We observe in grey the metal matrix and blue-brown the adherent material. The area selected for elemental chemical distribution (Fig. 9) is marked by a rectangle,

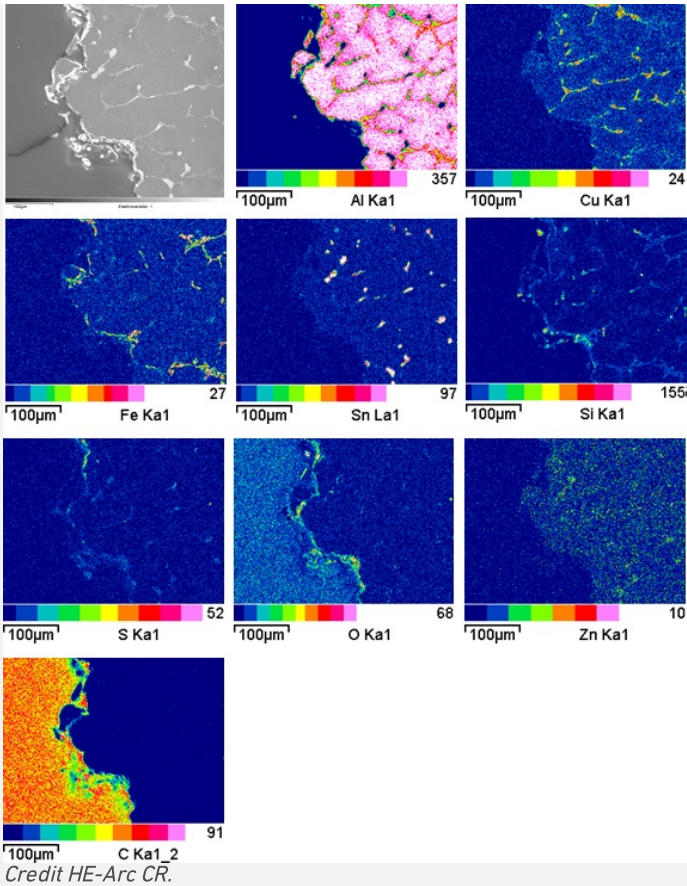
Fig. 9: SEM image, BSE-mode, and elemental chemical distribution of the selected area from Fig. 8 (reversed picture, detail). Method of examination: SEM/EDS, Laboratory of Analytical Chemistry, Empa,

Although not common at the beginning of the 20<sup>th</sup>, this Al-Cu-Sn-Zn-Si cast alloy was used on the Dufaux IV plane. No corrosion layer has been found on the metal surface except adherent silica-rich particles and the thin oxidised skin typical of Al alloys. The presence of these materials can be explained by the regular maintenance of the metal, probably using silicon carbide abrasive paper.
