# AIRCRAFT FRONT FASTENING PLATE VHS-497 (2) – AL CU SN ZN SI ALLOY – MODERN TIMES

**Artefact name** Aircraft front fastening plate VHS-497 (2)

**Authors** Marianne. Senn (EMPA, Dübendorf, Zurich, Switzerland) & Christian. Degrieny (HE-Arc CR, Neuchâtel, Neuchâtel, Switzerland)

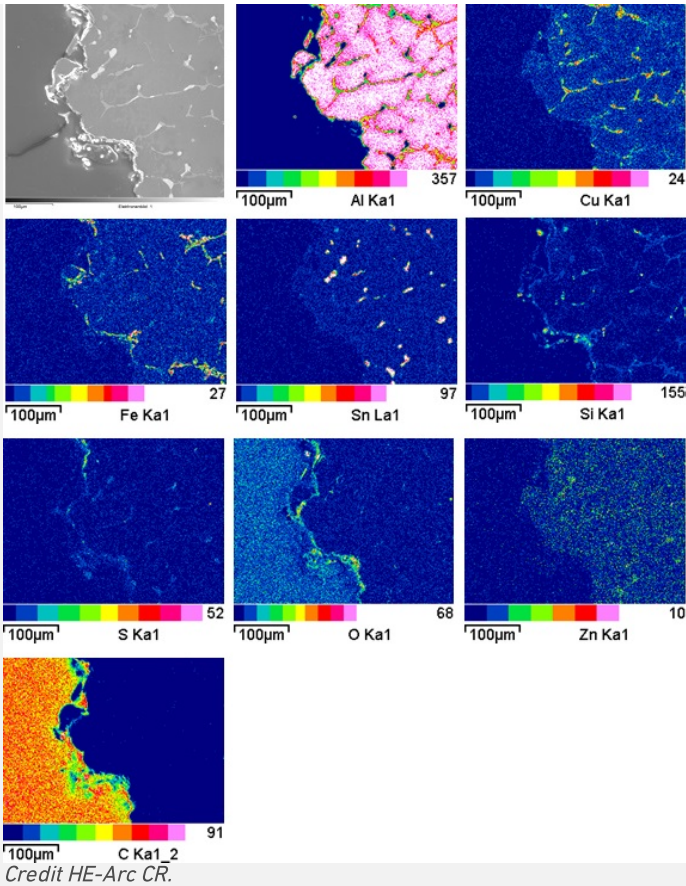
No corrosion layer can be seen on the metal surface (Figs. 3 and 7). Under polarized light small white and brown particles are visible on the broken edge (D1, Fig. 8). Their analysis reveals the presence of silica particles surrounded by dirt (Table 2 and Fig. 9). The metal surface is covered by a thin oxygen bearing skin (CP1, Fig. 9).

Fig. 9: SEM image, BSE-mode, and elemental chemical distribution of the selected area from Fig. 8 (reversed picture, detail). Method of examination: SEM/EDS, Laboratory of Analytical Chemistry, Empa,

Although not common at the beginning of the 20<sup>th</sup>, this Al-Cu-Sn-Zn-Si cast alloy was used on the Dufaux IV plane. No corrosion layer has been found on the metal surface except adherent silica-rich particles and the thin oxidised skin typical of Al alloys. The presence of these materials can be explained by the regular maintenance of the metal, probably using silicon carbide abrasive paper.
