# AIRCRAFT FRONT FASTENING PLATE VHS-497 (2) – AL CU SN ZN SI ALLOY – MODERN TIMES

| Artefact name | Aircraft front fastening plate VHS-497 (2) |
| Authors | Marianne. Senn (EMPA, Dübendorf, Zurich, Switzerland) & Christian. Degriigny (HE-Arc CR, Neuchâtel, Neuchâtel, Switzerland) |

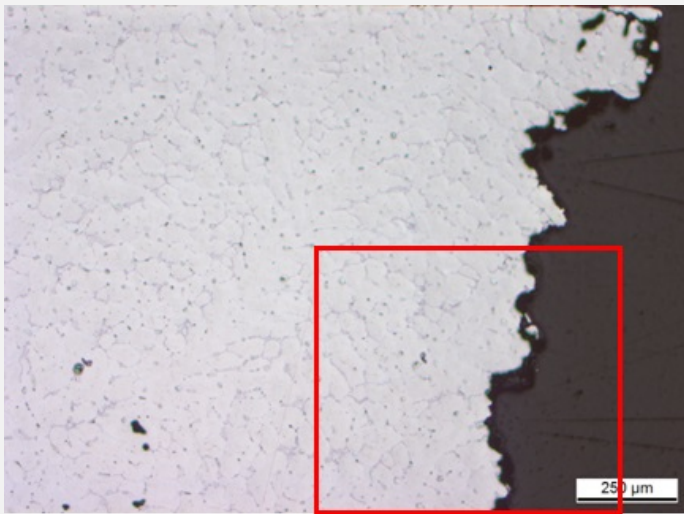
No corrosion layer can be seen on the metal surface (Figs. 3 and 7). Under polarized light small white and brown particles are visible on the broken edge (D1, Fig. 8). Their analysis reveals the presence of silica particles surrounded by dirt (Table 2 and Fig. 9). The metal surface is covered by a thin oxygen bearing skin (CP1, Fig. 9).

Fig. 7: Micrograph showing the metal - "corrosion products" interface from Fig. 3 (reversed picture, detail), unetched, bright field. We observe in white the metal matrix, in dark-grey Al,Fe, Si & Cu phase and light-grey Al<sub>2</sub>Cu intermetallic compounds. The micrograph of Fig. 8 is marked by a rectangle,

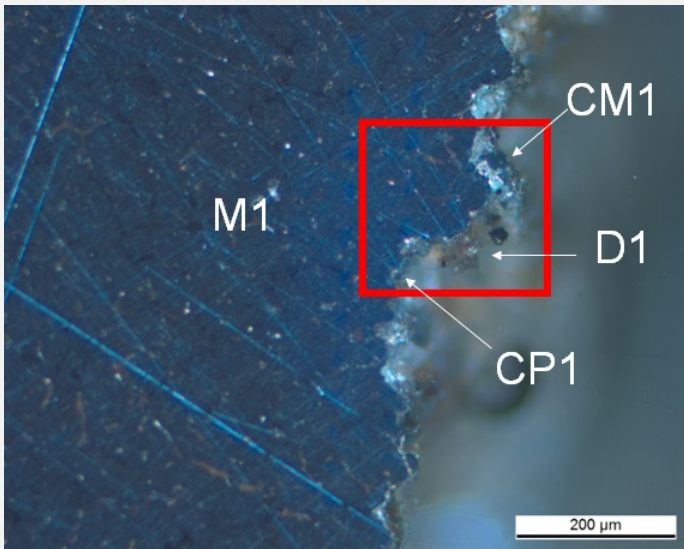
Fig. 8: Micrograph from Fig. 7 (detail) and corresponding to the stratigraphy of Fig. 4, unetched, polarised light. We observe in grey the metal matrix and blue-brown the adherent material. The area selected for elemental chemical distribution (Fig. 9) is marked by a rectangle,
