# AIRCRAFT FRONT FASTENING PLATE VHS-497 (2) – AL CU SN ZN SI ALLOY – MODERN TIMES

**Artefact name** Aircraft front fastening plate VHS-497 (2)

**Authors** Marianne. Senn (EMPA, Dübendorf, Zurich, Switzerland) & Christian. Degriy (HE-Arc CR, Neuchâtel, Neuchâtel, Switzerland)

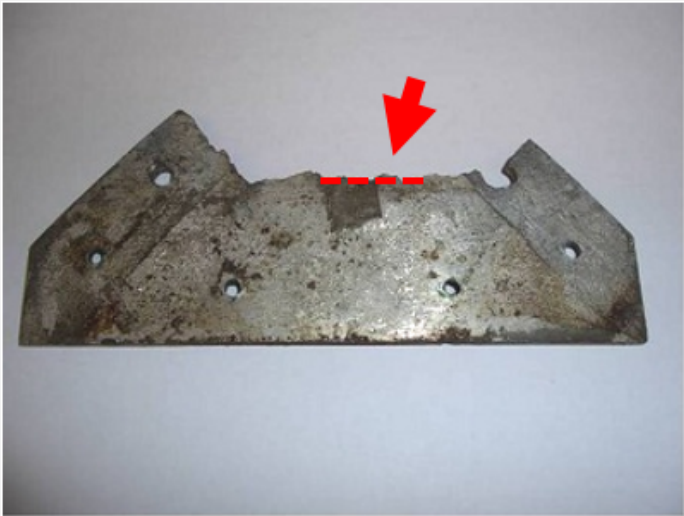
Fig. 2: Location of sampling area,

| <b>Description of sample</b> | The top part has been cut during sampling (Fig. 2). The more regular right side is the plate surface and the irregular side is the broken edge (Fig. 3). Dimensions: L = 4mm ; W = 4mm. |

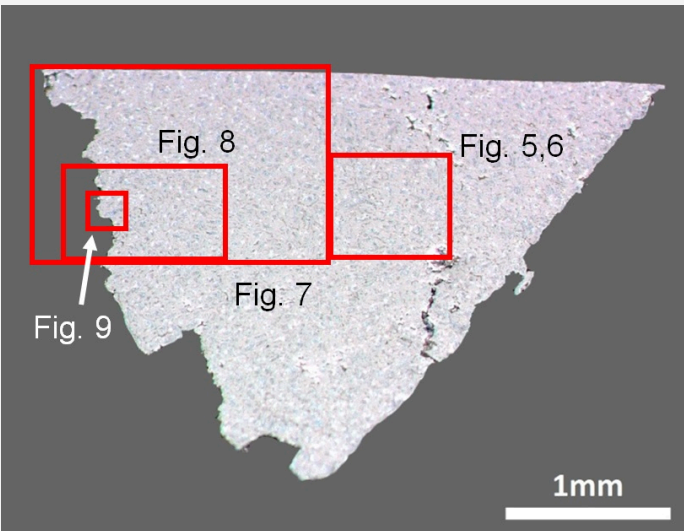
Fig. 3: Micrograph of the cross-section of the sample taken from the front fastening plate showing the location of Figs. 5 to 9,

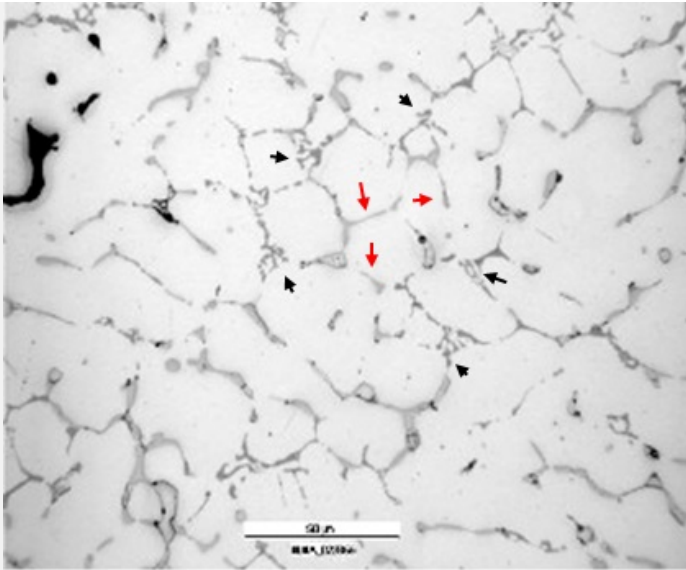
The metal is an aluminium alloy containing Cu, Sn, Zn and Si (Table 1). The unetched metal shows an as-cast structure consisting of the aluminium matrix with Sn (not soluble in Al) inclusions (Figs. 5 and 6), intermetallic compounds such as Al<sub>2</sub>Cu (Fig. 5, red arrows) and clusters of Al,Fe,Cu & Si phases (Fig. 5, black arrows). There are porosities in the metal (Figs. 3 and 5). The average hardness of the metal is HV1 80.

Fig. 5: Micrograph of the metal sample from Fig. 3 (detail), unetched, bright field. The cast structure is revealed by light grey intermetallic compounds (Al<sub>2</sub>Cu, red arrows), dark-grey Al,Fe,Si & Cu phase clusters (black arrows) and Sn inclusions (nodules). On the top left some pores can be seen,

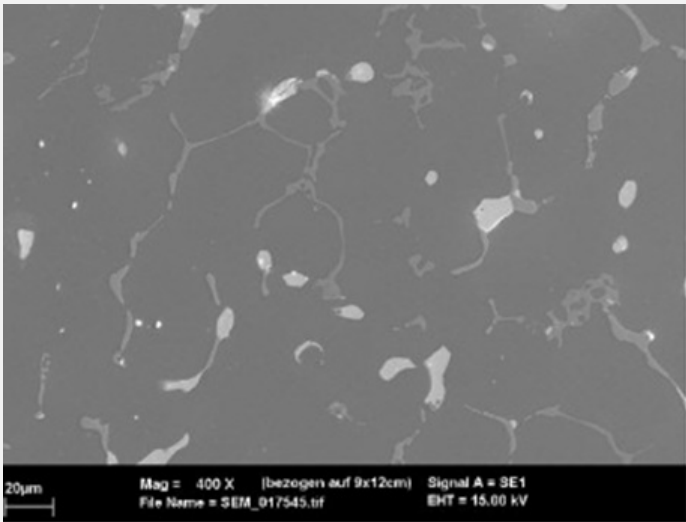
Fig. 6: SEM image of the metal sample from Fig. 3 (detail), SE-mode, unetched. We observe in dark-grey the metal matrix, in medium-grey the intermetallic compound Al<sub>2</sub>Cu as well as Al,Fe,Si & Cu phase clusters and in light-grey the Sn inclusions,

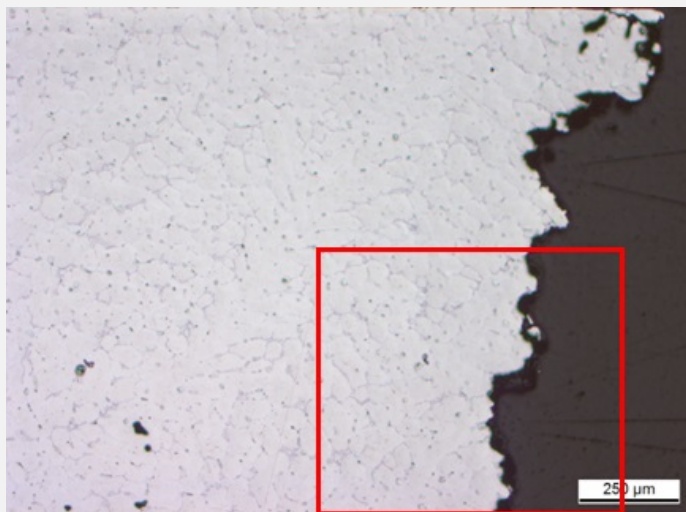
No corrosion layer can be seen on the metal surface (Figs. 3 and 7). Under polarized light small white and brown particles are visible on the broken edge (D1, Fig. 8). Their analysis reveals the presence of silica particles surrounded by dirt (Table 2 and Fig. 9). The metal surface is covered by a thin oxygen bearing skin (CP1, Fig. 9).

Fig. 7: Micrograph showing the metal - "corrosion products" interface from Fig. 3 (reversed picture, detail), unetched, bright field. We observe in white the metal matrix, in dark-grey Al,Fe, Si & Cu phase and light-grey Al<sub>2</sub>Cu intermetallic compounds. The micrograph of Fig. 8 is marked by a rectangle,

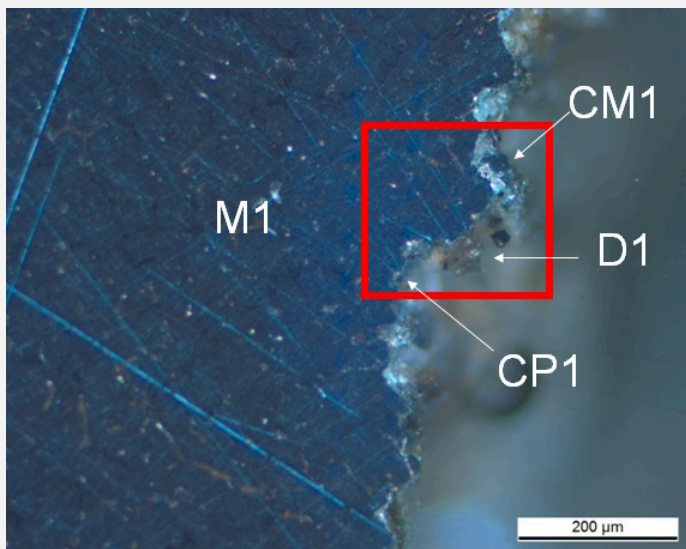
Fig. 8: Micrograph from Fig. 7 (detail) and corresponding to the stratigraphy of Fig. 4, unetched, polarised light. We observe in grey the metal matrix and blue-brown the adherent material. The area selected for elemental chemical distribution (Fig. 9) is marked by a rectangle,

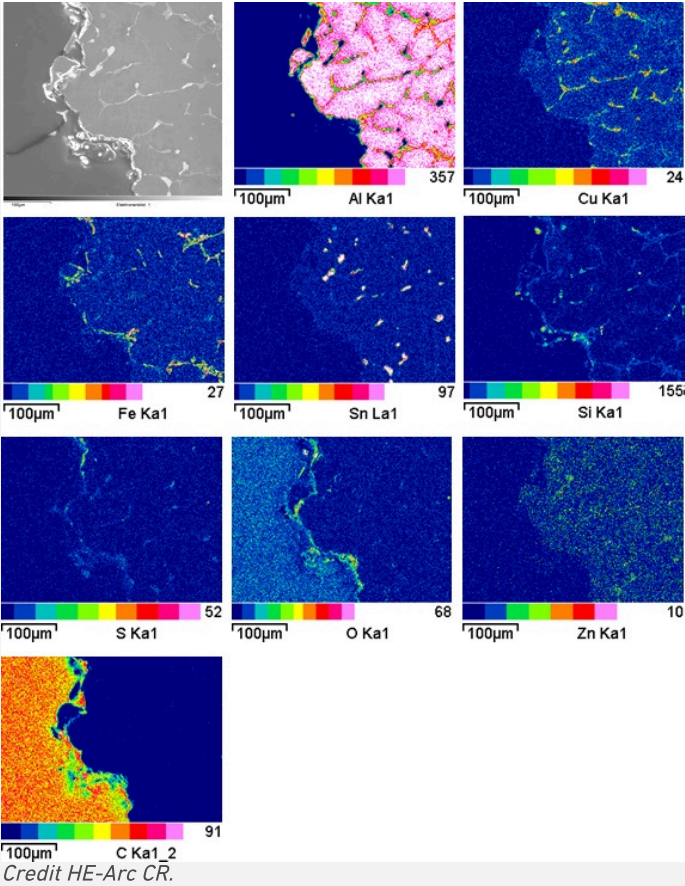
Fig. 9: SEM image, BSE-mode, and elemental chemical distribution of the selected area from Fig. 8 (reversed picture, detail). Method of examination: SEM/EDS, Laboratory of Analytical Chemistry, Empa,

Although not common at the beginning of the 20<sup>th</sup>, this Al-Cu-Sn-Zn-Si cast alloy was used on the Dufaux IV plane. No corrosion layer has been found on the metal surface except adherent silica-rich particles and the thin oxidised skin typical of Al alloys. The presence of these materials can be explained by the regular maintenance of the metal, probably using silicon carbide abrasive paper.
