SACRIFICIAL ANODE VHS-8339 - ZN ALLOY - MODERN TIMES

Artefact name	Sacrificial anode VHS-8339
Authors	Marianne. Senn (EMPA, Dübendorf, Zurich, Switzerland) & Christian. Degriigny (HE-Arc CR, Neuchâtel, Neuchâtel, Switzerland)
Url	/artefacts/705/

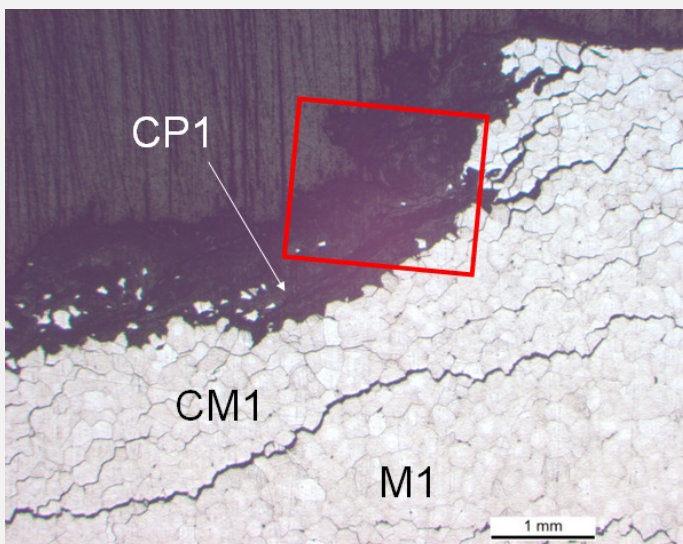
The remaining metal is an almost pure zinc alloy (Table 1). The oxygen content is not from the original alloy, but is due to secondary corrosion. The metal grains are visible without etching and present a polygonal structure (Figs. 5 and 6). The structure is recrystallised after annealing. The recrystallization of zinc alloys begins at room temperature.

Fig. 5: Micrograph of the metal sample from Fig. 3 (reversed picture, detail), unetched, bright field. Extensive intergranular corrosion is visible. The rectangle marks Fig. 7,

Extensive intergranular corrosion / cracking has developed in the metal structure (Figs. 5, 6). The metal is covered by a corrosion crust that is hardly visible in bright field and which contains remnant metal (Fig. 5). On most of the sample the corrosion crust is uniform. In areas we see cracks (Fig. 7) appearing as brown lines separating the corrosion crust (Fig. 8). In bright field the corrosion crust appears grey containing dark-grey zones (Fig. 7). Under polarized light, the corrosion crust appears white with darker parts including remnant metal (Fig. 8). It contains Zn and O as well as S along some cracks (Table 2 and Fig. 9).
