# SACRIFICIAL ANODE VHS-8339 - ZN ALLOY - MODERN TIMES

**Artefact name** Sacrificial anode VHS-8339

**Authors** Marianne. Senn (EMPA, Dübendorf, Zurich, Switzerland) & Christian. Degriigny (HE-Arc CR, Neuchâtel, Neuchâtel, Switzerland)

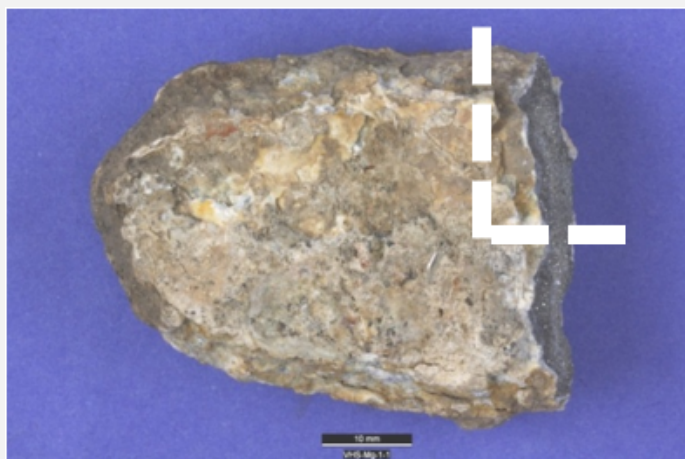
Fig. 2: Location of sampling area,

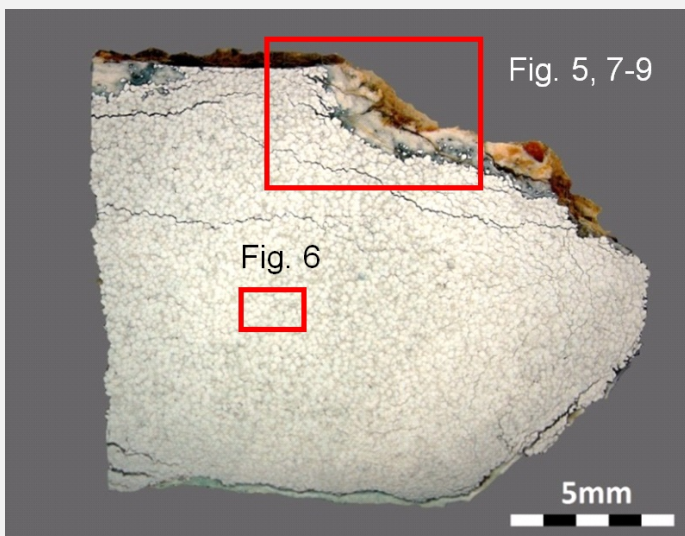
Fig. 3: Micrograph of the cross-section of the fragment sampled from the sacrificial anode showing the location of Figs. 5 to 9,

The sample (Fig. 3) shows a cross-section from the fragment of the sacrificial anode (Fig. 2). The thickness of the corrosion crust is variable. Dimensions: L = 17mm; W = 14mm.

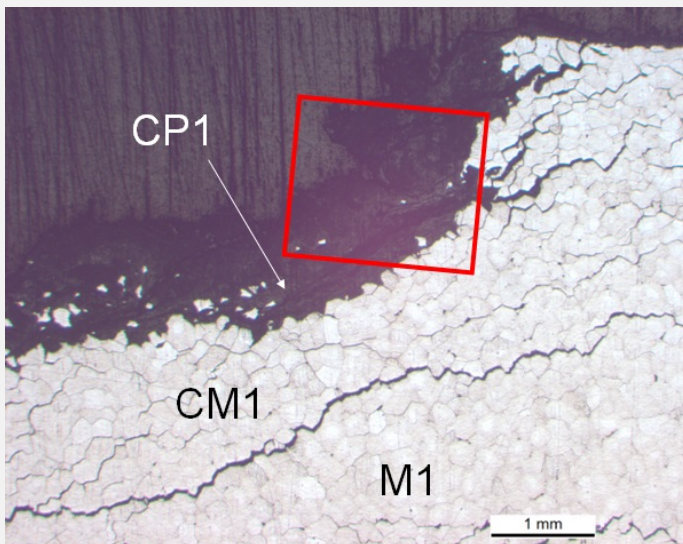
The remaining metal is an almost pure zinc alloy (Table 1). The oxygen content is not from the original alloy, but is due to secondary corrosion. The metal grains are visible without etching and present a polygonal structure (Figs. 5 and 6). The structure is recrystallised after annealing. The recrystallization of zinc alloys begins at room temperature.

Fig. 5: Micrograph of the metal sample from Fig. 3 (reversed picture, detail), unetched, bright field. Extensive intergranular corrosion is visible. The rectangle marks Fig. 7,

Extensive intergranular corrosion / cracking has developed in the metal structure (Figs. 5, 6). The metal is covered by a corrosion crust that is hardly visible in bright field and which contains remnant metal (Fig. 5). On most of the sample the corrosion crust is uniform. In areas we see cracks (Fig. 7) appearing as brown lines separating the corrosion crust (Fig. 8). In bright field the corrosion crust appears grey containing dark-grey zones (Fig. 7). Under polarized light, the corrosion crust appears white with darker parts including remnant metal (Fig. 8). It contains Zn and O as well as S along some cracks (Table 2 and Fig. 9).

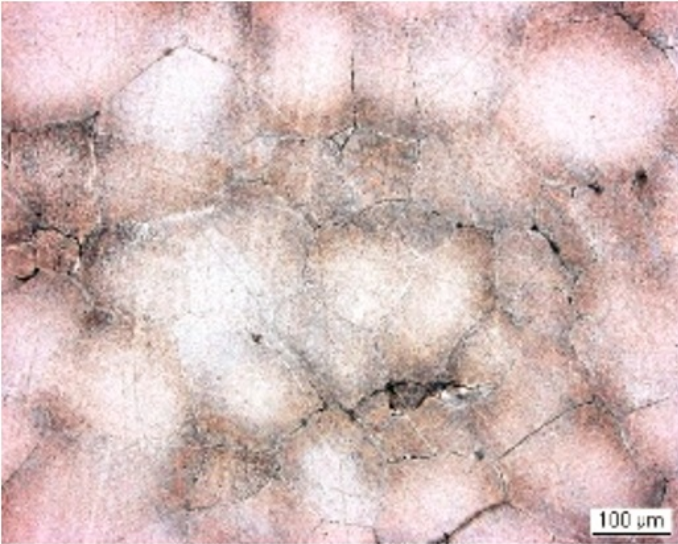
Fig. 6: Micrograph of the metal sample from Fig. 3 (detail), etched,

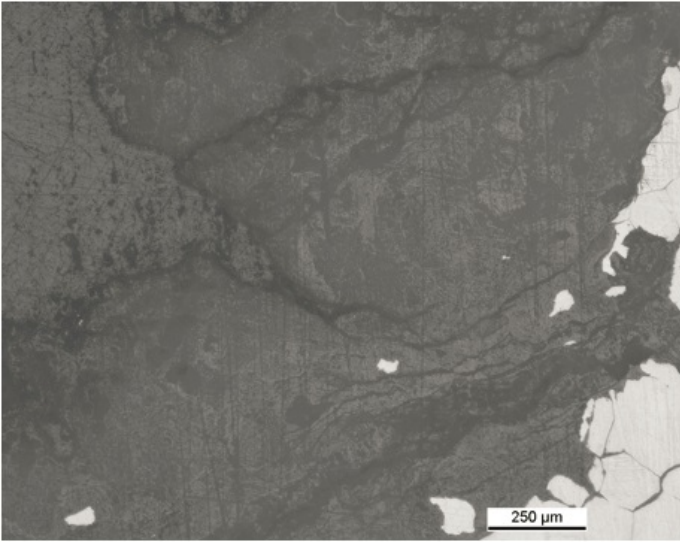
Fig. 7: Micrograph showing the metal - corrosion products interface from Fig. 5 (detail), unetched, bright field,

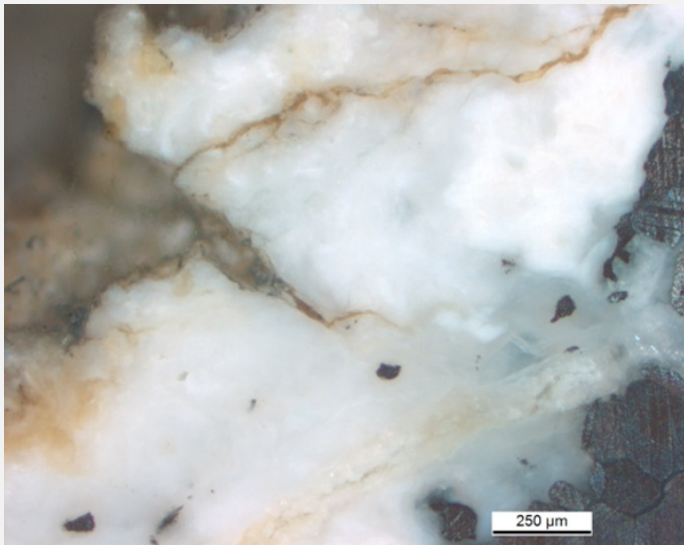
Fig. 8: Micrograph (same as Fig. 7) corresponding to the stratigraphy of Fig. 4, unetched, polarised light. We observe in dark-grey the metal, in white the corrosion crust separated by brown cracks including remnant metal,

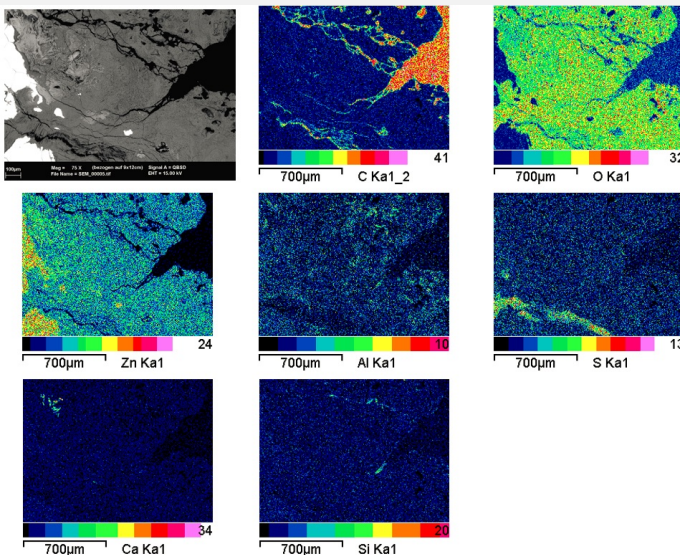
Fig. 9: SEM image, BSE-mode, and elemental chemical distribution of most of the area of Fig. 7 (reversed picture). Method of examination: SEM/EDS, Laboratory of Analytical Chemistry, Empa,
