# SACRIFICIAL ANODE VHS-8339 - ZN ALLOY - MODERN TIMES

Artefact name	Sacrificial anode VHS-8339
Authors	Marianne. Senn (EMPA, Dübendorf, Zurich, Switzerland) & Christian. Degriy (HE-Arc CR, Neuchâtel, Neuchâtel, Switzerland)
Url	/artefacts/705/

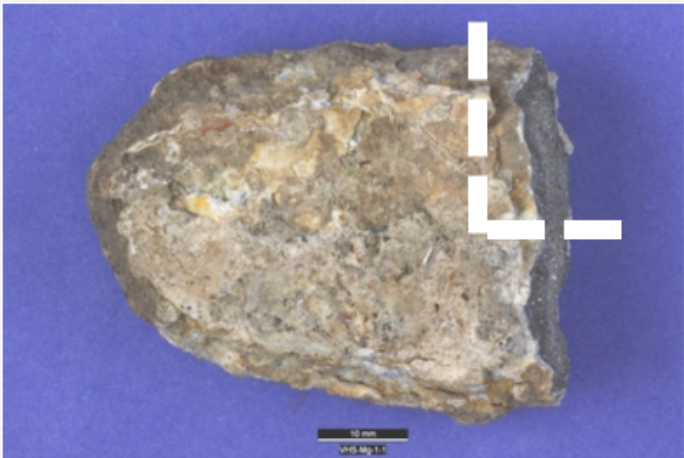
Fig. 2: Location of sampling area,

The sample (Fig. 3) shows a cross-section from the fragment of the sacrificial anode (Fig. 2). The thickness of the corrosion crust is variable. Dimensions: L = 17mm; W = 14mm.

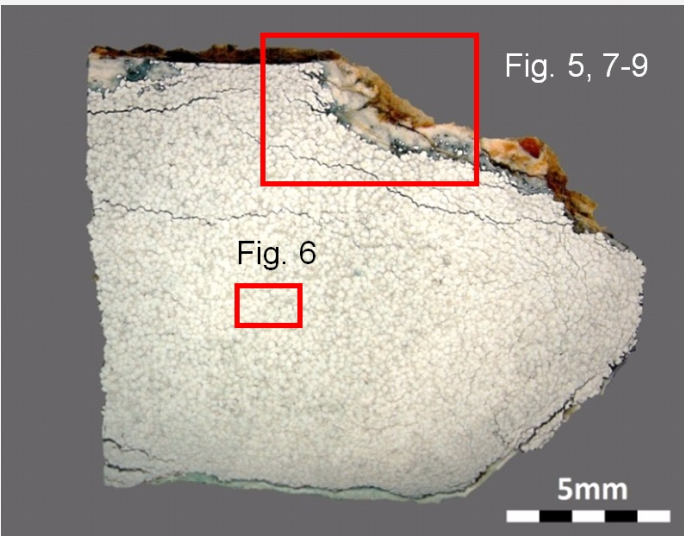
Fig. 3: Micrograph of the cross-section of the fragment sampled from the sacrificial anode showing the location of Figs. 5 to 9,

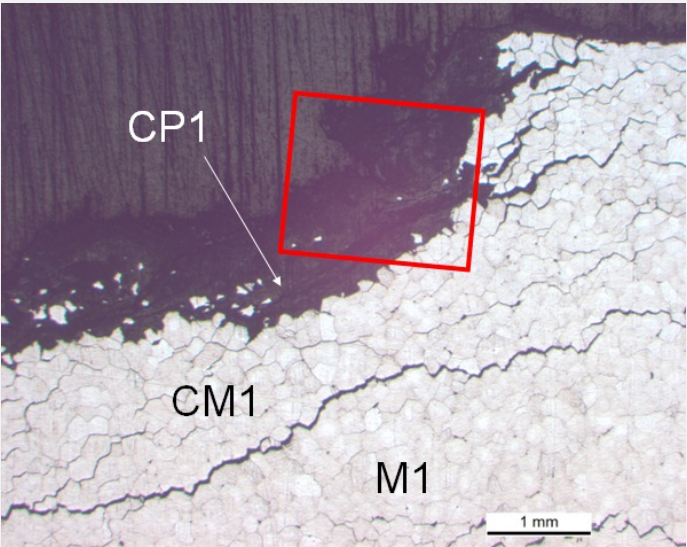
The remaining metal is an almost pure zinc alloy (Table 1). The oxygen content is not from the original alloy, but is due to secondary corrosion. The metal grains are visible without etching and present a polygonal structure (Figs. 5 and 6). The structure is recrystallised after annealing. The recrystallization of zinc alloys begins at room temperature.

Fig. 5: Micrograph of the metal sample from Fig. 3 (reversed picture, detail), unetched, bright field. Extensive intergranular corrosion is visible. The rectangle marks Fig. 7,

Extensive intergranular corrosion / cracking has developed in the metal structure (Figs. 5, 6). The metal is covered by a corrosion crust that is hardly visible in bright field and which contains remnant metal (Fig. 5). On most of the sample the corrosion crust is uniform. In areas we see cracks (Fig. 7) appearing as brown lines separating the corrosion crust (Fig. 8). In bright field the corrosion crust appears grey containing dark-grey zones (Fig. 7). Under polarized light, the corrosion crust appears white with darker parts including remnant metal (Fig. 8). It contains Zn and O as well as S along some cracks (Table 2 and Fig. 9).

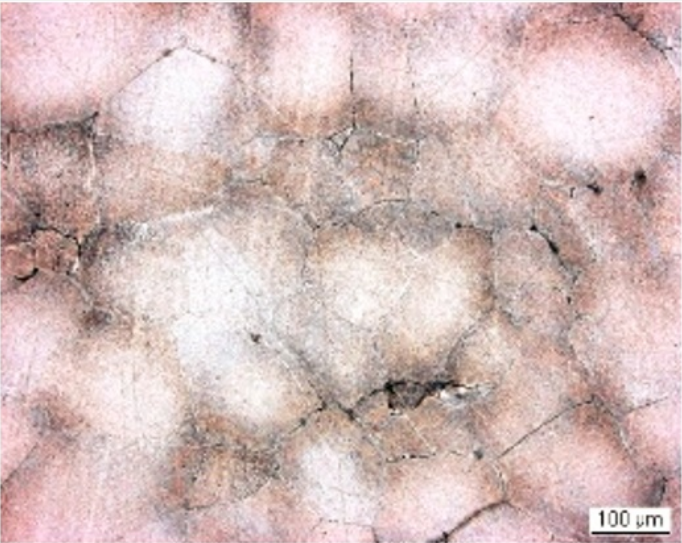
Fig. 6: Micrograph of the metal sample from Fig. 3 (detail), etched,

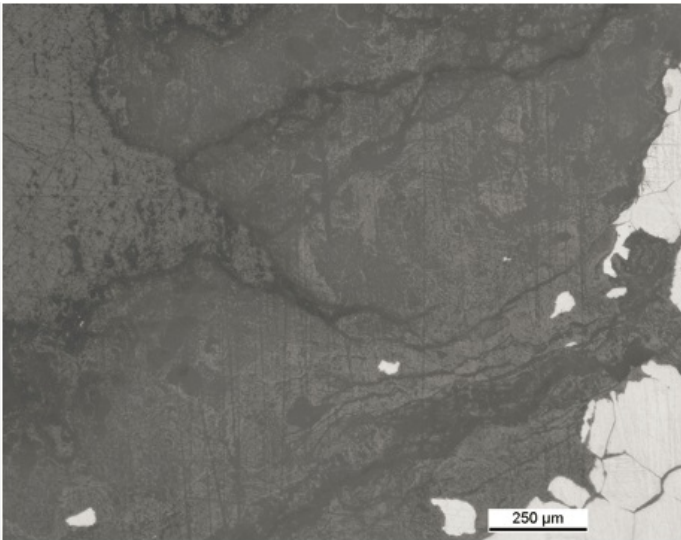
Table 2. Chemical composition (mass %) of the corrosion layer from Figs. 7 and 9. Method of analysis: SEM/EDS, Laboratory of Analytical Chemistry, Empa.

Fig. 7: Micrograph showing the metal - corrosion products interface from Fig. 5 (detail), unetched, bright field,

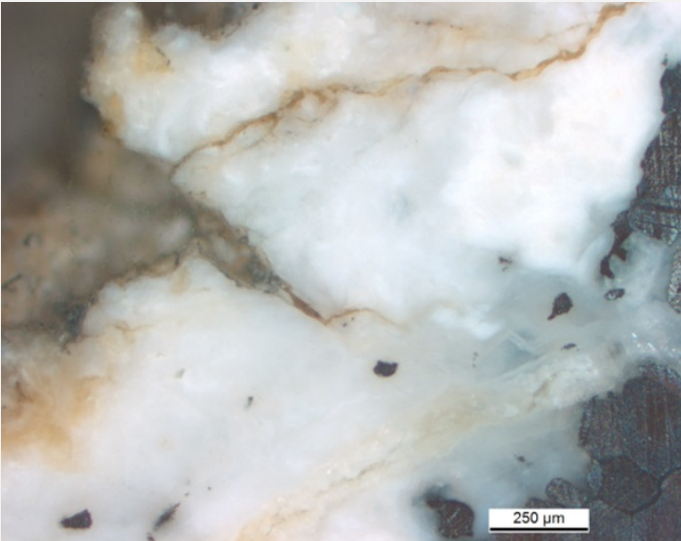
Fig. 8: Micrograph (same as Fig. 7) corresponding to the stratigraphy of Fig. 4, unetched, polarised light. We observe in dark-grey the metal, in white the corrosion crust separated by brown cracks including remnant metal,

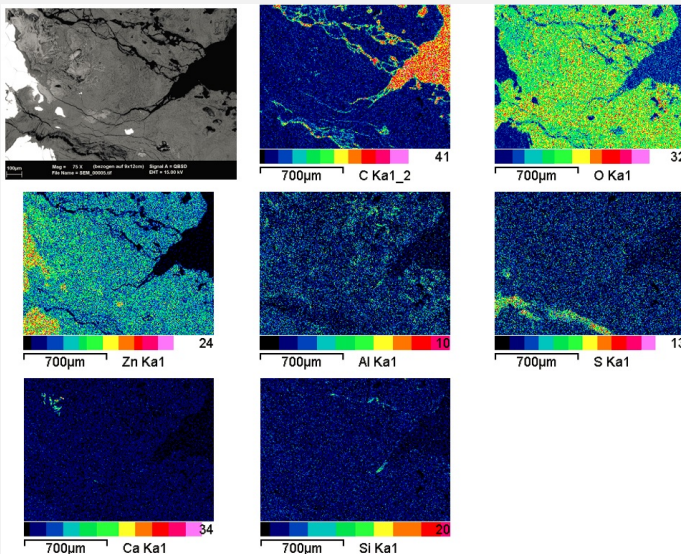
Fig. 9: SEM image, BSE-mode, and elemental chemical distribution of most of the area of Fig. 7 (reversed picture). Method of examination: SEM/EDS, Laboratory of Analytical Chemistry, Empa,
