# SACRIFICIAL ANODE VHS-8339 – ZN ALLOY – MODERN TIMES

Artefact name	Sacrificial anode VHS-8339
Authors	Marianne. Senn (EMPA, Dübendorf, Zurich, Switzerland) & Christian. Degriy (HE-Arc CR, Neuchâtel, Neuchâtel, Switzerland)
Url	/artefacts/705/

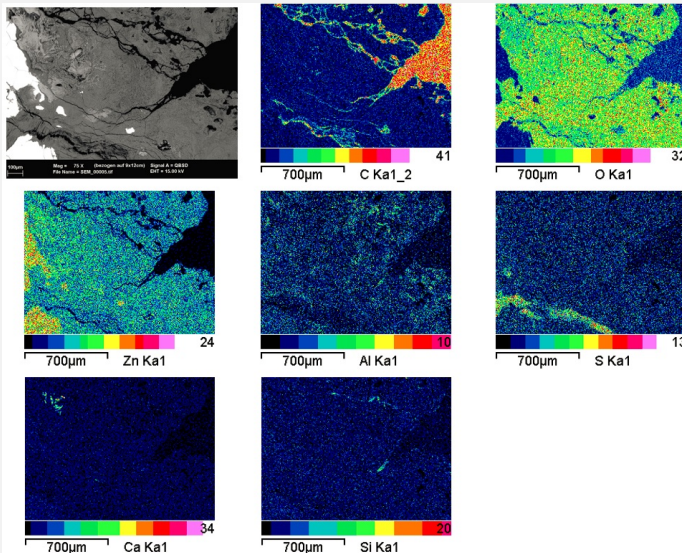
Table 2. Chemical composition (mass %) of the corrosion layer from Figs. 7 and 9. Method of analysis: SEM/EDS, Laboratory of Analytical Chemistry, Empa.

Fig. 9: SEM image, BSE-mode, and elemental chemical distribution of most of the area of Fig. 7 (reversed picture). Method of examination: SEM/EDS, Laboratory of Analytical Chemistry, Empa,
