# MILITARY ID TAG 5668-MXX-1008-1 - ZN PB ALLOY - MODERN TIMES - FRANCE

<b>Artefact name</b>	Military ID tag 5668-MXX-1008-1
<b>Authors</b>	Christian. Degryny (HE-Arc CR, Neuchâtel, Neuchâtel, Switzerland) & Marie-Jeanne. Scholl (HE-Arc CR, Neuchâtel, Neuchâtel, Switzerland) & Valentin. Boissonnas (HE-Arc CR, Neuchâtel, Neuchâtel, Switzerland)
<b>Url</b>	/artefacts/706/

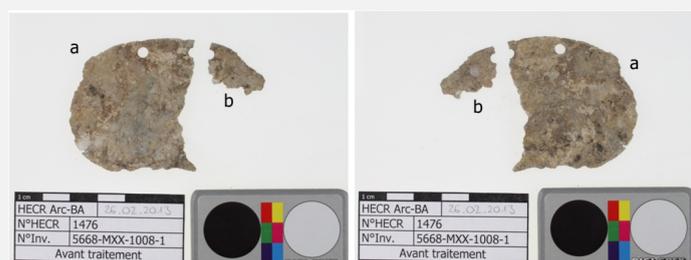
Fig. 1: German military ID tag from First World War, recto and verso, 2013,

<b>Description of the artefact</b>	Fragments from an oval shaped German military plate with two circular holes at the central upper edge (Fig. 1). Information concerning the soldier were given in the centre of the plate. The plate is covered with sediments. Dimensions (70 x 50 mm initially): L = 65mm; W = 50mm; T = 1 mm; WT = 6.3g.
<b>Type of artefact</b>	Military object
<b>Origin</b>	German army, 94th Infantry Regiment, 1918, Carspach, Alsace, France
<b>Recovering date</b>	Recovered in 2011
<b>Chronology category</b>	Modern Times
<b>chronology tpe</b>	<input type="text" value="1915"/> A.D. ▾
<b>chronology taq</b>	<input type="text" value="1915"/> A.D. ▾
<b>Chronology comment</b>	First World War
<b>Burial conditions / environment</b>	Soil
<b>Artefact location</b>	Pôle d'Archéologie Interdépartemental Rhénan, Sélestat, Alsace
<b>Owner</b>	Pôle d'Archéologie Interdépartemental Rhénan, Sélestat, Alsace

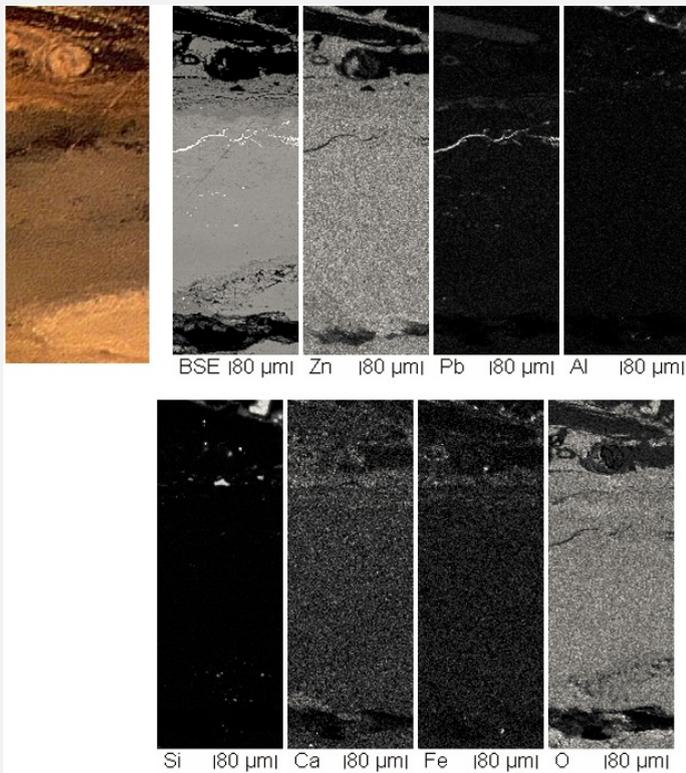
Fig. 12: SEM image of the cross-section from Fig. 11 (detail), SE-mode, and elemental chemical distribution. Method of examination: SEM/EDS, Lab of Electronic Microscopy and microanalysis, IMA (Néode), HEI Arc,

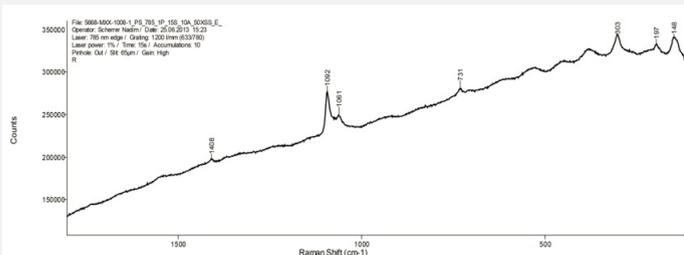
Fig. 16: Raman spectrum of the inner white layer (CP2, zinc hydroxycarbonate?). Settings: laser wavelength 532nm, acquisition time 10s, one accumulation, filter D2 (0.75-0.8mW), hole 500, slit 80, grating 600. Method of analysis: Raman spectroscopy, Art Technological Laboratory, Departement Conservation HKB,

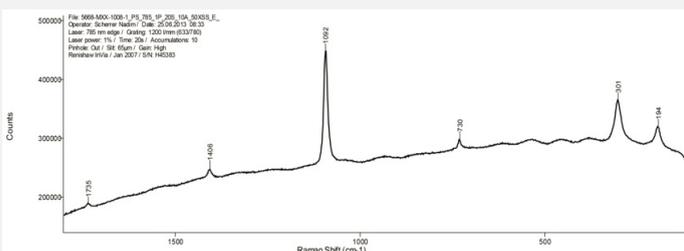
Fig. 17: Raman spectrum of the inner black layer (zinc carbonate?). Settings: laser wavelength 532nm, acquisition time 10s, one accumulation, filter D2 (0.75-0.8mW), hole 500, slit 80, grating 600. Method of analysis: Raman spectroscopy, Art Technological Laboratory, Departement Conservation HKB,

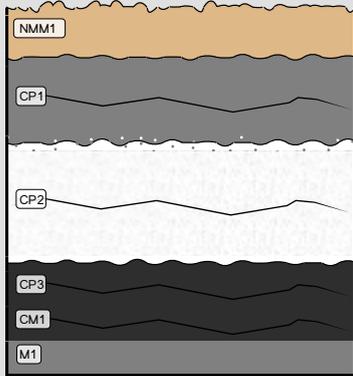
Fig. 5: Stratigraphic representation of fragment b of the military tag in cross-section (dark field) using the MiCorr application. The characteristics of the strata are only accessible by clicking on the drawing that redirects you to the search tool by stratigraphy representation. This representation can be compared to Fig. 10, Credit HE-Arc CR, M-J.Scholl.

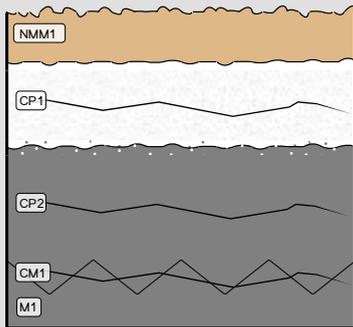
Fig. 6: Stratigraphic representation of fragment b of the military tag in cross-section (dark field) using the MiCorr application. The characteristics of the strata are only accessible by clicking on the drawing that redirects you to the search tool by stratigraphy representation. This representation is different from Fig. 10 due to the inversion of CP1 and CP2. Furthermore, CP3 is not represented, Credit HE-Arc CR, M-J.Scholl.

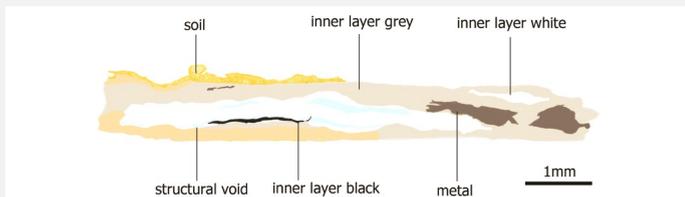
Fig. 16: Improved representation of the stratigraphy of corrosion layers of the military tag from visual observations and analyses,

The military tag is made of a laminated sheet of zinc-lead alloy. The corrosion has entirely penetrated the objet leaving though some spots of remaining original metal inside the corrosion products. Lead particles are not affected by the corrosion process. The main corrosion products are zinc carbonates (smithsonite) and hydroxycarbonates (hydrozincite) but mixtures of different corrosion products can occur. These corrosion products are intermixed and heavily cracked.
