# MILITARY ID TAG 5668-MXX-1008-1 - ZN PB ALLOY - MODERN TIMES - FRANCE

<b>Artefact name</b>	Military ID tag 5668-MXX-1008-1
<b>Authors</b>	Christian. Degryny (HE-Arc CR, Neuchâtel, Neuchâtel, Switzerland) & Marie-Jeanne. Scholl (HE-Arc CR, Neuchâtel, Neuchâtel, Switzerland) & Valentin. Boissonnas (HE-Arc CR, Neuchâtel, Neuchâtel, Switzerland)
<b>Url</b>	/artefacts/706/

<b>Inv. number</b>	5668-MXX-1008-1
<b>Recorded conservation data</b>	Not conserved

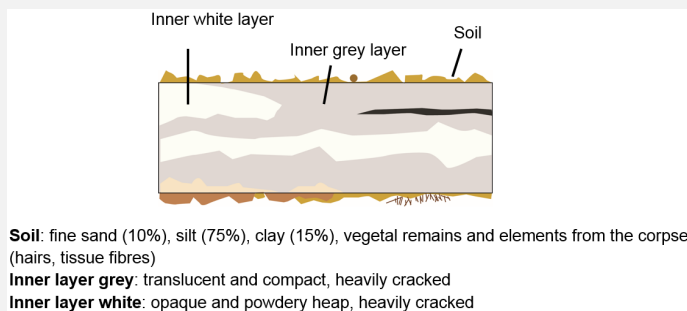
Fig. 3: Stratigraphic representation of fragment b of the military tag in cross-section by macroscopic observation,

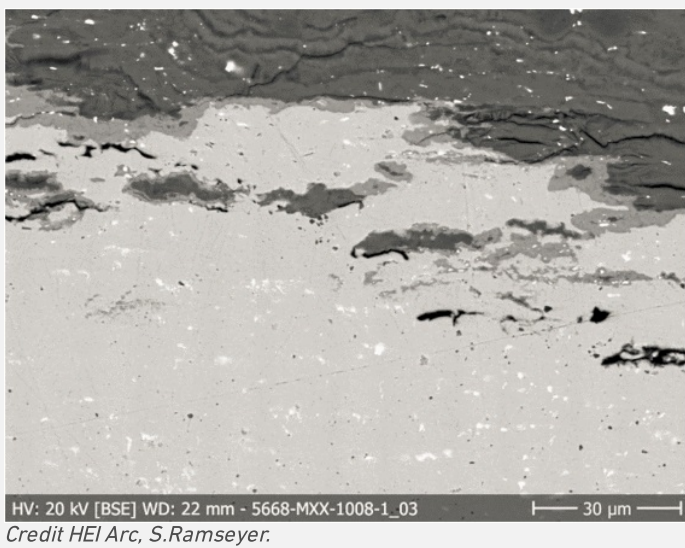
The remaining metal is a zinc alloy (Table 1) containing 1.8% in weight lead. Lead appears in the metal in the form of small flattened white Pb inclusions (Fig. 8), confirming the manufacturing technique, namely lamination. The etched metal does not show any specific microstructure (Fig. 9).

Fig. 8: SEM image of the cross-section, from Fig. 7 (detail), BSE-mode,

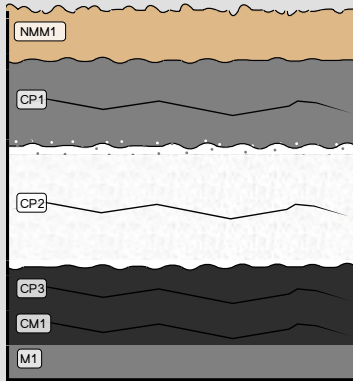
Fig. 5: Stratigraphic representation of fragment b of the military tag in cross-section (dark field) using the MiCorr application. The characteristics of the strata are only accessible by clicking on the drawing that redirects you to the search tool by stratigraphy representation. This representation can be compared to Fig. 10, Credit HE-Arc CR, M-J.Scholl.

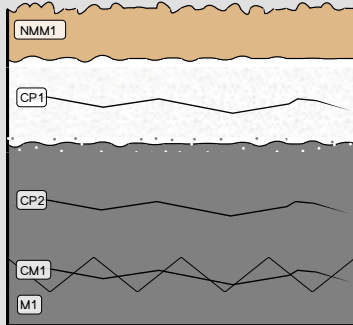
Fig. 6: Stratigraphic representation of fragment b of the military tag in cross-section (dark field) using the MiCorr application. The characteristics of the strata are only accessible by clicking on the drawing that redirects you to the search tool by stratigraphy representation. This representation is different from Fig. 10 due to the inversion of CP1 and CP2. Furthermore, CP3 is not represented, Credit HE-Arc CR, M-J.Scholl.

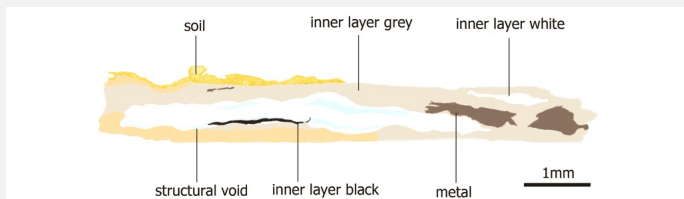
Fig. 16: Improved representation of the stratigraphy of corrosion layers of the military tag from visual observations and analyses,

The military tag is made of a laminated sheet of zinc-lead alloy. The corrosion has entirely penetrated the objet leaving though some spots of remaining original metal inside the corrosion products. Lead particles are not affected by the corrosion process. The main corrosion products are zinc carbonates (smithsonite) and hydroxycarbonates (hydrozincite) but mixtures of different corrosion products can occur. These corrosion products are intermixed and heavily cracked.
