# MILITARY ID TAG 5668-MXX-1008-1 - ZN PB ALLOY - MODERN TIMES - FRANCE

<b>Artefact name</b>	Military ID tag 5668-MXX-1008-1
<b>Authors</b>	Christian. Degryny (HE-Arc CR, Neuchâtel, Neuchâtel, Switzerland) & Marie-Jeanne. Scholl (HE-Arc CR, Neuchâtel, Neuchâtel, Switzerland) & Valentin. Boissonnas (HE-Arc CR, Neuchâtel, Neuchâtel, Switzerland)
<b>Url</b>	/artefacts/706/

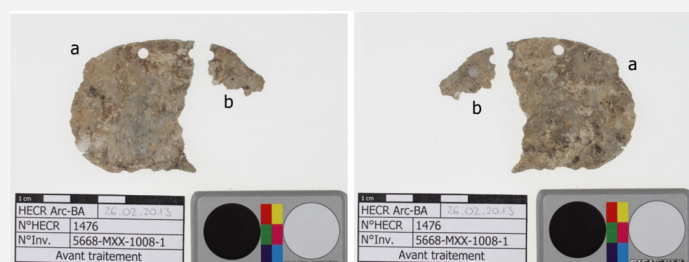
Fig. 1: German military ID tag from First World War, recto and verso, 2013,

<b>Description of the artefact</b>	Fragments from an oval shaped German military plate with two circular holes at the central upper edge (Fig. 1). Information concerning the soldier were given in the centre of the plate. The plate is covered with sediments. Dimensions (70 x 50 mm initially): L = 65mm; W = 50mm; T = 1 mm; WT = 6.3g.
<b>Type of artefact</b>	Military object
<b>Origin</b>	German army, 94th Infantry Regiment, 1918, Carspach, Alsace, France
<b>Recovering date</b>	Recovered in 2011
<b>Chronology category</b>	Modern Times
<b>chronology tpe</b>	<input type="text" value="1915"/> A.D. ▾
<b>chronology taq</b>	<input type="text" value="1915"/> A.D. ▾
<b>Chronology comment</b>	First World War
<b>Burial conditions / environment</b>	Soil
<b>Artefact location</b>	Pôle d'Archéologie Interdépartemental Rhénan, Sélestat, Alsace
<b>Owner</b>	Pôle d'Archéologie Interdépartemental Rhénan, Sélestat, Alsace

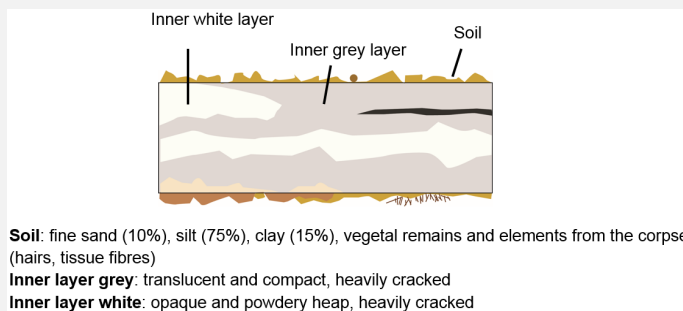
Fig. 3: Stratigraphic representation of fragment b of the military tag in cross-section by macroscopic observation,

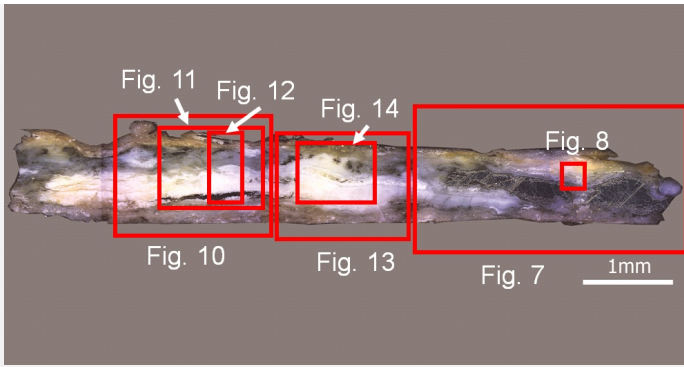
Fig. 4: Micrograph of the cross-section of fragment b of the military tag showing the location of Figs. 7, 8 and 10 to 14. Unetched, dark field, 50x,

<b>Description of sample</b>	This sample was cut out of fragment b in Fig. 1. The cross-section shows the entire thickness of the plate (L = 8 mm, W= 1 mm). The corrosion goes through the whole metal thickness but a metallic core remains (Figs. 4 and 7).
<b>Alloy</b>	Zn Pb Alloy
<b>Technology</b>	Cold worked (laminated)
<b>Lab number of sample</b>	None
<b>Sample location</b>	HE-Arc CR, Neuchâtel, Neuchâtel
<b>Responsible institution</b>	Pôle d'Archéologie Interdépartemental Rhénan, Sélestat, Alsace
<b>Date and aim of sampling</b>	2013, metallography and chemical analyses

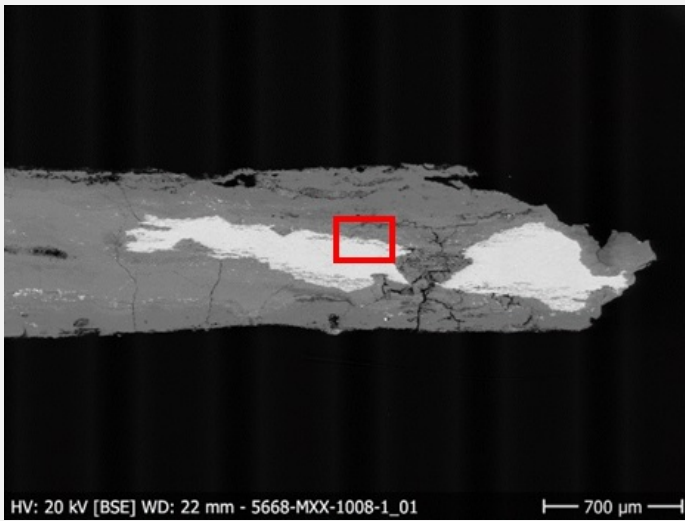
Fig. 7: SEM image of the cross-section, from Fig. 4 (detail), BSE-mode. Note the presence of Pb inclusions all through the thickness of the heavily cracked corrosion layers. The SEM image of Fig. 8 is marked by a rectangle,

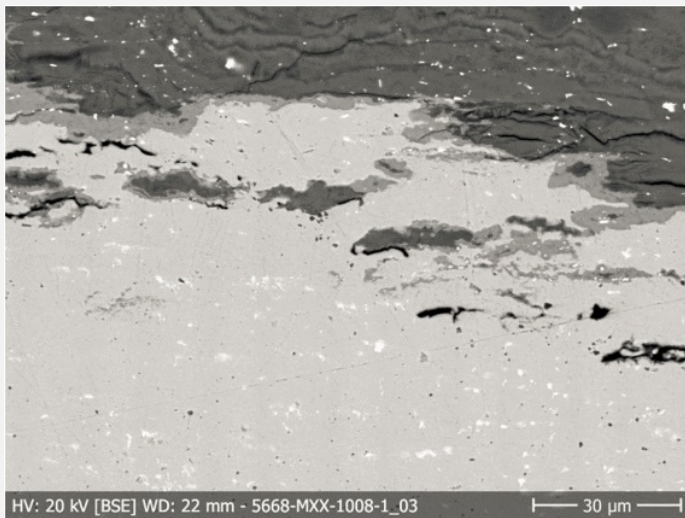
The remaining metal is a zinc alloy (Table 1) containing 1.8% in weight lead. Lead appears in the metal in the form of small flattened white Pb inclusions (Fig. 8), confirming the manufacturing technique, namely lamination. The etched metal does not show any specific microstructure (Fig. 9).

Fig. 8: SEM image of the cross-section, from Fig. 7 (detail), BSE-mode,

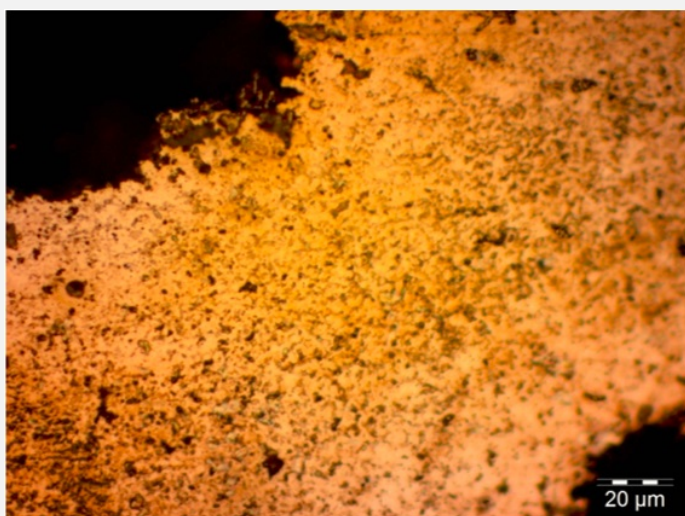
Fig. 9: Micrograph of the cross-section, etched, bright field, 500x,

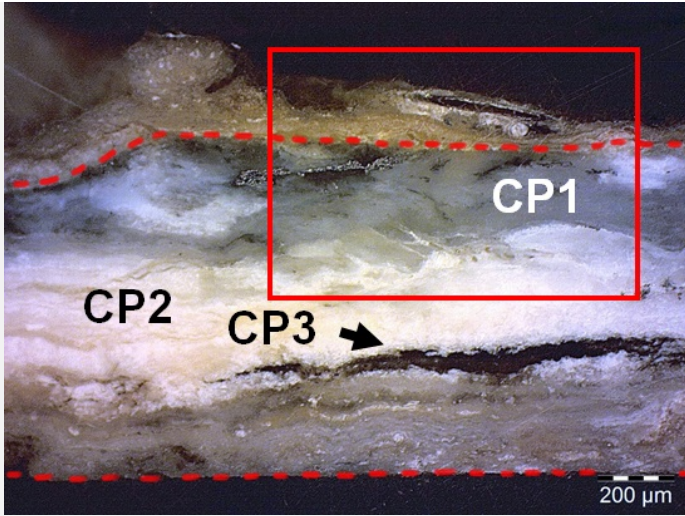
The inner grey layer (CP1, Figs. 5 and 10) has been identified by FTIR as a zinc carbonate (smithsonite), mixed with other unidentified corrosion products. Raman spectra seems to confirm it (Fig. 15). The exact composition of the inner white layer (CP2) is unknown. It shows a bluish fluorescence under UV light and has been identified by FTIR as a mixture of zinc oxides and carbonates, that could be zinc hydroxycarbonates (hydrozincite). Raman spectroscopy shows also a mixture of carbonates and other corrosion products (Fig. 16). The inner black layer (CP3) is a zinc carbonate as well, identified by FTIR and Raman spectroscopy (Fig. 17) appearing as a vein between layers of grey and white (Fig. 10).

Fig. 10: Micrograph of the cross-section, from Fig. 4 (detail) and corresponding to the stratigraphy of Fig. 5, unetched, dark field, 50x. View of the inner layers and the limit of the original surface (red line). We can see that the interfaces between the different layers are not well defined: some of the white corrosion product is found inside the inner grey layer. The micrograph of Fig. 11 is marked by a rectangle,

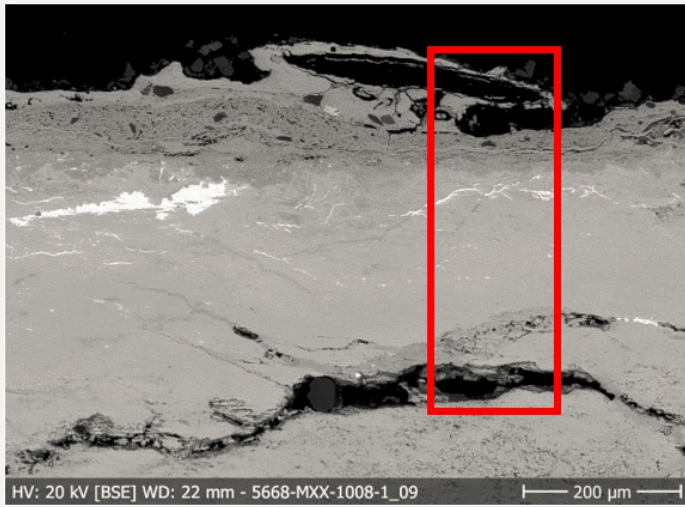
Fig. 11: SEM image of the cross-section from Fig. 10 (detail), BSE-mode. The area selected for elemental chemical distribution (Fig. 12) is marked by a rectangle,

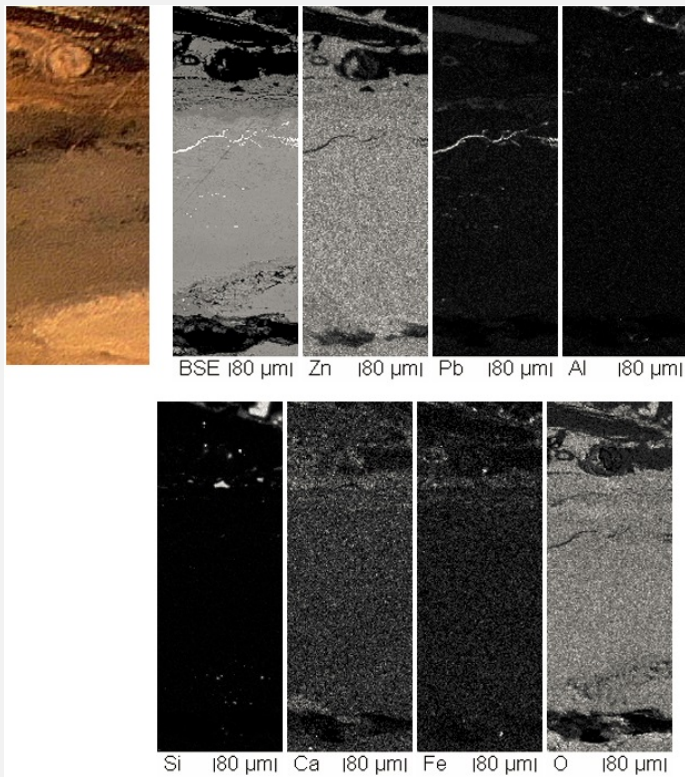
Fig. 12: SEM image of the cross-section from Fig. 11 (detail), SE-mode, and elemental chemical distribution. Method of examination: SEM/EDS, Lab of Electronic Microscopy and microanalysis, IMA (Néode), HEI Arc,

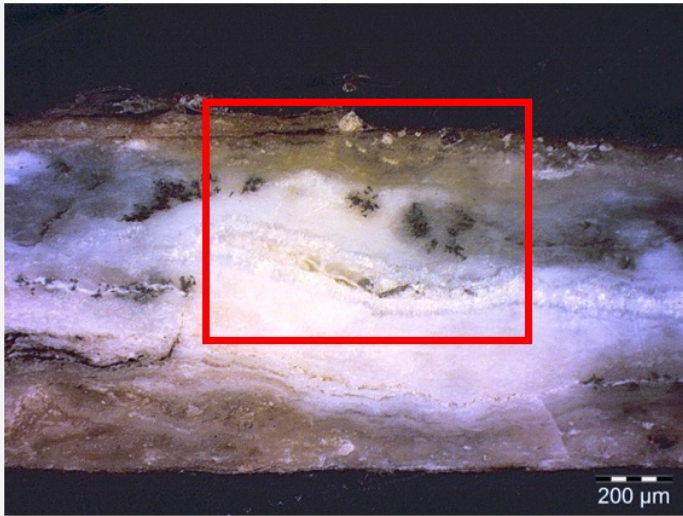
- **Inner grey layer – CP1** (up to 1 mm thick) is a translucent, compact layer and constitutes most part of the corrosion products. Corroded metal appears inside this layer as lead inclusions within a black corrosion product (Figs. 13 and 14). Sulphur has also been detected by SEM-EDS inside this layer, near the surface, where the colour turns into grey-orange (zinc sulfide or sulphates but to be confirmed, table 2).

Fig. 13: Micrograph of the cross-section, from Fig. 4 (detail), unetched, dark field, 50x. The micrograph of Fig. 14 is marked by a rectangular,

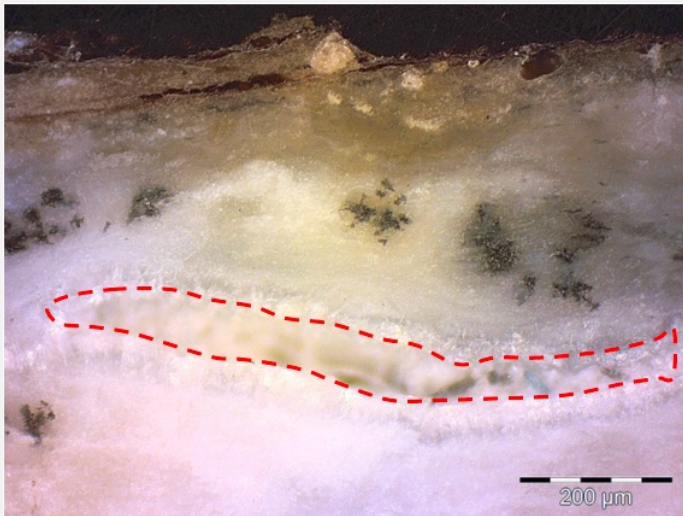
- **Inner white layer – CP2** (up to 0.6 mm thick) is an opaque and powdery heap, occurring in different places inside inner grey layer and sometimes near the surface, as pitting corrosion. The interface between inner layers grey and white is diffuse. Localized aggregates showing a crystalline microstructure of thickness of 50 µm are located against the walls of a structural void, inside the white corrosion product (Fig. 14).

Fig. 14: Micrograph of the cross-section, from Fig. 11 (detail) unetched, dark field, 100x. Structural void (dotted red line) with aggregates,

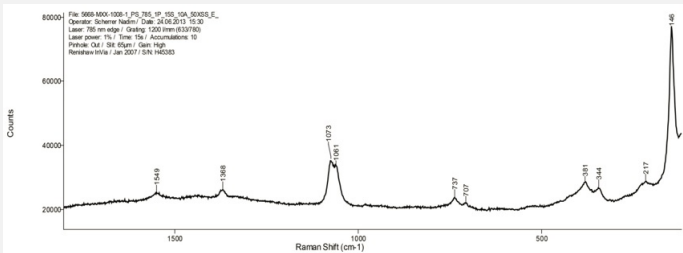
Fig. 15: Raman spectrum of the inner grey layer (CP1, ZnCO<sub>3</sub> – smithsonite?). Settings: laser wavelength 532nm, acquisition time 10s, one accumulation, filter D2 (0.75-0.8mW), hole 500, slit 80, grating 600. Method of analysis: Raman spectroscopy, Art Technological Laboratory, Departement Conservation HKB,

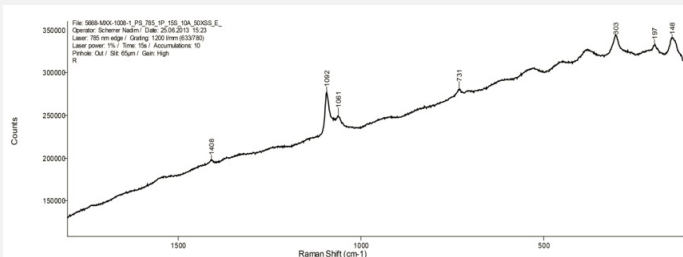
Fig. 16: Raman spectrum of the inner white layer (CP2, zinc hydroxycarbonate?). Settings: laser wavelength 532nm, acquisition time 10s, one accumulation, filter D2 (0.75-0.8mW), hole 500, slit 80, grating 600. Method of analysis: Raman spectroscopy, Art Technological Laboratory, Departement Conservation HKB,

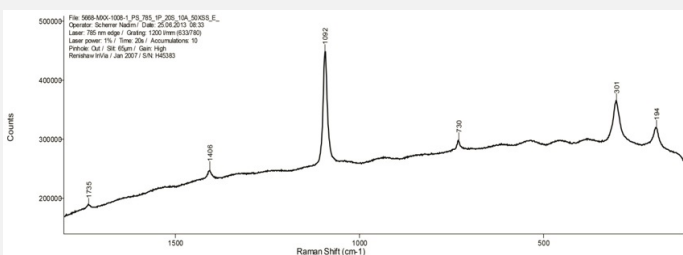
Fig. 17: Raman spectrum of the inner black layer (zinc carbonate?). Settings: laser wavelength 532nm, acquisition time 10s, one accumulation, filter D2 (0.75-0.8mW), hole 500, slit 80, grating 600. Method of analysis: Raman spectroscopy, Art Technological Laboratory, Departement Conservation HKB,

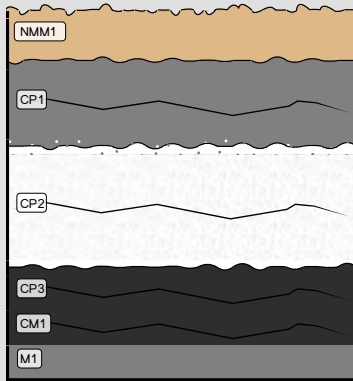
Fig. 5: Stratigraphic representation of fragment b of the military tag in cross-section (dark field) using the MiCorr application. The characteristics of the strata are only accessible by clicking on the drawing that redirects you to the search tool by stratigraphy representation. This representation can be compared to Fig. 10, Credit HE-Arc CR, M-J.Scholl.

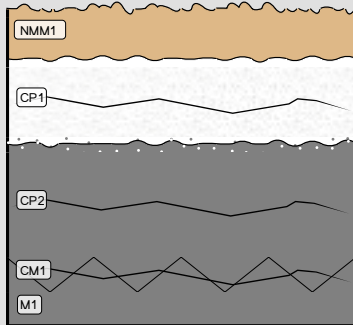
Fig. 6: Stratigraphic representation of fragment b of the military tag in cross-section (dark field) using the MiCorr application. The characteristics of the strata are only accessible by clicking on the drawing that redirects you to the search tool by stratigraphy representation. This representation is different from Fig. 10 due to the inversion of CP1 and CP2. Furthermore, CP3 is not represented, Credit HE-Arc CR, M-J.Scholl.

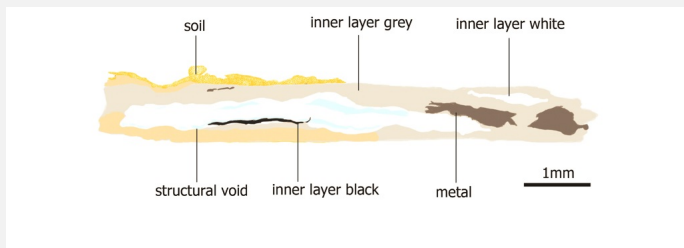
Fig. 16: Improved representation of the stratigraphy of corrosion layers of the military tag from visual observations and analyses,
