ARMATURE FROM A CLOCK MOVEMENT MIH IV-212 - ZN AL SN CU ALLOY - MODERN TIMES

Artefact name	Armature from a clock movement MIH IV-212
Authors	Marianne. Senn (EMPA, Dübendorf, Zurich, Switzerland) & Christian. Degryny (HE-Arc CR, Neuchâtel, Neuchâtel, Switzerland)
Url	/artefacts/707/

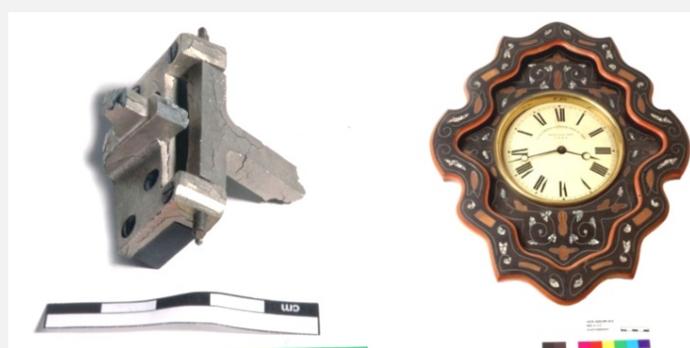
Fig. 1: Broken armature (left) from the clock movement of a wooden wall clock (right) (after Seematter 2009),

Description of the artefact	Armature from the clock movement of a wooden wall clock with electric movement broken in two elements (Fig. 1 and Fig. 2) with a heavily cracked surface.
Type of artefact	Horological object
Origin	Wooden wall clock
Recovering date	1902-1904
Chronology category	Modern Times
chronology tpg	<input type="text" value="1902"/> A.D. ▼
chronology taq	<input type="text" value="1904"/> A.D. ▼
Chronology comment	
Burial conditions / environment	Indoor atmosphere
Artefact location	International museum of horology (IMH), La Chaux-de-Fonds, Neuchâtel
Owner	International museum of horology (IMH), La Chaux-de-Fonds, Neuchâtel
Inv. number	MIH IV-212

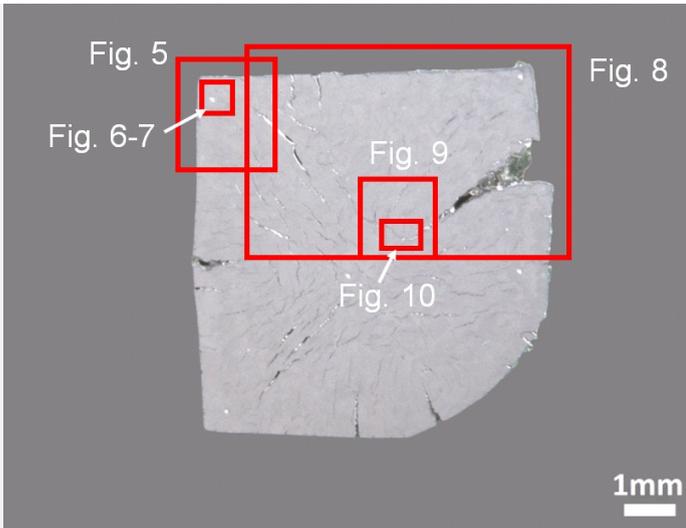
Fig. 3: Micrograph of the cross-section of the fragment sampled from the armature showing the location of Figs. 5 to 10,

Description of sample	This sample is the complete cross-section from an element of the armature (Fig. 2). The metal has huge cracks radiating from the centre to the outside which have deformed the armature (Fig. 3). The metal is covered with a Ni coating.
Alloy	Zn Al Sn Cu Alloy
Technology	As-cast
Lab number of sample	MIH-VI-212
Sample location	HE-Arc CR, Neuchâtel, Neuchâtel
Responsible institution	International museum of horology (IMH), La Chaux-de-Fonds, Neuchâtel
Date and aim of sampling	2009, metal analysis

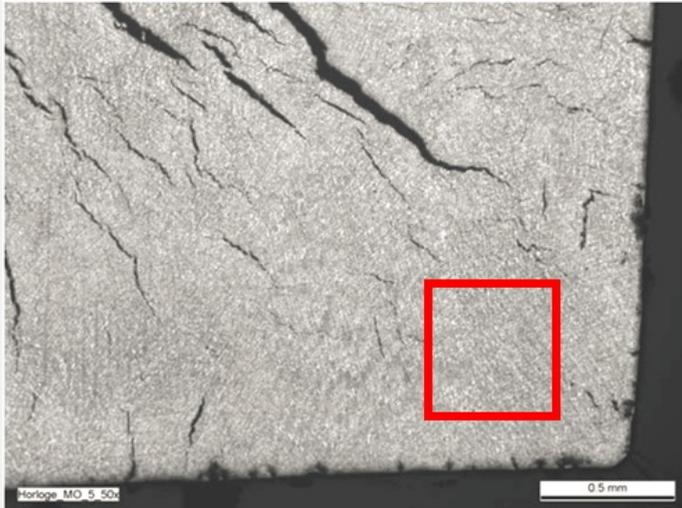
The metal is a Zn-Al-Sn-Cu alloy (Table 1) with an average hardness of HV1 105. A fine dendritic structure is observed (Fig. 5) which consists of clearly separated Zn, Al-Cu and Sn-rich phases (Figs. 6 and 7). Pb is associated with Sn but also forms tiny nodules.

Fig. 5: Micrograph of the metal sample from Fig. 3 (inverted picture, rotated by 270°, detail), unetched, bright field. A dendritic structure is visible. The micrograph of Fig. 6 is marked by a square,

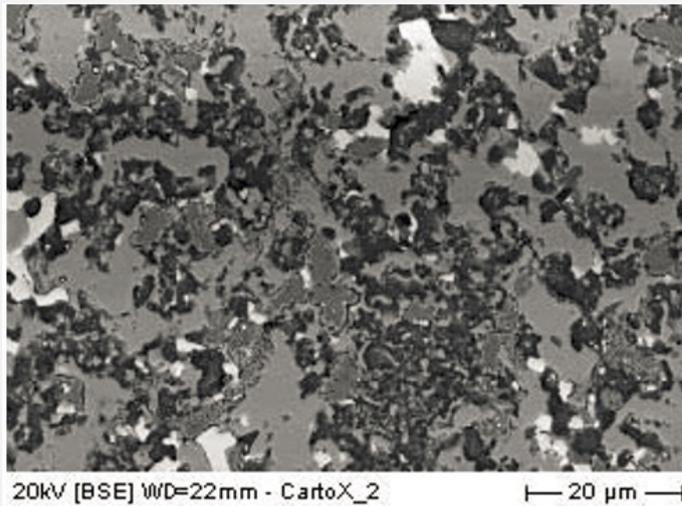
Fig. 6: SEM image, BSE-mode, detail from Fig. 5 (detail), unetched, bright field. Three phases appear: in light-grey the Zn-rich phase, in dark-grey the Al and Cu-rich phase and in white the Sn-rich phase,

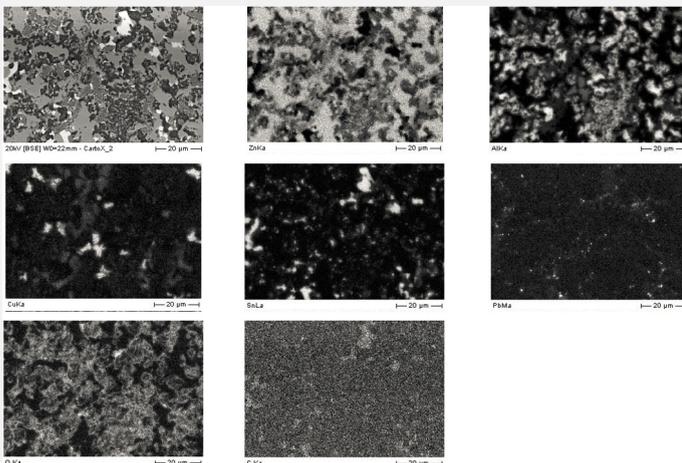
Fig. 7: SEM image, BSE-mode, and elemental chemical distribution of the selected area from Fig. 6. Method of examination: SEM/EDS, Lab of Electronic Microscopy and microanalysis, IMA (Néode), HEI Arc,

The Zn-rich phase is heavily oxidised internally (Fig. 7). The corrosion has developed throughout the entire metal body, generating cracks (Figs. 8 and 9). The cracks are Zn, O and C-rich (Fig. 10) and could be composed of zinc carbonate.

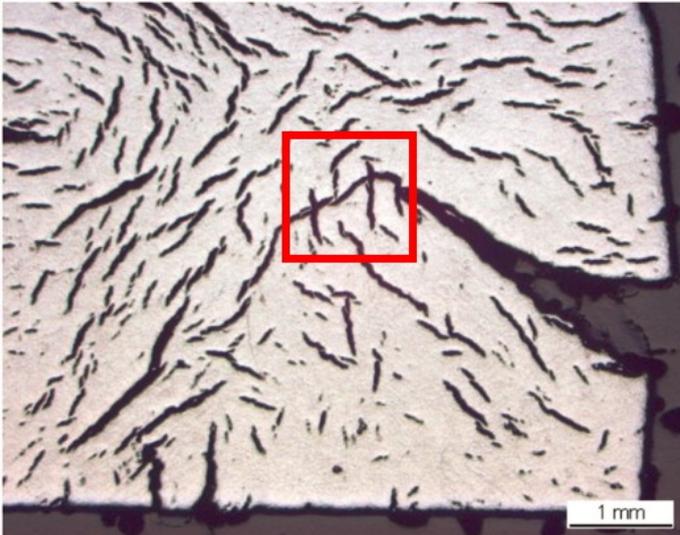
Fig. 8: Micrograph showing the metal - "corrosion products" interface from Fig. 3 (reversed picture, detail), unetched, bright field. We observe in white the metal matrix and dark-grey the adhering material,

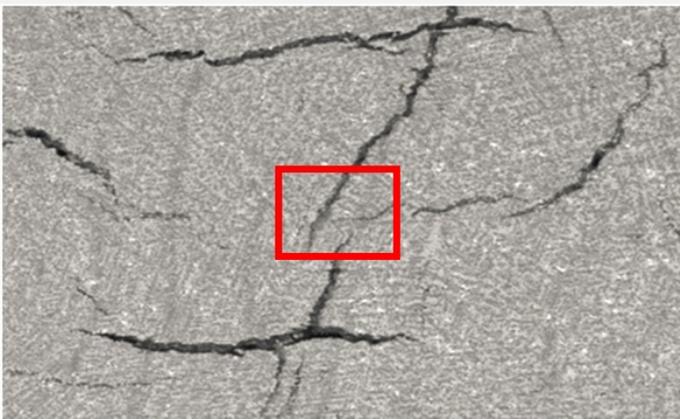
Fig. 9: Micrograph of the metal sample, detail from Fig. 8 (reversed and rotated by 90°), unetched, bright field. A dendritic structure is visible. The area selected for elementary mapping (Fig. 10) is marked by a rectangle,
