ARMATURE FROM A CLOCK MOVEMENT MIH IV-212 – ZN AL SN CU ALLOY – MODERN TIMES

Artefact name	Armature from a clock movement MIH IV-212
Authors	Marianne. Senn (EMPA, Dübendorf, Zurich, Switzerland) & Christian. Degrigny (HE-Arc CR, Neuchâtel, Neuchâtel, Switzerland)
Url	/artefacts/707/

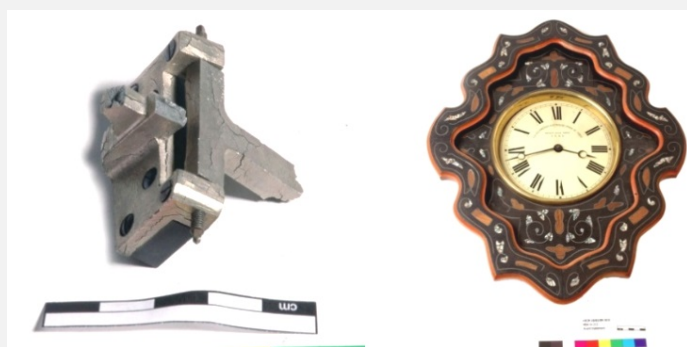
Fig. 1: Broken armature (left) from the clock movement of a wooden wall clock (right) (after Seematter 2009),

Description of the artefact	Armature from the clock movement of a wooden wall clock with electric movement broken in two elements (Fig. 1 and Fig. 2) with a heavily cracked surface.
Type of artefact	Horological object
Origin	Wooden wall clock
Recovering date	1902-1904
Chronology category	Modern Times
chronology tpq	1902 A.D. ▼
chronology taq	1904 A.D. ▼
Chronology comment	
Burial conditions / environment	Indoor atmosphere
Artefact location	International museum of horology (IMH), La Chaux-de-Fonds, Neuchâtel
Owner	International museum of horology (IMH), La Chaux-de-Fonds, Neuchâtel
Inv. number	MIH IV-212

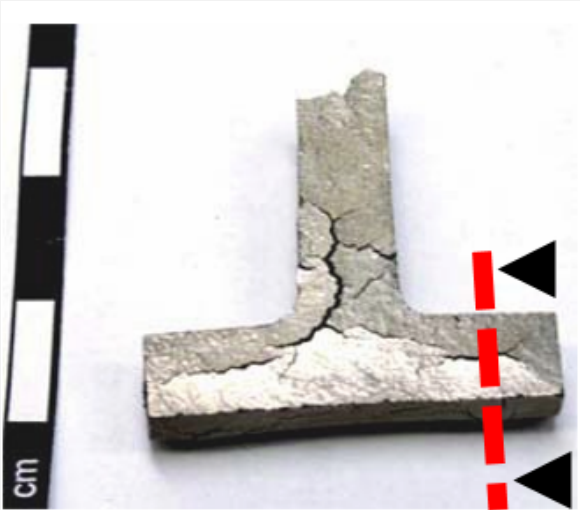
Fig. 2: Location of sampling area on the second element of the armature,

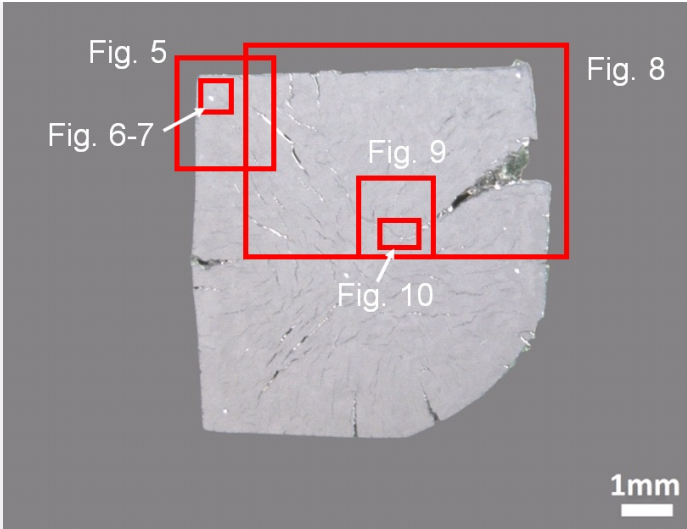
Fig. 3: Micrograph of the cross-section of the fragment sampled from the armature showing the location of Figs. 5 to 10,

Description of sample	This sample is the complete cross-section from an element of the armature (Fig. 2). The metal has huge cracks radiating from the centre to the outside which have deformed the armature (Fig. 3). The metal is covered with a Ni coating.
Alloy	Zn Al Sn Cu Alloy
Technology	As-cast
Lab number of sample	MIH-VI-212
Sample location	HE-Arc CR, Neuchâtel, Neuchâtel
Responsible institution	International museum of horology (IMH), La Chaux-de-Fonds, Neuchâtel
Date and aim of sampling	2009, metal analysis

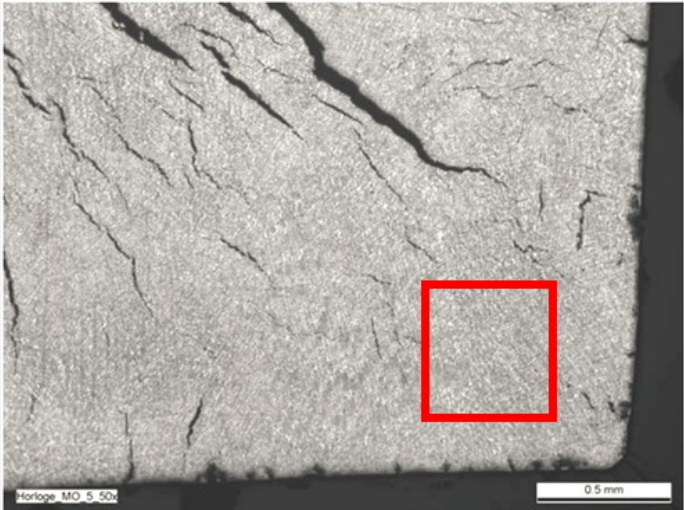
The metal is a Zn-Al-Sn-Cu alloy (Table 1) with an average hardness of HV1 105. A fine dendritic structure is observed (Fig. 5) which consists of clearly separated Zn, Al-Cu and Sn-rich phases (Figs. 6 and 7). Pb is associated with Sn but also forms tiny nodules.

Fig. 5: Micrograph of the metal sample from Fig. 3 (inverted picture, rotated by 270°, detail), unetched, bright field. A dendritic structure is visible. The micrograph of Fig. 6 is marked by a square,

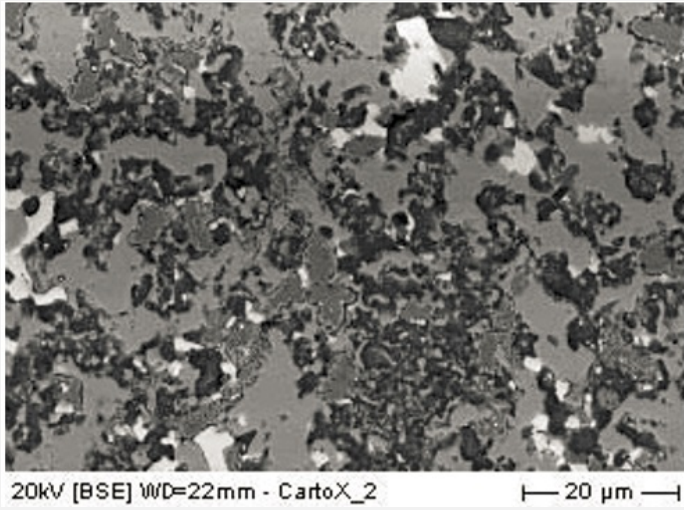
Fig. 6: SEM image, BSE-mode, detail from Fig. 5 (detail), unetched, bright field. Three phases appear: in light-grey the Zn-rich phase, in dark-grey the Al and Cu-rich phase and in white the Sn-rich phase,

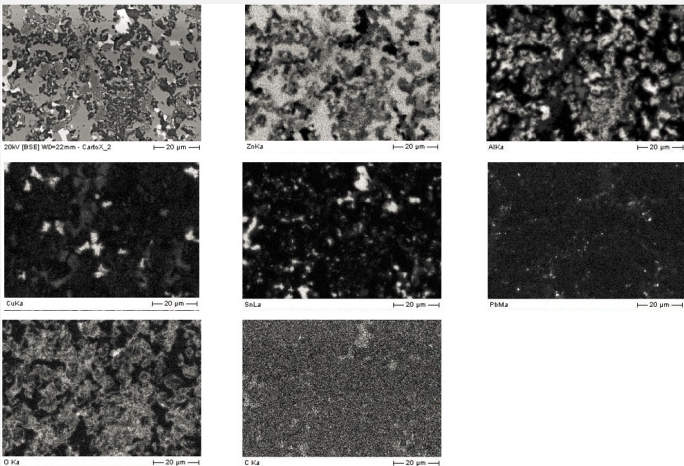
Fig. 7: SEM image, BSE-mode, and elemental chemical distribution of the selected area from Fig. 6. Method of examination: SEM/EDS, Lab of Electronic Microscopy and microanalysis, IMA (Néode), HEI Arc,

The Zn-rich phase is heavily oxidised internally (Fig. 7). The corrosion has developed throughout the entire metal body, generating cracks (Figs. 8 and 9). The cracks are Zn, O and C-rich (Fig. 10) and could be composed of zinc carbonate.

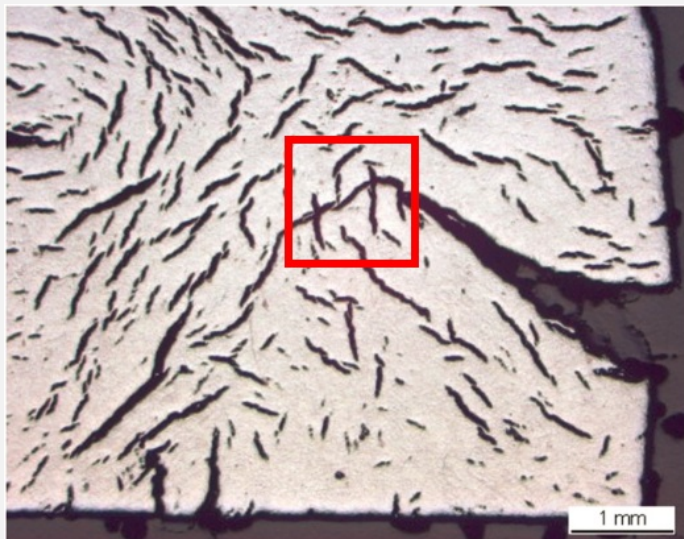
Fig. 8: Micrograph showing the metal - "corrosion products" interface from Fig. 3 (reversed picture, detail), unetched, bright field. We observe in white the metal matrix and dark-grey the adhering material,

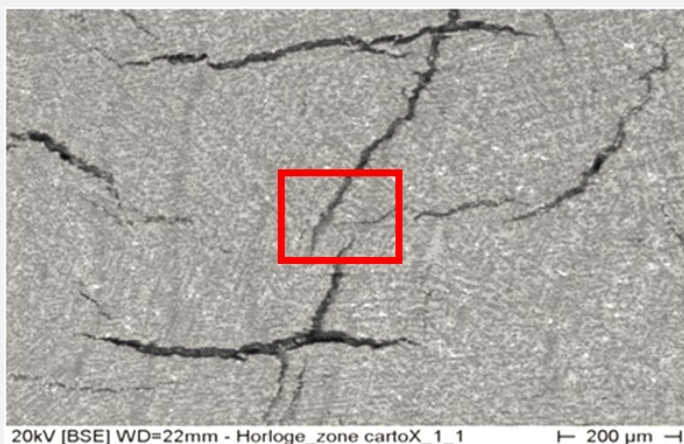
Fig. 9: Micrograph of the metal sample, detail from Fig. 8 (reversed and rotated by 90°), unetched, bright field. A dendritic structure is visible. The area selected for elementary mapping (Fig. 10) is marked by a rectangle,
