# ARMATURE FROM A CLOCK MOVEMENT MIH IV-212 – ZN AL SN CU ALLOY – MODERN TIMES

<b>Artefact name</b>	Armature from a clock movement MIH IV-212
<b>Authors</b>	Marianne. Senn (EMPA, Dübendorf, Zurich, Switzerland) & Christian. Degriigny (HE-Arc CR, Neuchâtel, Neuchâtel, Switzerland)
<b>Url</b>	/artefacts/707/

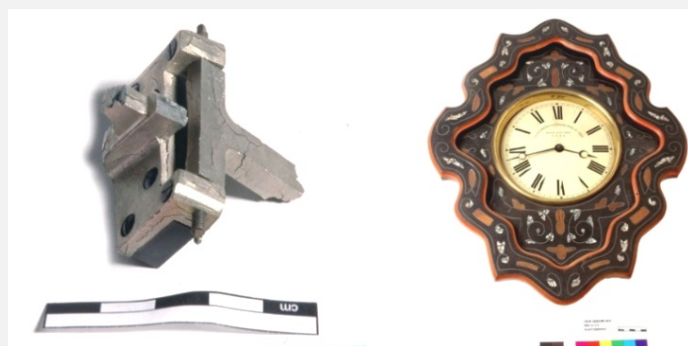
Fig. 1: Broken armature (left) from the clock movement of a wooden wall clock (right) (after Seematter 2009),

<b>Description of the artefact</b>	Armature from the clock movement of a wooden wall clock with electric movement broken in two elements (Fig. 1 and Fig. 2) with a heavily cracked surface.
<b>Type of artefact</b>	Horological object
<b>Origin</b>	Wooden wall clock
<b>Recovering date</b>	1902-1904
<b>Chronology category</b>	Modern Times
<b>chronology tpeq</b>	<input type="text" value="1902"/> A.D. ∨
<b>chronology taq</b>	<input type="text" value="1904"/> A.D. ∨
<b>Chronology comment</b>	
<b>Burial conditions / environment</b>	Indoor atmosphere
<b>Artefact location</b>	International museum of horology (IMH), La Chaux-de-Fonds, Neuchâtel
<b>Owner</b>	International museum of horology (IMH), La Chaux-de-Fonds, Neuchâtel
<b>Inv. number</b>	MIH IV-212
<b>Recorded conservation data</b>	Not conserved

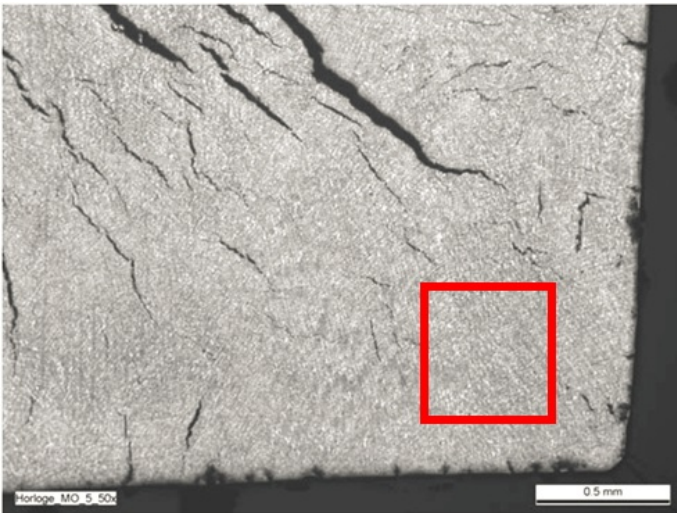
The metal is a Zn-Al-Sn-Cu alloy (Table 1) with an average hardness of HV1 105. A fine dendritic structure is observed (Fig. 5) which consists of clearly separated Zn, Al-Cu and Sn-rich phases (Figs. 6 and 7). Pb is associated with Sn but also forms tiny nodules.

Fig. 5: Micrograph of the metal sample from Fig. 3 (inverted picture, rotated by 270°, detail), unetched, bright field. A dendritic structure is visible. The micrograph of Fig. 6 is marked by a square,

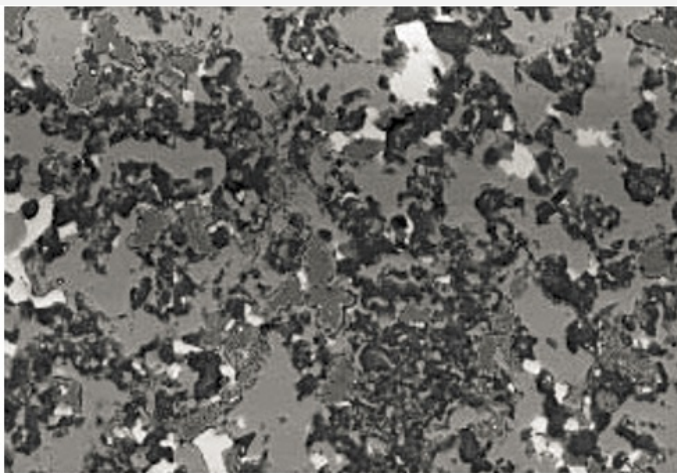
Fig. 6: SEM image, BSE-mode, detail from Fig. 5 (detail), unetched, bright field. Three phases appear: in light-grey the Zn-rich phase, in dark-grey the Al and Cu-rich phase and in white the Sn-rich phase,

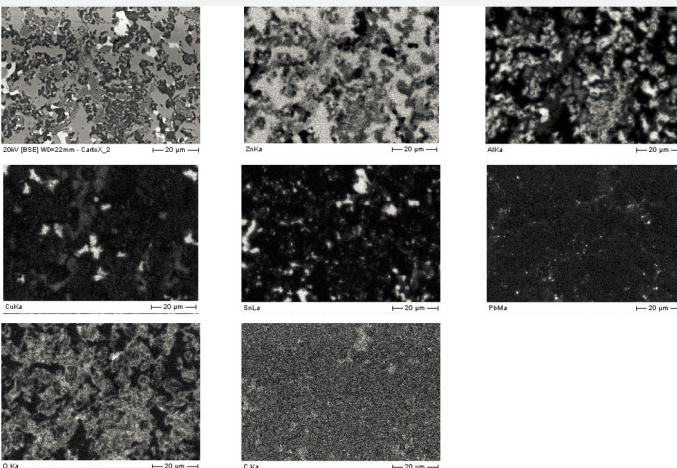
Fig. 7: SEM image, BSE-mode, and elemental chemical distribution of the selected area from Fig. 6. Method of examination: SEM/EDS, Lab of Electronic Microscopy and microanalysis, IMA (Néode), HEI Arc,

The Zn-rich phase is heavily oxidised internally (Fig. 7). The corrosion has developed throughout the entire metal body, generating cracks (Figs. 8 and 9). The cracks are Zn, O and C-rich (Fig. 10) and could be composed of zinc carbonate.

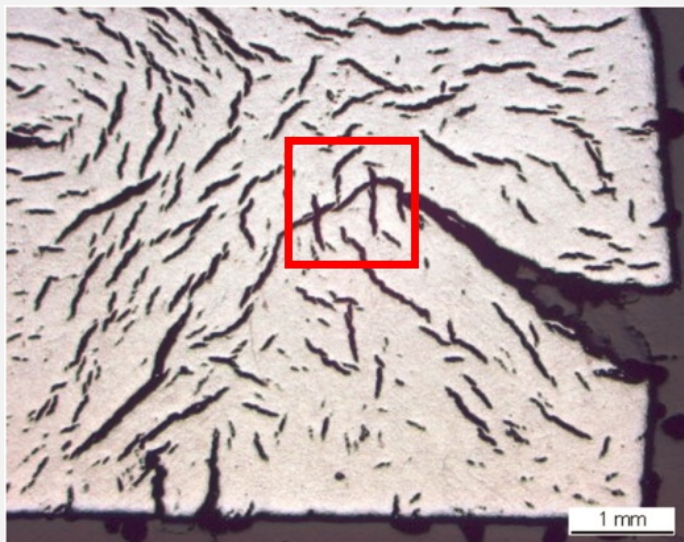
Fig. 8: Micrograph showing the metal - "corrosion products" interface from Fig. 3 (reversed picture, detail), unetched, bright field. We observe in white the metal matrix and dark-grey the adhering material,

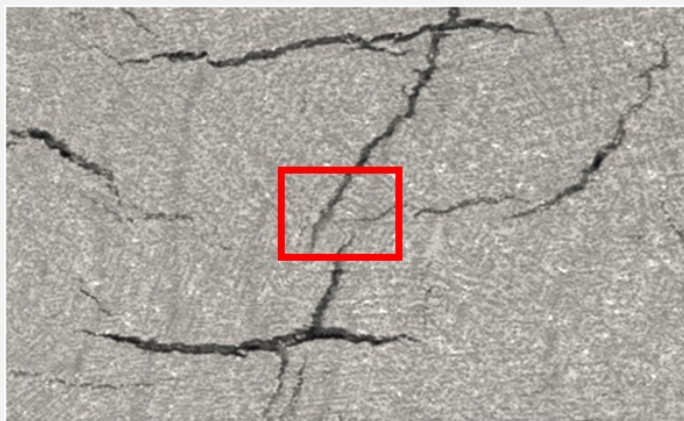
Fig. 9: Micrograph of the metal sample, detail from Fig. 8 (reversed and rotated by 90°), unetched, bright field. A dendritic structure is visible. The area selected for elementary mapping (Fig. 10) is marked by a rectangle,

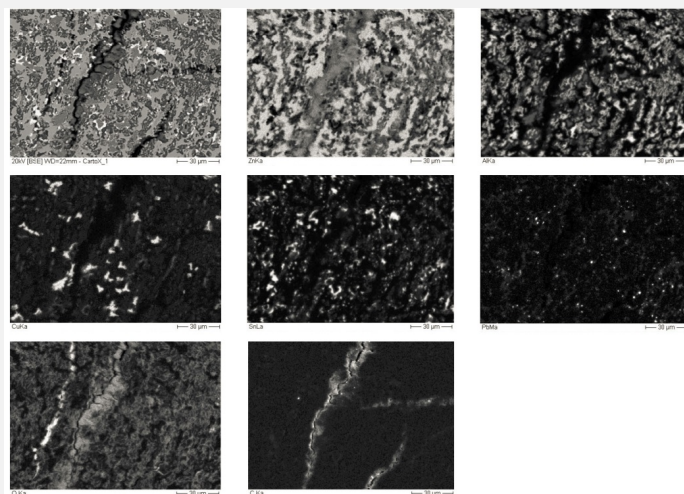
Fig. 10: SEM image, BSE-mode, and elemental chemical distribution of the selected area from Fig. 9 (detail). Method of examination: SEM/EDX, Lab of Electronic Microscopy and microanalysis, IMA (Néode), HEI Arc,

Corrosion form	Internal cracking
Corrosion type	zinc pest
