ARMATURE FROM A CLOCK MOVEMENT MIH IV-212 – ZN AL SN CU ALLOY – MODERN TIMES

Artefact name	Armature from a clock movement MIH IV-212
Authors	Marianne. Senn (EMPA, Dübendorf, Zurich, Switzerland) & Christian. Degrigny (HE-Arc CR, Neuchâtel, Neuchâtel, Switzerland)
Url	/artefacts/707/

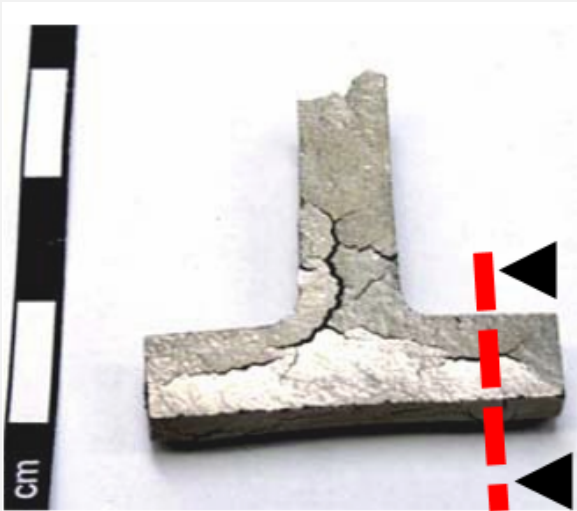
Fig. 2: Location of sampling area on the second element of the armature,

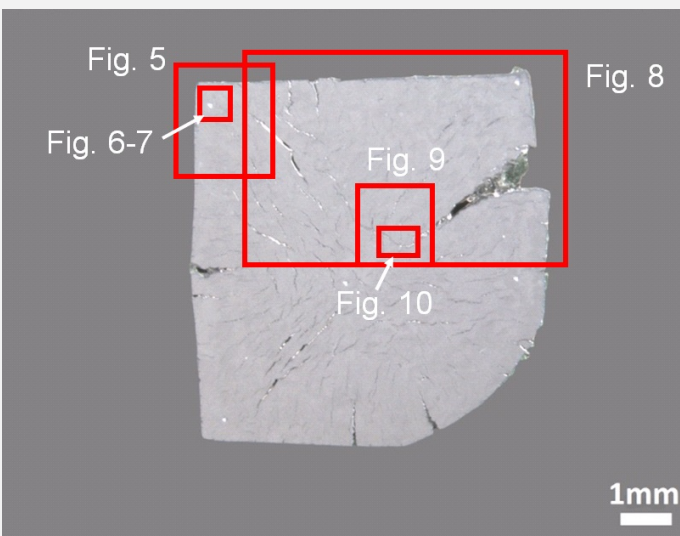
Fig. 3: Micrograph of the cross-section of the fragment sampled from the armature showing the location of Figs. 5 to 10,

Description of sample	This sample is the complete cross-section from an element of the armature (Fig. 2). The metal has huge cracks radiating from the centre to the outside which have deformed the armature (Fig. 3). The metal is covered with a Ni coating.
Alloy	Zn Al Sn Cu Alloy
Technology	As-cast
Lab number of sample	MIH-VI-212
Sample location	HE-Arc CR, Neuchâtel, Neuchâtel
Responsible institution	International museum of horology (IMH), La Chaux-de-Fonds, Neuchâtel
Date and aim of sampling	2009, metal analysis
