ARMATURE FROM A CLOCK MOVEMENT MIH IV-212 – ZN AL SN CU ALLOY – MODERN TIMES

Artefact name	Armature from a clock movement MIH IV-212
Authors	Marianne. Senn (EMPA, Dübendorf, Zurich, Switzerland) & Christian. Degrigny (HE-Arc CR, Neuchâtel, Neuchâtel, Switzerland)
Url	/artefacts/707/

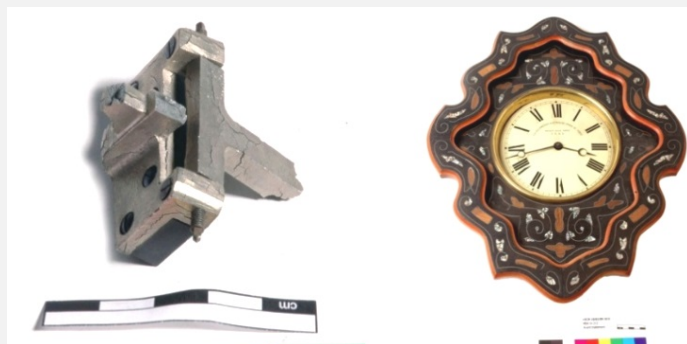
Fig. 1: Broken armature (left) from the clock movement of a wooden wall clock (right) (after Seematter 2009),

Description of the artefact	Armature from the clock movement of a wooden wall clock with electric movement broken in two elements (Fig. 1 and Fig. 2) with a heavily cracked surface.
Type of artefact	Horological object
Origin	Wooden wall clock
Recovering date	1902-1904
Chronology category	Modern Times
chronology tpq	1902 A.D. ▼
chronology taq	1904 A.D. ▼
Chronology comment	
Burial conditions / environment	Indoor atmosphere
Artefact location	International museum of horology (IMH), La Chaux-de-Fonds, Neuchâtel
Owner	International museum of horology (IMH), La Chaux-de-Fonds, Neuchâtel
Inv. number	MIH IV-212
Recorded conservation data	Not conserved

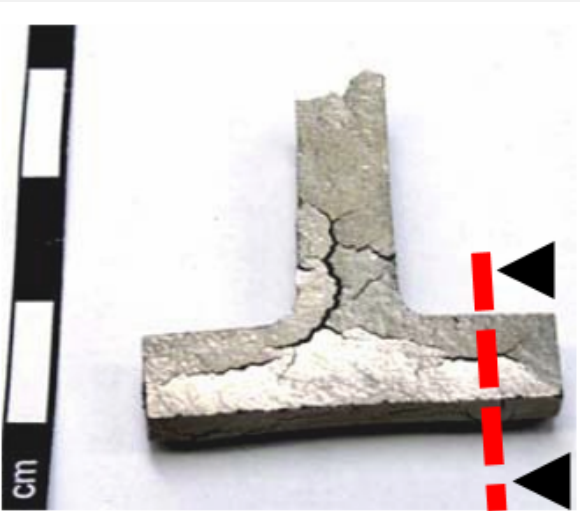
Fig. 2: Location of sampling area on the second element of the armature,

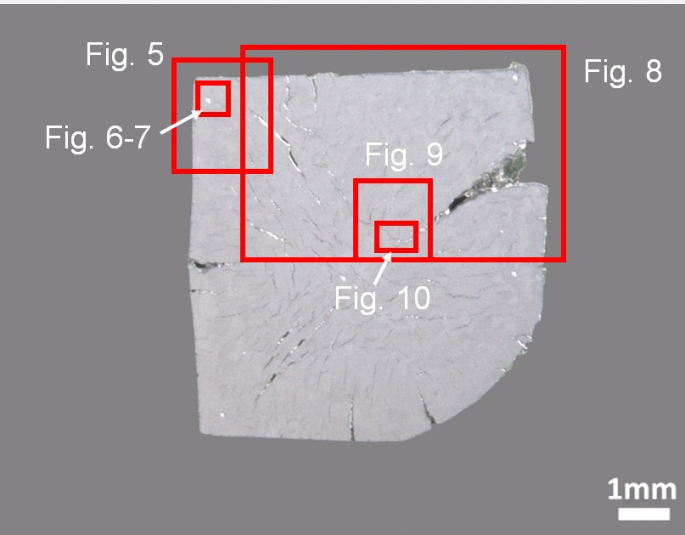
Fig. 3: Micrograph of the cross-section of the fragment sampled from the armature showing the location of Figs. 5 to 10,

Description of sample	This sample is the complete cross-section from an element of the armature (Fig. 2). The metal has huge cracks radiating from the centre to the outside which have deformed the armature (Fig. 3). The metal is covered with a Ni coating.
Alloy	Zn Al Sn Cu Alloy
Technology	As-cast
Lab number of sample	MIH-VI-212
Sample location	HE-Arc CR, Neuchâtel, Neuchâtel
Responsible institution	International museum of horology (IMH), La Chaux-de-Fonds, Neuchâtel
Date and aim of sampling	2009, metal analysis

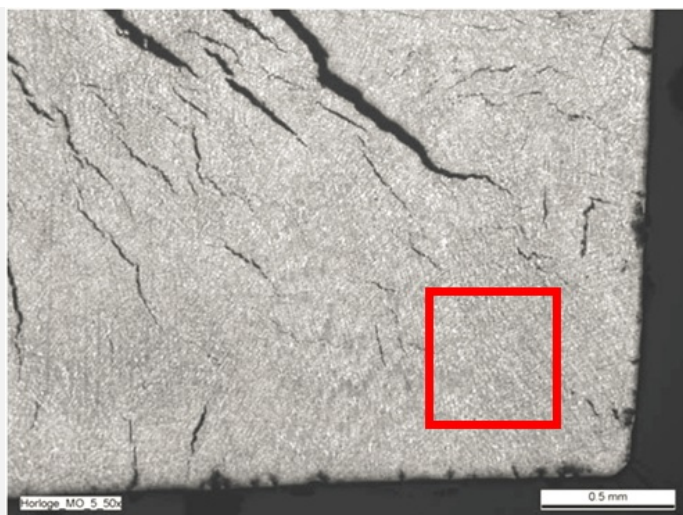
The metal is a Zn-Al-Sn-Cu alloy (Table 1) with an average hardness of HV1 105. A fine dendritic structure is observed (Fig. 5) which consists of clearly separated Zn, Al-Cu and Sn-rich phases (Figs. 6 and 7). Pb is associated with Sn but also forms tiny nodules.

Fig. 5: Micrograph of the metal sample from Fig. 3 (inverted picture, rotated by 270°, detail), unetched, bright field. A dendritic structure is visible. The micrograph of Fig. 6 is marked by a square,

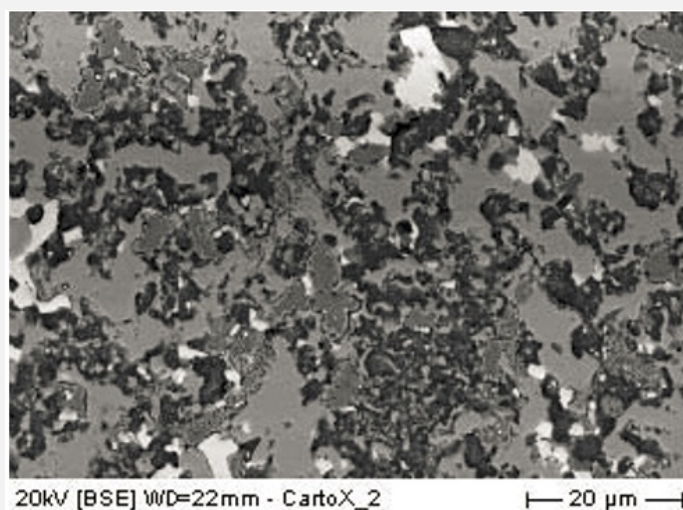
Fig. 6: SEM image, BSE-mode, detail from Fig. 5 (detail), unetched, bright field. Three phases appear: in light-grey the Zn-rich phase, in dark-grey the Al and Cu-rich phase and in white the Sn-rich phase,

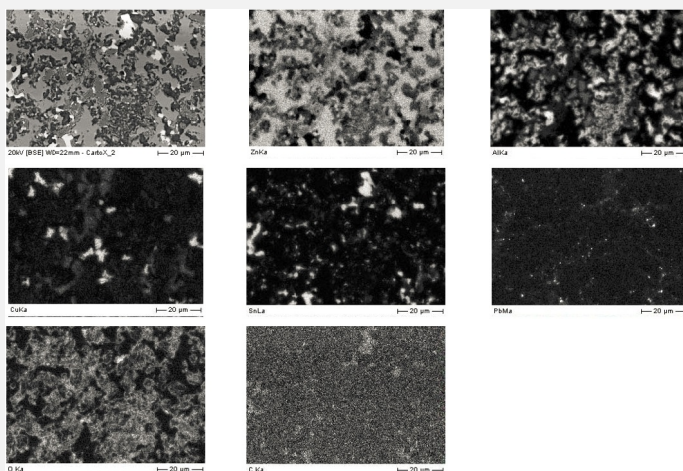
Fig. 7: SEM image, BSE-mode, and elemental chemical distribution of the selected area from Fig. 6. Method of examination: SEM/EDS, Lab of Electronic Microscopy and microanalysis, IMA (Néode), HEI Arc,

The Zn-rich phase is heavily oxidised internally (Fig. 7). The corrosion has developed throughout the entire metal body, generating cracks (Figs. 8 and 9). The cracks are Zn, O and C-rich (Fig. 10) and could be composed of zinc carbonate.
