# SHOE NAIL 2637 1370.B. – HYPOEUTECTOID STEEL – ROMAN TIMES – SWITZERLAND

<b>Artefact name</b>	Shoe nail 2637 1370.B.
<b>Authors</b>	Christian. Degryny (HE-Arc CR, Neuchâtel, Neuchâtel, Switzerland) & Valentin. Boissonnas (HE-Arc CR, Neuchâtel, Neuchâtel, Switzerland) & Vincent Chappuis. (HE-Arc CR, Neuchâtel, Neuchâtel, Switzerland)
<b>Url</b>	/artefacts/708/

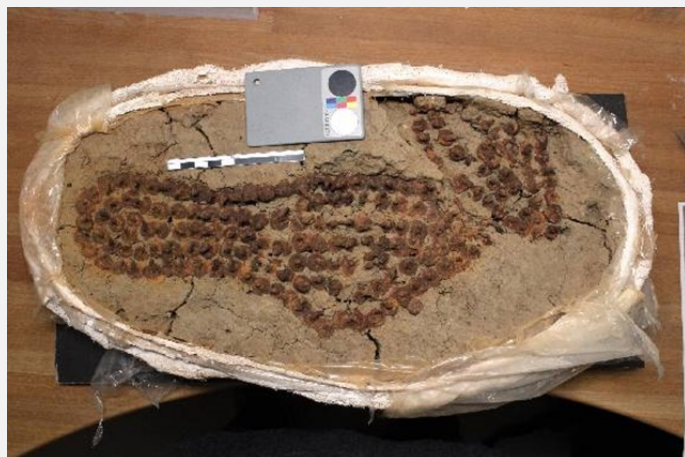
Fig. 1: A nail from a block-lifted Roman shoes before conservation.

<b>Description of the artefact</b>	A nail from a block-lifted Roman shoes (Fig. 1) covered with a thick corrosion crust. The forged nails were hammered into the leather soles on a bucking tool. Average dimensions of the shoe nails: L = about 14mm; diamter = 11mm; W = up to 0.8g.
<b>Type of artefact</b>	Shoe nail
<b>Origin</b>	Hofstetterfeld, near Roman Necropolis, Sursee, Lucerne, Switzerland
<b>Recovering date</b>	None
<b>Chronology category</b>	Roman Times
<b>chronology tpq</b>	<input type="text" value="50"/> A.D. ▼
<b>chronology taq</b>	<input type="text" value="100"/> A.D. ▼
<b>Chronology comment</b>	2nd half 1st century AD.
<b>Burial conditions / environment</b>	Soil

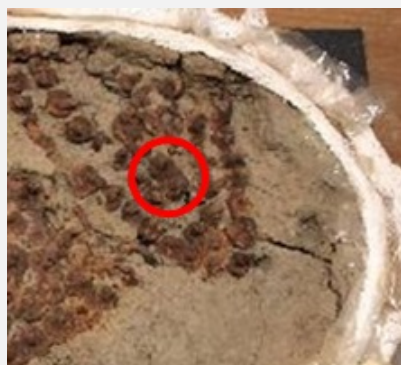
Fig. 2: Incomplete shoe from which the nail was sampled (in red circle),

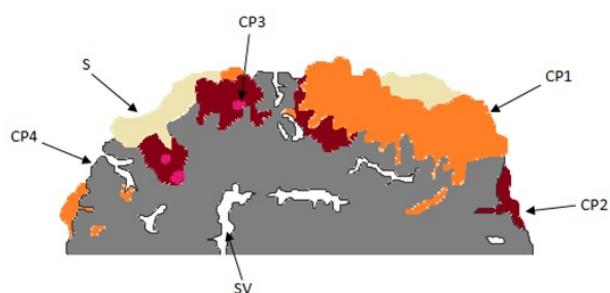
S = compact sand-clay soil.  
 CP1 = powdery soil, orange-coloured by corrosion products.  
 CP2 = dark-red corrosion crust, breaks into bits.  
 CP3 = vivid pink-red and globular corrosion products.  
 CP4 = dark grey to black and very hard corrosion products, results in an dark-orange powder when scratched.  
 SV = structural void near the center of the cross section, seems to draw a square shape.

Fig. 3: Preliminary stratigraphy of the corrosion layers based on the observation of a broken nail,

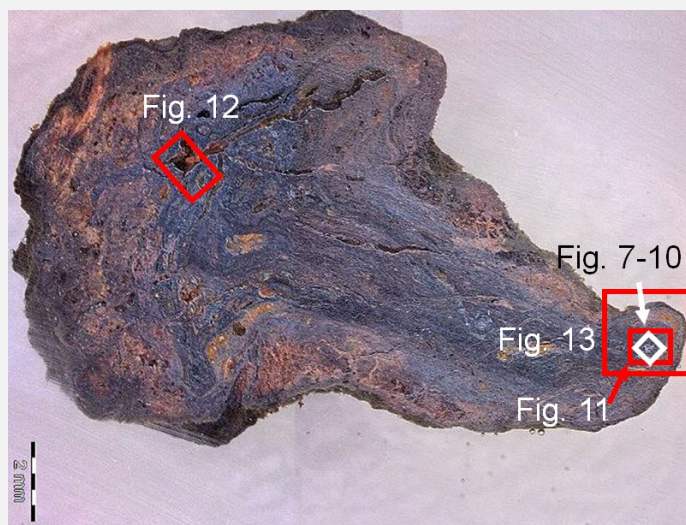
Fig. 4: Micrograph of the cross-section of the nail showing the location of figs. 7 to 13,

<b>Description of sample</b>	A longitudinal cut through the nail (Fig. 4). Dimensions: L = 16.4mm; W = about 12.0mm.
<b>Alloy</b>	Hypoeutectoid steel
<b>Technology</b>	Forged
<b>Lab number of sample</b>	HE-Arc CR 1457-S1.
<b>Sample location</b>	HE-Arc CR, Neuchâtel, Neuchâtel
<b>Responsible institution</b>	HE-Arc CR, Neuchâtel, Neuchâtel
<b>Date and aim of sampling</b>	2013, metallography and elementary composition of the metal

The metal is heavily corroded and the thickness of the corrosion crust is irregular, varying from 0.8 to 3.8mm, with an average of about 2mm. The corrosion has replaced most of the metal (Fig. 4). Between corrosion layers the limit of the original structure is visible. Some leather fibers seem to be preserved as pseudomorphic structures in voids of the metal core (POM1, Figs. 11 and 12). The carbon mapping (Fig.13) shows the presence of carbon in these areas. This can also be due to the penetration of the mounting resin in the cracks.

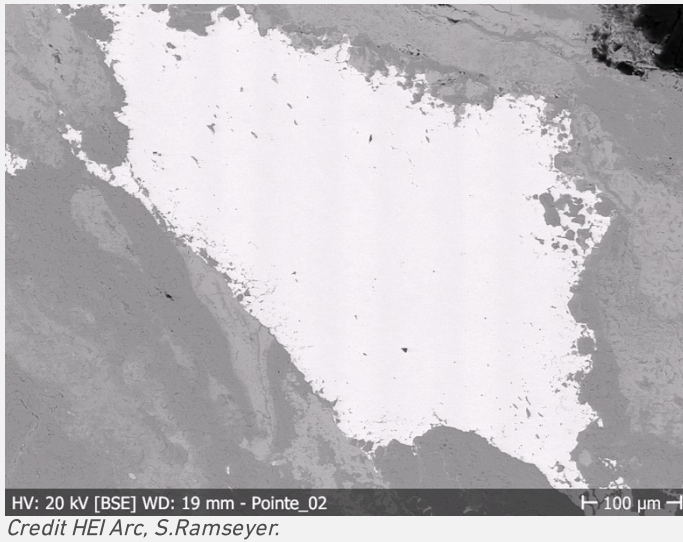
The remaining metal is an hypoeutectoid steel (Fig. 7 and 8), containing Fe, Si and O slags inclusions (possibly fayalite  $\text{FeO}, \text{SiO}_2$ ), and consisting of less than 1% of the total volume of the highly mineralized nail. After Nital etching, it shows intergranular corrosion on one of its sides (Figs. 9 and 10).

Fig. 7: SEM, BSE-mode picture of remaining metal,

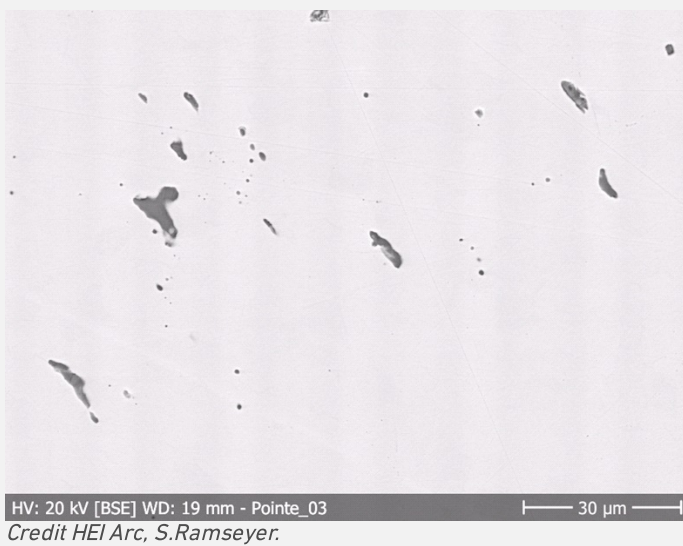
Fig. 8: SEM, BSE-mode picture of inclusions in remaining metal,

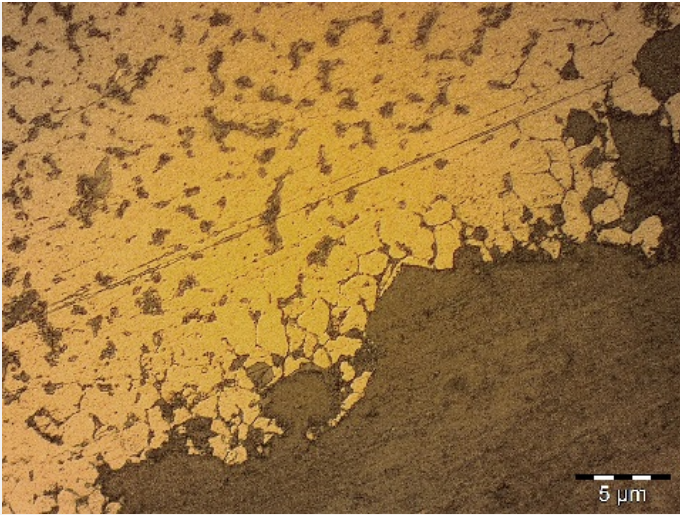
Fig. 10: Micrograph of the selected area of Fig. 9, Nital etched with no clear grain structure, bright field, Intergranular corrosion and grey phase (perlite?) are observed,

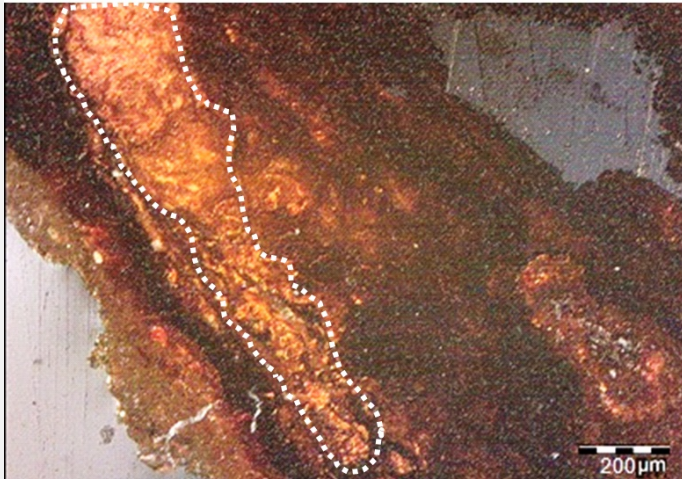
Fig. 11: Micrograph of the metal sample, bright field. The delimited zone shows what could be leather pseudomorphic fibers filling a void,

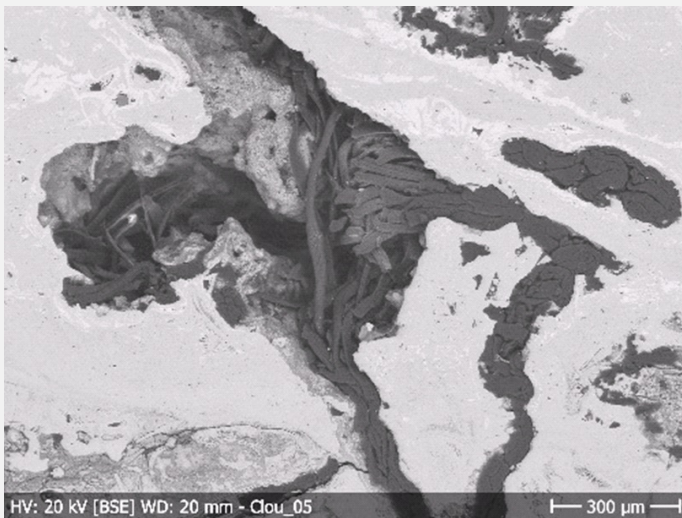
Fig. 12: Micrograph (SEM - BSE-mode) of another void filled with fibers in the head of the nail,

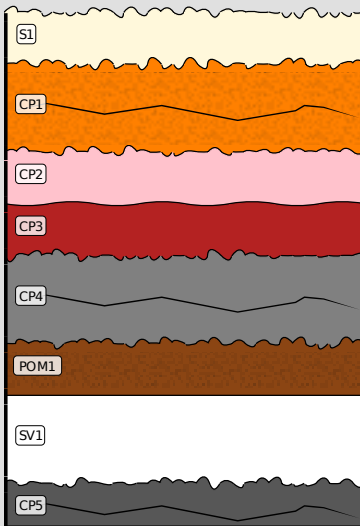
Fig. 5: Stratigraphic representation of the nail in cross-section (dark field) using the MiCorr application. The characteristics of the strata are only accessible by clicking on the drawing that redirects you to the search tool by stratigraphy representation. This representation can be compared to Fig. 14, Credit HE-Arc CR, V.Chappuis.

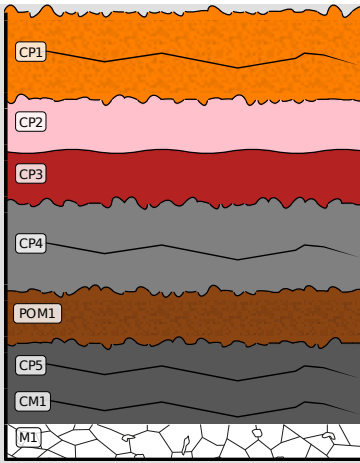
Fig. 6: Stratigraphic representation of the nail in cross-section (dark field) using the MiCorr application. The characteristics of the strata are only accessible by clicking on the drawing that redirects you to the search tool by stratigraphy representation. This representation can be compared to Fig. 14, Credit HE-Arc CR, V.Chappuis.

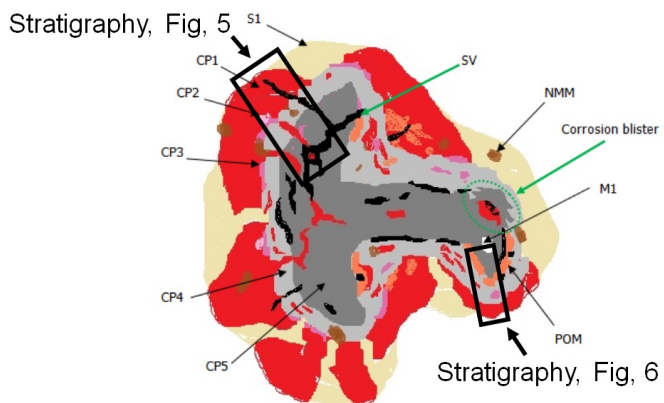
The schematic representation of corrosion layers of Fig. 3 integrating additional information based on the analyses carried out is given in Fig. 14. The following strata were identified:

Fig. 14: Improved stratigraphic representation of the nail from visual observations and analyses and visualization of the two stratigraphies of Figs. 5 and 6,
