# SHOE NAIL 2637 1370.B. – HYPOEUTECTOID STEEL – ROMAN TIMES – SWITZERLAND

**Artefact name** Shoe nail 2637 1370.B.

**Authors** Christian. Degriigny (HE-Arc CR, Neuchâtel, Neuchâtel, Switzerland) & Valentin. Boissonnas (HE-Arc CR, Neuchâtel, Neuchâtel, Switzerland) & Vincent Chappuis. (HE-Arc CR, Neuchâtel, Neuchâtel, Switzerland)

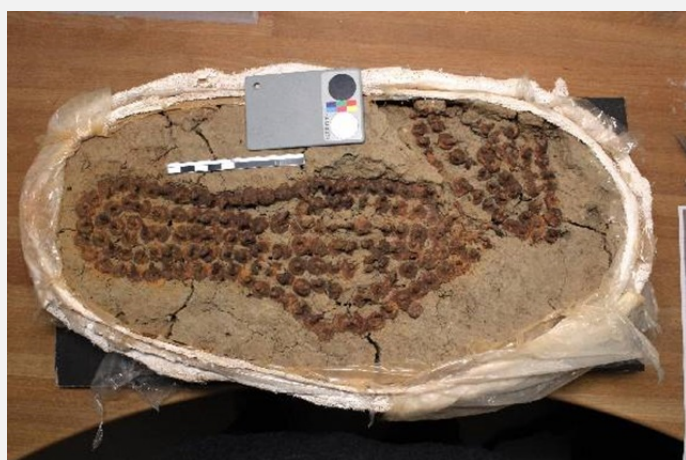
Fig. 1: A nail from a block-lifted Roman shoes before conservation.

**Description of the artefact** A nail from a block-lifted Roman shoes (Fig. 1) covered with a thick corrosion crust. The forged nails were hammered into the leather soles on a bucking tool. Average dimensions of the shoe nails: L = about 14mm; diamter = 11mm; W = up to 0.8g.

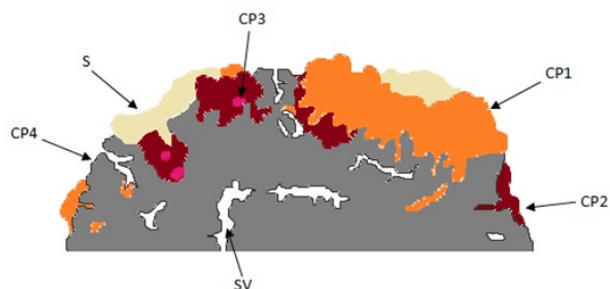
- S = compact sand-clay soil.
- CP1 = powdery soil, orange-coloured by corrosion products.
- CP2 = dark-red corrosion crust, breaks into bits.
- CP3 = vivid pink-red and globular corrosion products.
- CP4 = dark grey to black and very hard corrosion products, results in an dark-orange powder when scratched.
- SV = structural void near the center of the cross section, seems to draw a square shape.

Fig. 3: Preliminary stratigraphy of the corrosion layers based on the observation of a broken nail,

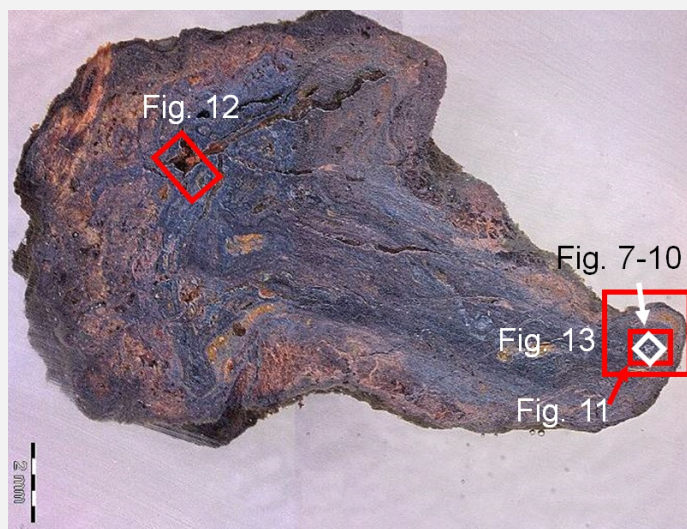
Fig. 4: Micrograph of the cross-section of the nail showing the location of figs. 7 to 13,

The metal is heavily corroded and the thickness of the corrosion crust is irregular, varying from 0.8 to 3.8mm, with an average of about 2mm. The corrosion has replaced most of the metal (Fig. 4). Between corrosion layers the limit of the original structure is visible. Some leather fibers seem to be preserved as pseudomorphic structures in voids of the metal core (POM1, Figs. 11 and 12). The carbon mapping (Fig.13) shows the presence of carbon in these areas. This can also be due to the penetration of the mounting resin in the cracks.

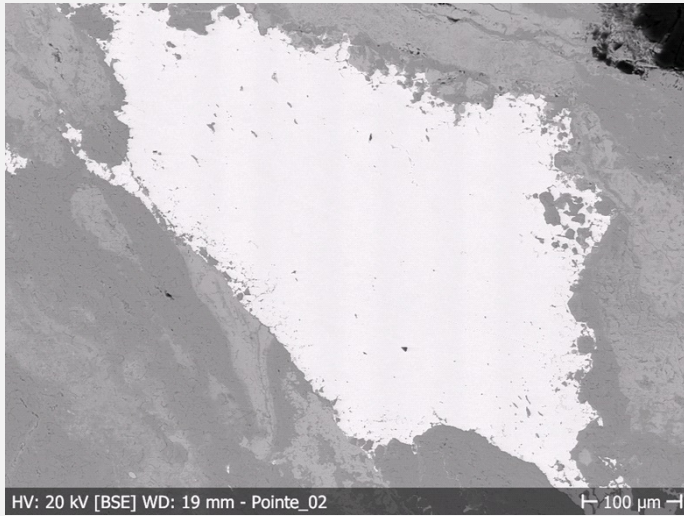
The remaining metal is an hypoeutectoid steel (Fig. 7 and 8), containing Fe, Si and O slags inclusions (possibly fayalite  $\text{FeO}, \text{SiO}_2$ ), and consisting of less than 1% of the total volume of the highly mineralized nail. After Nital etching, it shows intergranular corrosion on one of its sides (Figs. 9 and 10).

Fig. 7: SEM, BSE-mode picture of remaining metal,

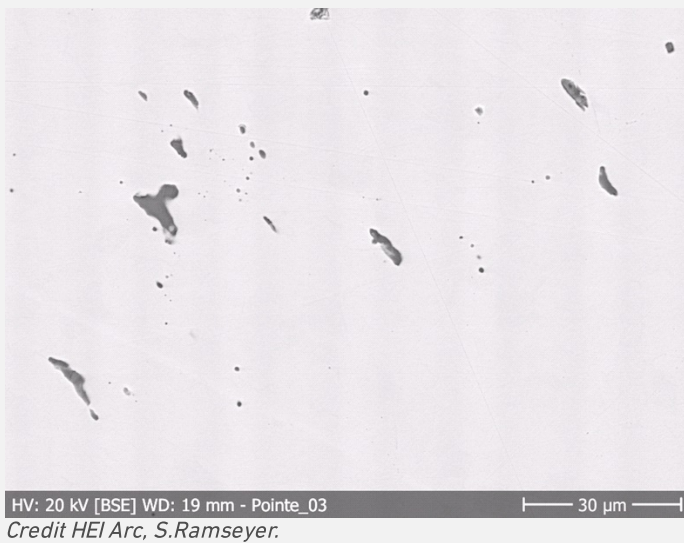
Fig. 8: SEM, BSE-mode picture of inclusions in remaining metal,

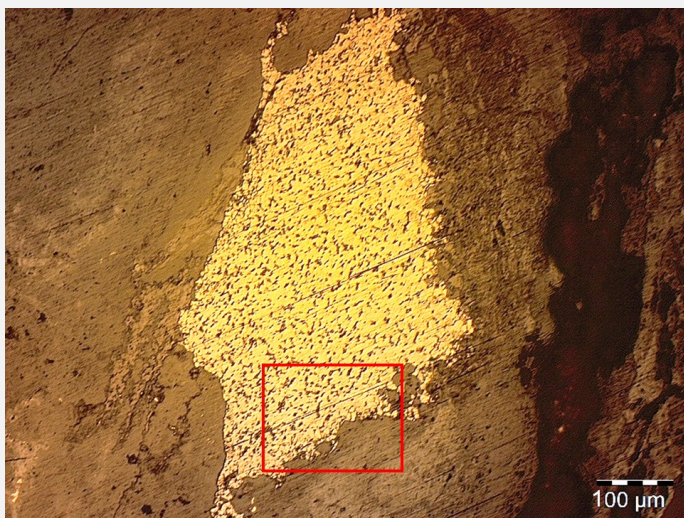
Fig. 9: Micrograph of the metal sample from Fig. 7 (detail, rotated 90°), Nital etched, bright field,

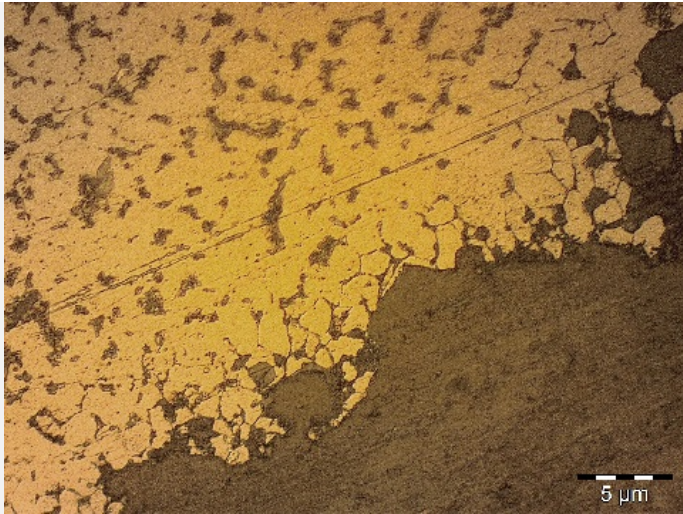
Fig. 10: Micrograph of the selected area of Fig. 9, Nital etched with no clear grain structure, bright field, Intergranular corrosion and grey phase (perlite?) are observed,

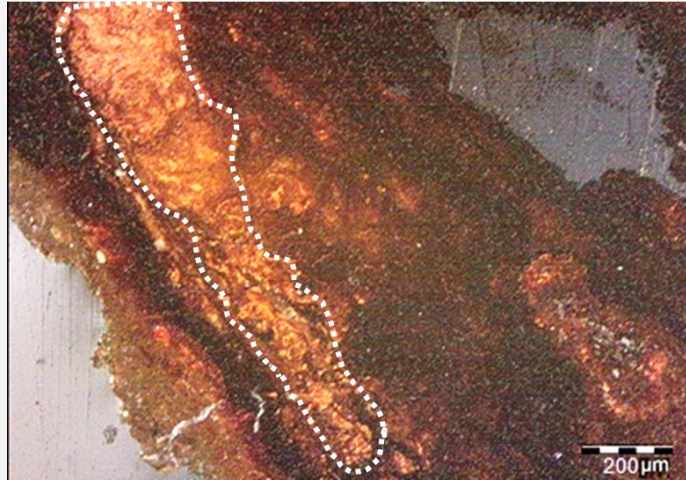
Fig. 11: Micrograph of the metal sample, bright field. The delimited zone shows what could be leather pseudomorphic fibers filling a void,

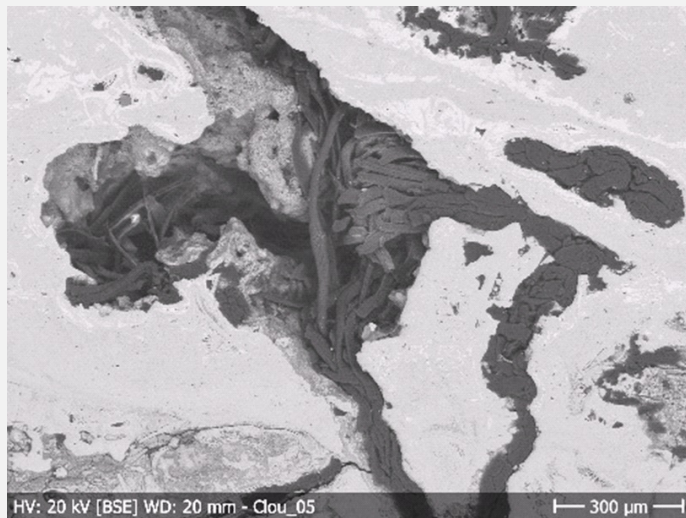
Fig. 12: Micrograph (SEM - BSE-mode) of another void filled with fibers in the head of the nail,

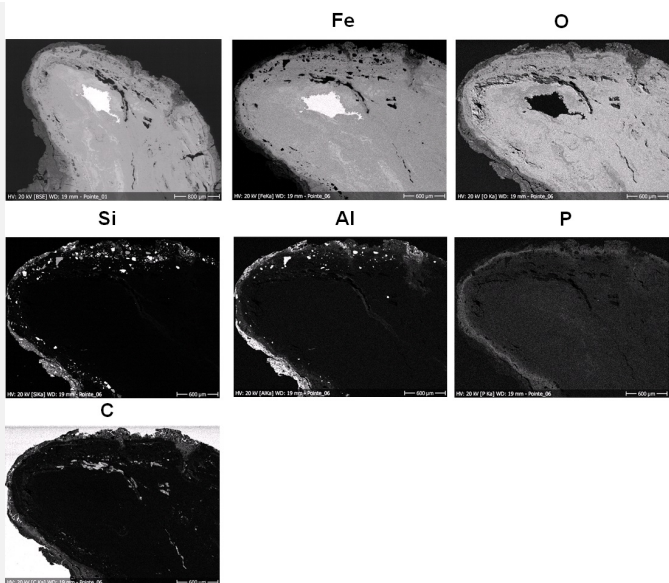
Si, Al, P and K can be considered external markers, helping to determine the limit of the original surface (Fig. 13 and Table 1). The outer layer of corrosion products (CP1-3) ranges from dark grey to orange in bright field and contains less O and Fe on its borders than the inner layer (CP4-5, Figs. 4 and 13, Table 1). The SEM pictures show a marbling appearance of the inner corrosion layer (CP5). Cl and S do not seem to be present in the sampled nail.

Fig. 13: Elemental chemical distribution of the selected area from Fig. 4 (90° counter-clockwise rotated). SEM-EDS,

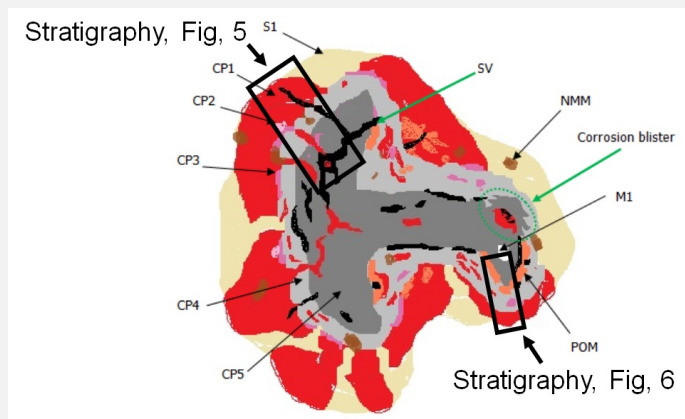
The schematic representation of corrosion layers of Fig. 3 integrating additional information based on the analyses carried out is given in Fig. 14. The following strata were identified:

Fig. 14: Improved stratigraphic representation of the nail from visual observations and analyses and visualization of the two stratigraphies of Figs. 5 and 6,
