# COFFEE FILTER – AL ALLOY – MODERN TIMES – FRANCE

**Artefact name** Coffee filter

**Authors** Christian. Degriigny (HE-Arc CR, Neuchâtel, Neuchâtel, Switzerland)

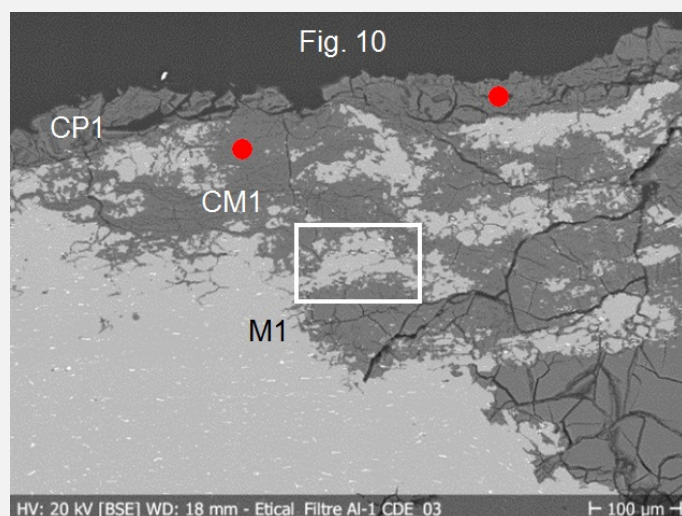
analysis indicates that the metal is, as expected, covered by a layer rich in Al and O containing chlorides (red spots on Fig. 9) and surprisingly Na (Figs. 10 and 11). Chlorides do not seem to form active corrosion. A new examination carried out after 4 months (Fig. 12) shows new forms of alteration with a local enrichment of Na, C and O (Na<sub>2</sub>CO<sub>3</sub>?).

Fig. 9: SEM picture (detail of Fig. 4 with location (red spots) of EDS analyses of Fig. 10), BSE-mode. From bottom to top left: the metal (M1) in light grey, the corroded metal (CM1) and CP1. The area selected for elemental chemical distributions (Figs. 11 and 12) is marked by a rectangle,

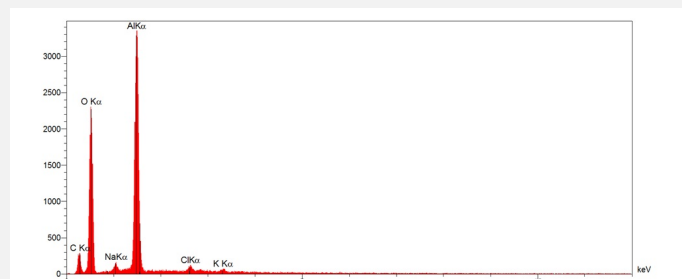
Fig. 10: EDS spectrum of red spots in Fig. 9,

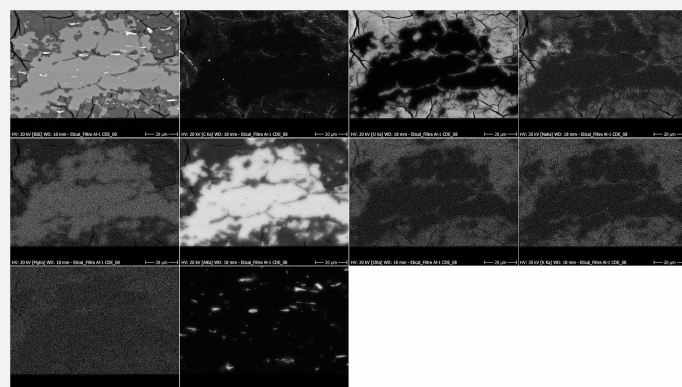
Fig. 11: SEM image, BSE-mode, and elemental chemical distribution of the selected area of Fig. 9. Method of examination: SEM-EDS, Lab of Electronic Microscopy and Microanalysis, IMA (Néode), HEI Arc,
