# TOWEL BAR – AL ALLOY – MODERN TIMES – FRANCE

<b>Artefact name</b>	Towel bar
<b>Authors</b>	Christian. Degriigny (HE-Arc CR, Neuchâtel, Neuchâtel, Switzerland)
<b>Url</b>	/artefacts/712/

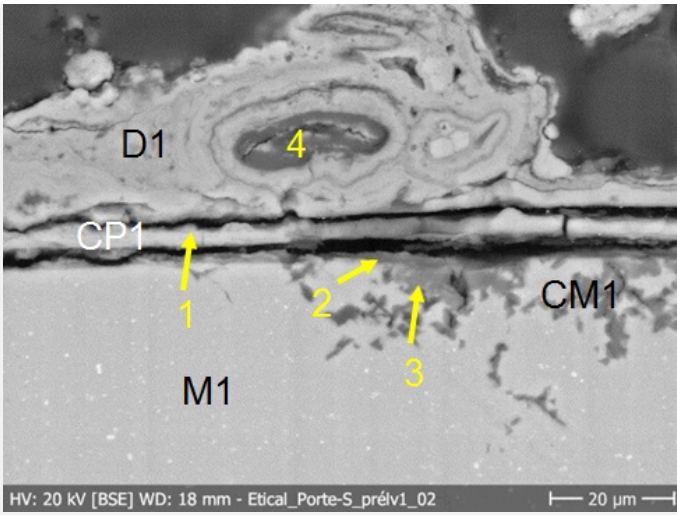
A very thin and loose oxide film has formed on the metal surface (CP1) and is locally covered by white deposits (D1). Intergranular corrosion has developed under the deposits (Fig. 7). EDS-SEM analysis indicates that the oxide layer rich in Al and O is contaminated with P and Si (area 1 on Fig. 7 and Fig. 8). These elements are even more present at the interface between CM1 and CP1 with Cl and S (area 2 on Fig. 7 and Fig. 9). The concentration of P and Si decreases in CM1 (area 3 on Fig. 7 and Fig. 10) while the concentration of S and Cl increases (Fig. 11). The deposit is mainly constituted of Ca, O, C and Si (probably CaCO<sub>3</sub> and SiO<sub>2</sub>, area 4 on Fig. 7 and Fig. 12).

Fig. 7: SEM picture with location of EDS analyses of areas 1 to 4), BSE-mode. From bottom to top: the metal (M1) in light grey, the corroded metal (CM1), CP1 and D1,

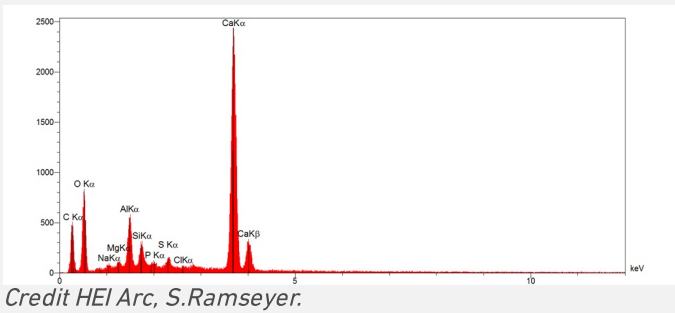
Fig. 8: EDS spectrum of area 1 of Fig. 7,

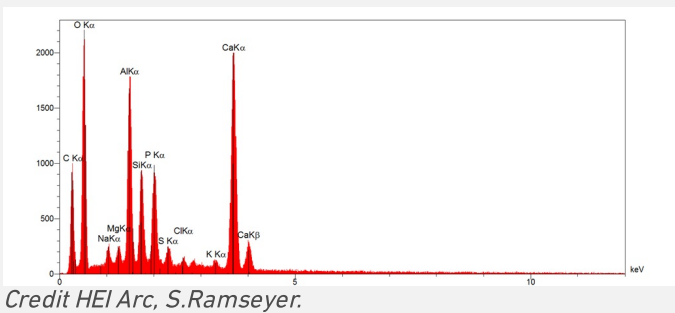
Fig. 9: EDS spectrum of area 2 of Fig. 7,

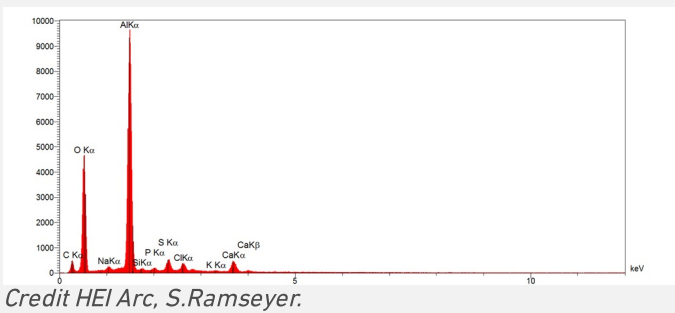
Fig. 10: EDS spectrum of area 3 of Fig. 7,

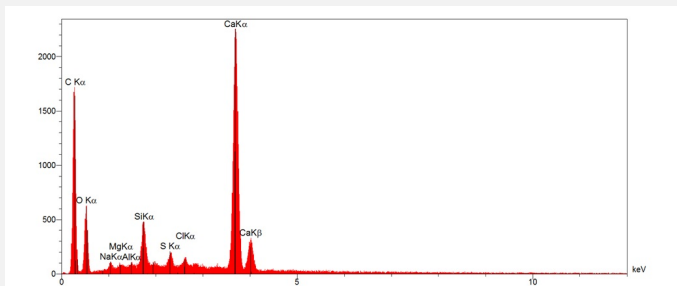
Fig. 12: EDS spectrum of area 4 of Fig. 7,

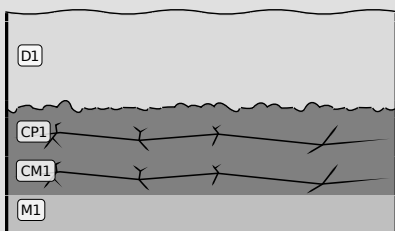
Fig. 4: Stratigraphic representation of the fragment sampled from the towel bar in cross-section (SEM-BSE) using the MiCorr application. The characteristics of the strata are only accessible by clicking on the drawing that redirects you to the search tool by stratigraphy representation. This representation can be compared to Fig. 7, Credit HE-Arc CR, C.Degrigny.
