TOWEL BAR – AL ALLOY – MODERN TIMES – FRANCE

Artefact name Towel bar

Authors Christian. Degriigny (HE-Arc CR, Neuchâtel, Neuchâtel, Switzerland)

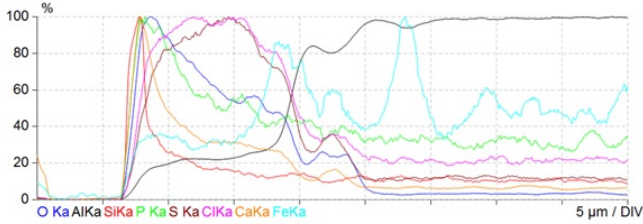
Fig. 11: EDS Linescan from CM1 to M1,

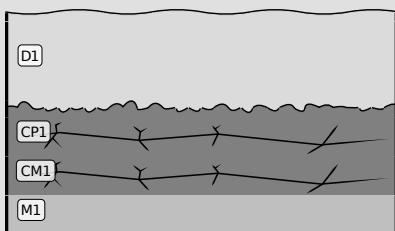
Fig. 4: Stratigraphic representation of the fragment sampled from the towel bar in cross-section (SEM-BSE) using the MiCorr application. The characteristics of the strata are only accessible by clicking on the drawing that redirects you to the search tool by stratigraphy representation. This representation can be compared to Fig. 7, Credit HE-Arc CR, C.Degrigny.
