TOWEL BAR - AL ALLOY - MODERN TIMES - FRANCE

Artefact name Towel bar

Authors Christian. Degrigny (HE-Arc CR, Neuchâtel, Neuchâtel, Switzerland)

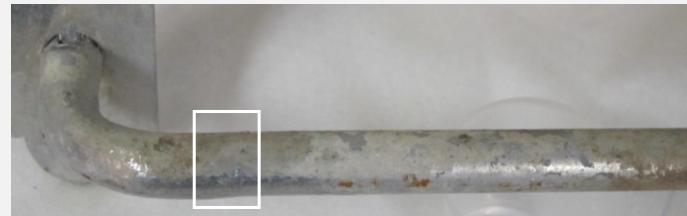
Fig. 2: Detail of the back side of the towel bar showing the location of the sampling area,

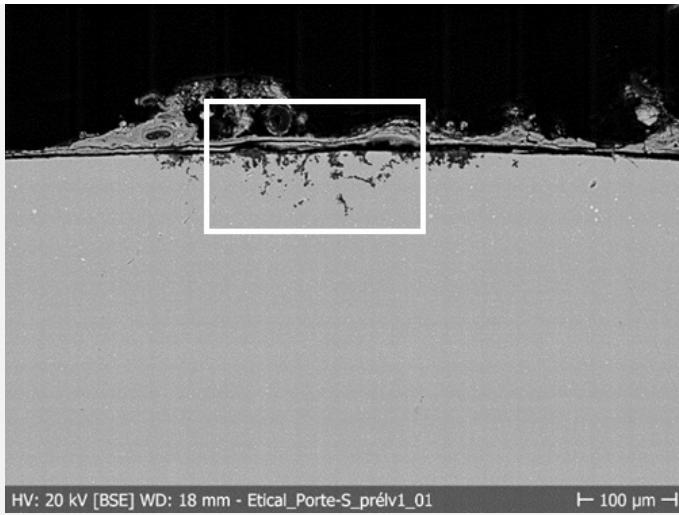
Fig. 3: SEM image of the cross-section of the fragment sampled from the towel bar showing the location of Fig. 5,

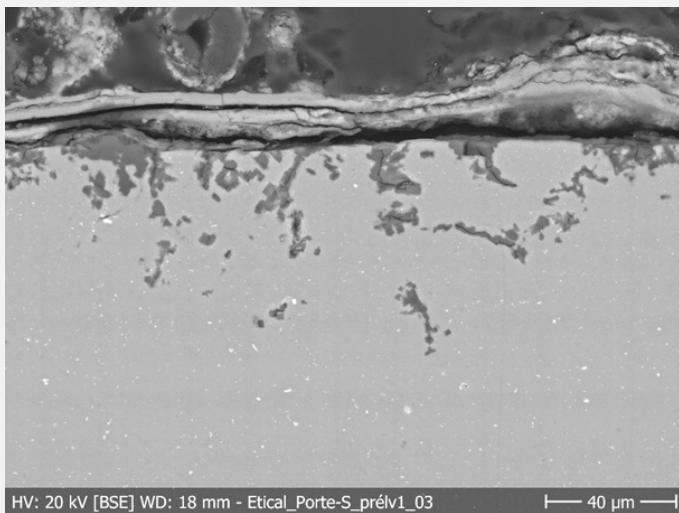
The metal is a relatively pure aluminium alloy with numerous inclusions (Fig. 5). From their chemical composition they can be interpreted as Al₃Fe intermetallic compounds (Fig. 6). Pitting corrosion as well as a start of intergranular corrosion developing locally under the deposits, outlining some of the grains (Fig. 5).

Fig. 5: SEM image of the metal sample from Fig. 3 (detail), BSE-mode. We observe the presence of numerous inclusions,

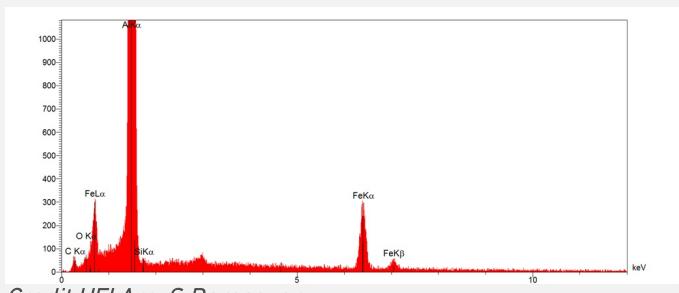
Fig. 6: EDS spectrum of the inclusions of Fig. 5,

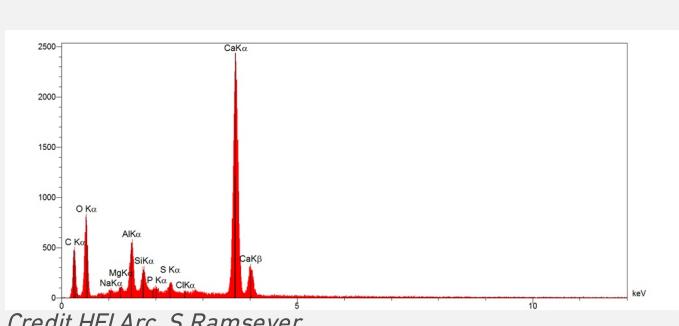
Fig. 8: EDS spectrum of area 1 of Fig. 7,

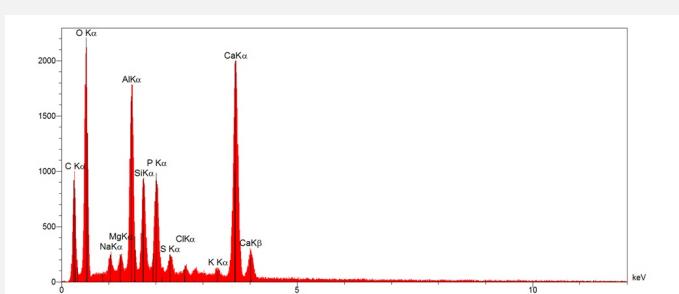
Fig. 9: EDS spectrum of area 2 of Fig. 7,

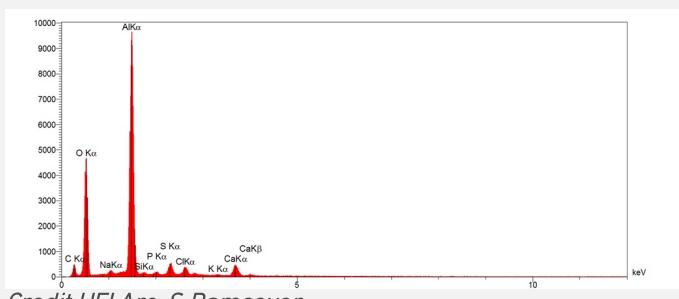
Fig. 10: EDS spectrum of area 3 of Fig. 7,

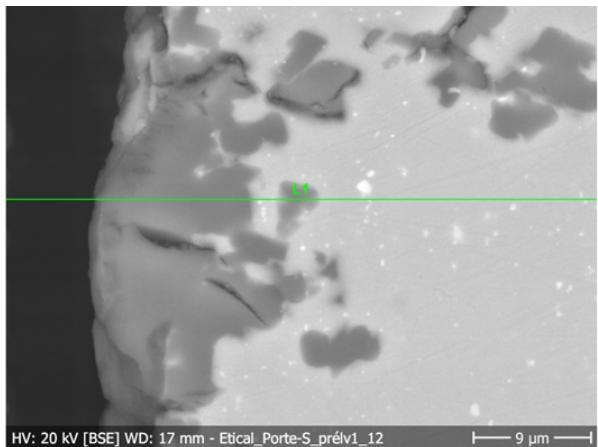
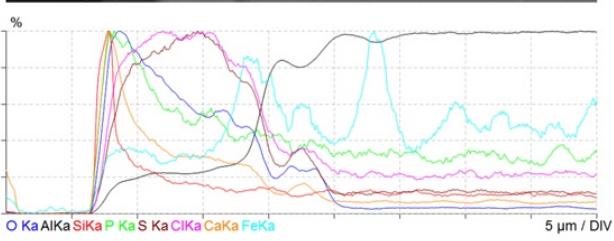
Fig. 11: EDS Linescan from CM1 to M1,

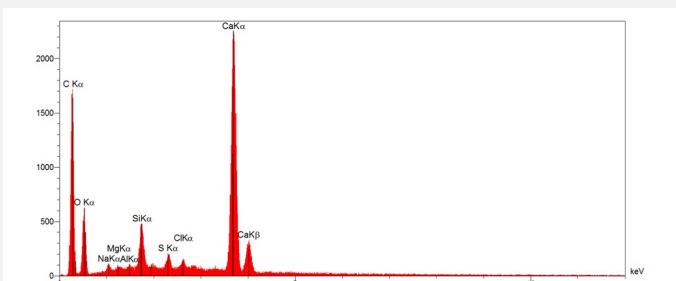
Fig. 12: EDS spectrum of area 4 of Fig. 7,

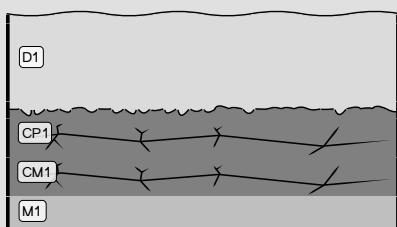
Fig. 4: Stratigraphic representation of the fragment sampled from the towel bar in cross-section (SEM-BSE) using the MiCorr application. The characteristics of the strata are only accessible by clicking on the drawing that redirects you to the search tool by stratigraphy representation. This representation can be compared to Fig. 7, Credit HE-Arc CR, C.Degrigny.
