TOWEL BAR – AL ALLOY – MODERN TIMES – FRANCE

Artefact name	Towel bar
Authors	Christian. Degriigny (HE-Arc CR, Neuchâtel, Neuchâtel, Switzerland)
Url	/artefacts/712/

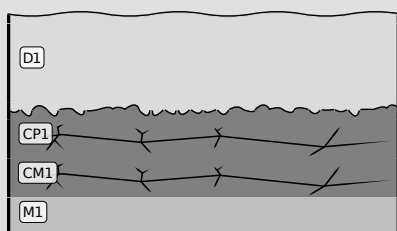
Fig. 4: Stratigraphic representation of the fragment sampled from the towel bar in cross-section (SEM-BSE) using the MiCorr application. The characteristics of the strata are only accessible by clicking on the drawing that redirects you to the search tool by stratigraphy representation. This representation can be compared to Fig. 7, Credit HE-Arc CR, C.Degrigny.
