## ROOF GUTTER ELEMENT – ZN ALLOY – MODERN TIMES – FRANCE

<b>Artefact name</b>	Roof gutter element
<b>Authors</b>	Christian. Degrigny (HE-Arc CR, Neuchâtel, Neuchâtel, Switzerland) & Mathea. Hovind (University of Oslo, Department of archaeology, conservation and history (IAKH-UiO), Oslo, Oslo, Norway)
<b>Url</b>	/artefacts/713/

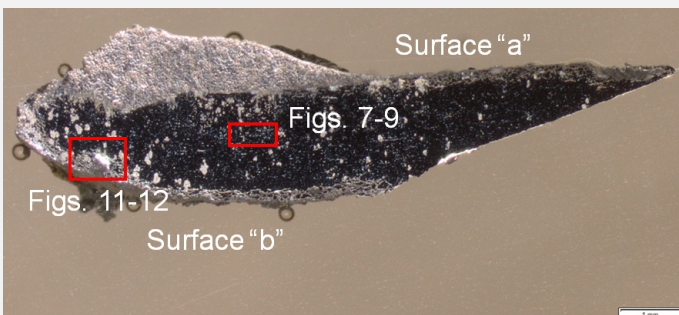
Fig. 4: Micrograph of the sample taken from the roof gutter showing the locations of Figs. 7-9 and 11-12. The uppermost area (in white) is remains of solder, while the zinc metal appears dark grey to black (the white patches are due to secondary oxidation of the sample),

A cross-section (Fig. 4) was cut out where the metal is at an angle of approximately 90° to the flat surface. Its upper edge corresponds to surface "a" and contains remains of solder, while the lower edge corresponds to surface "b".

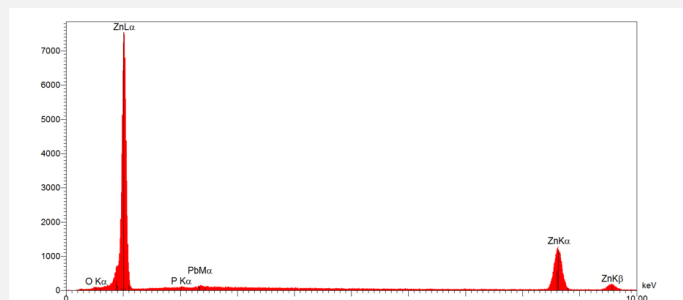
The roof gutter element is composed of Zn with P and Pb at lower concentrations (Fig. 6). The latter is probably originating from the solder that was applied to adjoin several metal sheets for the roof gutter.

Fig. 6: Chemical composition of the metal. Method of analysis: SEM-EDS. Lab. of Electronic Microscopy and Microanalysis, Néode, HEI Arc,

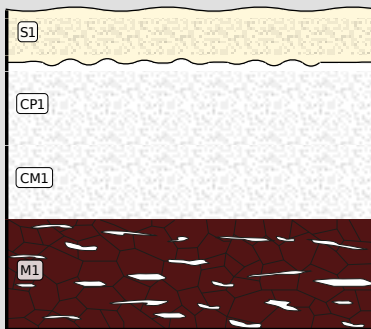
Fig. 5: Stratigraphic representation of the sample taken from the roof gutter (surface "b") in cross-section (dark field) using the MiCorr application. The characteristics of the strata are only accessible by clicking on the drawing that redirects you to the search tool by stratigraphy representation. This representation can be compared to Figs. 11 and 12, Credit UiO-IAKH, M.Hovind.
