ROOF GUTTER ELEMENT – ZN ALLOY – MODERN TIMES – FRANCE

Artefact name	Roof gutter element
Authors	Christian. Degriigny (HE-Arc CR, Neuchâtel, Neuchâtel, Switzerland) & Mathea. Hovind (University of Oslo, Department of archaeology, conservation and history (IAKH-UiO), Oslo, Oslo, Norway)
Url	/artefacts/713/

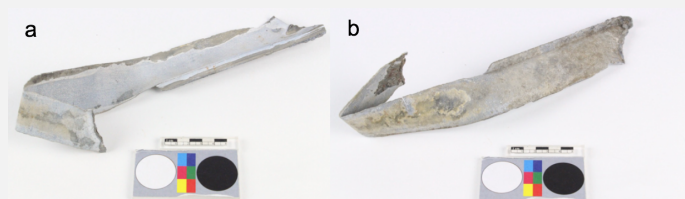
Fig. 1: Roof gutter element having different appearances on each of its surfaces: "a" on the left and "b" on the right,

Description of the artefact	A roof gutter element with remains of lead solder (Fig. 1). Its surfaces are covered by a white, strongly adherent oxide layer. Surface "b" is slightly darker in colour than surface "a" due to the presence of soil particles. Dimensions: L = 265mm; W = 47mm; T = 1mm; WT = 93g.
Type of artefact	Architectural element
Origin	Château de Germolles (14th century), Mellecey, Bourgogne, France
Recovering date	Unknown
Chronology category	Modern Times
chronology tpq	1900 A.D. ▼
chronology taq	2000 A.D. ▼
Chronology comment	19th-20th century
Burial conditions / environment	Outdoor atmosphere
Artefact location	Haute Ecole Arc Conservation-Restauration
Owner	Château de Germolles, Mellecey, Bourgogne
Inv. number	None
Recorded conservation data	Not conserved

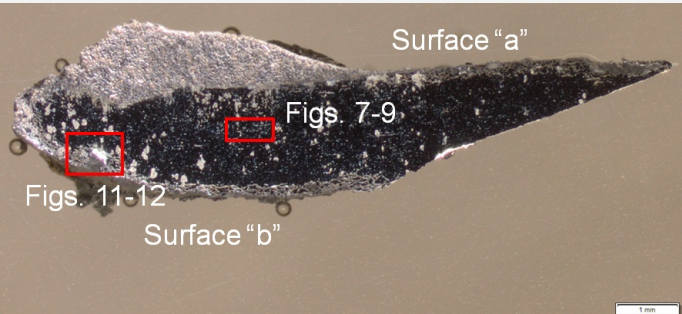
Fig. 4: Micrograph of the sample taken from the roof gutter showing the locations of Figs. 7-9 and 11-12. The uppermost area (in white) is remains of solder, while the zinc metal appears dark grey to black (the white patches are due to secondary oxidation of the sample),

A cross-section (Fig. 4) was cut out where the metal is at an angle of approximately 90° to the flat surface. Its upper edge corresponds to surface "a" and contains remains of solder, while the lower edge corresponds to surface "b".

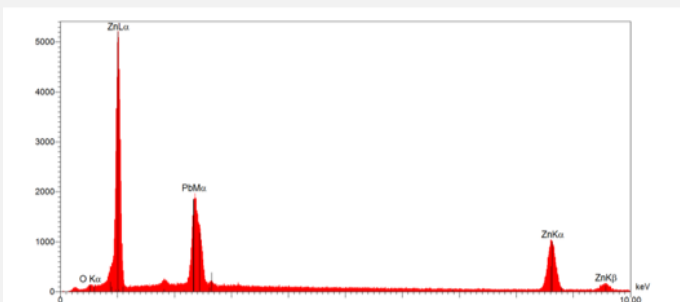
Fig. 10: SEM-EDS spectrum showing the composition of the elongated inclusions from Fig. 9. Method of analysis: SEM-EDS. Lab. of Electronic Microscopy and Microanalysis, Néode, HEI Arc,

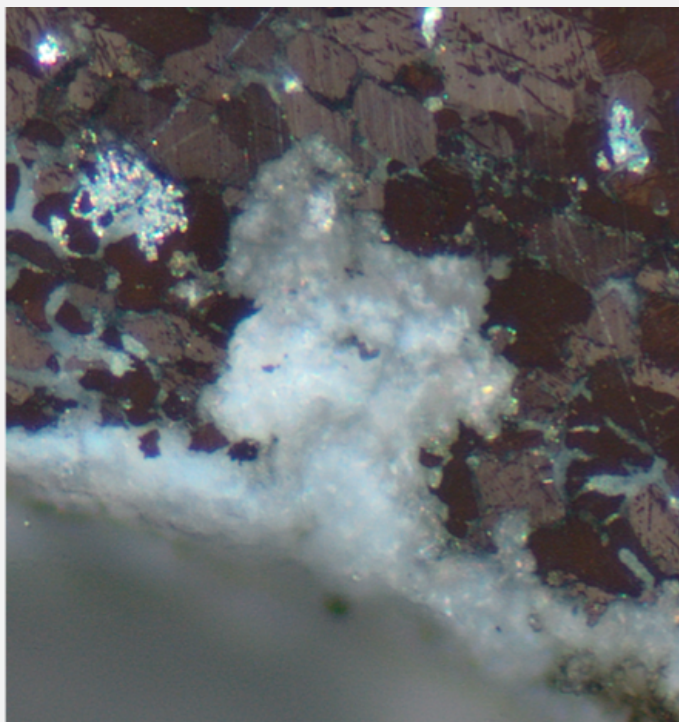
The metal is suffering from intergranular corrosion visible as a white corrosion product (CP1) located within crevices and along the grain boundaries (Figs. 11 and 12). Both the porous and powdery corrosion product (CP1) and the corroded metal (CM1) appear dark grey in bright field (Fig. 11) and white-grey under polarized light (Fig. 12). They both consist of Zn and O (Table 1). The external corrosion product (CP1) contains some S (and not Pb as suggested by Table 1 and Fig. 14) which is probably due to atmospheric pollution. The structural composition of the corrosion product was determined by crystallographic analysis (XRD) to consist of a mixture of zincite (ZnO) and pure zinc (Zn) (Table 2, Fig 13). Mapping of the corroded area by SEM-EDS displays a similar composition but shows additionally the presence of Cl in some of the veins of the corroded metal (Fig. 14). S1 (soil material) is found on the very top of CP1.

Fig. 12: Micrograph similar to Fig. 11 but under polarized light, the corrosion product (CP1) and the corroded metal (CM1) appear white,

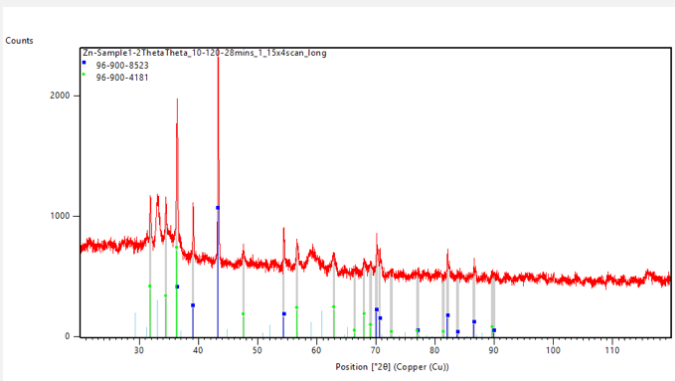
Table 2: Summary of the results from the crystallographic analysis of the white corrosion product (CP1). A representative spectrum is given in Fig. 13. Method of analysis: XRD. Center of X-ray Analytics, Empa-Swiss Federal Laboratories for Materials Science and Technology (Dübendorf), credit MiCorr_Empa, Z.Balogh-Michels. *The results are based on the analysis of two powder samples from different areas (see Fig. 2 for sample locations).

Fig. 13: XRD-spectrum for the analysis of powder sample 1. Ref. 96-900-8523 (in blue) corresponds to pure zinc and 96-900-4181 (in green) to zincite (ZnO),

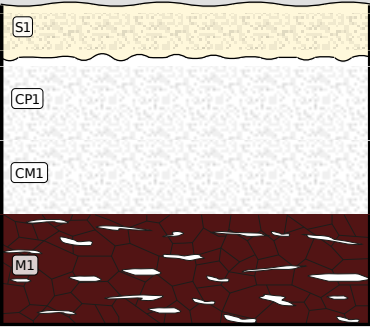
Fig. 5: Stratigraphic representation of the sample taken from the roof gutter (surface "b") in cross-section (dark field) using the MiCorr application. The characteristics of the strata are only accessible by clicking on the drawing that redirects you to the search tool by stratigraphy representation. This representation can be compared to Figs. 11 and 12, Credit UiO-IAKH, M.Hovind.
