ROOF GUTTER ELEMENT – ZN ALLOY – MODERN TIMES – FRANCE

Artefact name Roof gutter element

Authors Christian. Degrigny (HE-Arc CR, Neuchâtel, Neuchâtel, Switzerland) & Mathea. Hovind (University of Oslo, Department of archaeology, conservation and history (IAKH-UiO), Oslo, Oslo, Norway)

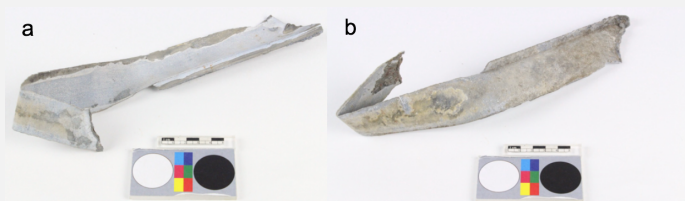
Fig. 1: Roof gutter element having different appearances on each of its surfaces: "a" on the left and "b" on the right,

Description of the artefact	A roof gutter element with remains of lead solder (Fig. 1). Its surfaces are covered by a white, strongly adherent oxide layer. Surface "b" is slightly darker in colour than surface "a" due to the presence of soil particles. Dimensions: L = 265mm; W = 47mm; T = 1mm; WT = 93g.
Type of artefact	Architectural element
Origin	Château de Germolles, Mellecey, Bourgogne, France
Recovering date	Unknown
Chronology category	Modern Times
chronology tpq	<input type="text" value="1900"/> A.D. ▼
chronology taq	<input type="text" value="2000"/> A.D. ▼
Chronology comment	19th-20th century
Burial conditions / environment	Outdoor atmosphere
Artefact location	Haute Ecole Arc Conservation-Restauration
Owner	Château de Germolles, Mellecey, Bourgogne
Inv. number	None
Recorded conservation data	Not conserved

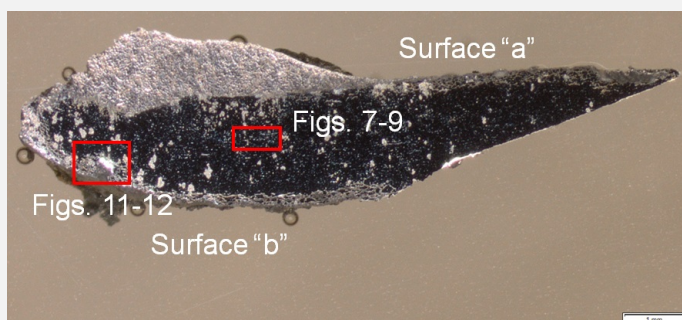
Fig. 4: Micrograph of the sample taken from the roof gutter showing the locations of Figs. 7-9 and 11-12. The uppermost area (in white) is remains of solder, while the zinc metal appears dark grey to black (the white patches are due to secondary oxidation of the sample),

A cross-section (Fig. 4) was cut out where the metal is at an angle of approximately 90° to the flat surface. Its upper edge corresponds to surface "a" and contains remains of solder, while the lower edge corresponds to surface "b".

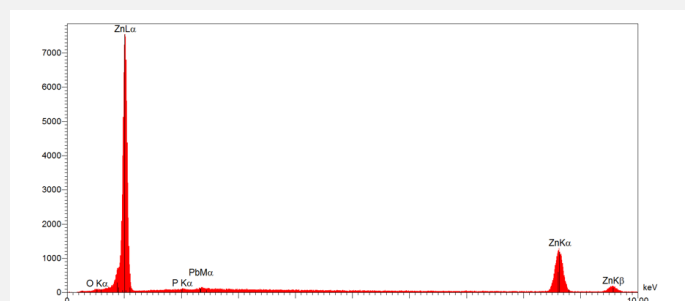
The roof gutter element is composed of Zn with P and Pb at lower concentrations (Fig. 6). The latter is probably originating from the solder that was applied to adjoin several metal sheets for the roof gutter.

Fig. 6: Chemical composition of the metal. Method of analysis: SEM-EDS. Lab. of Electronic Microscopy and Microanalysis, Néode, HEI Arc,
