ROOF GUTTER ELEMENT – ZN ALLOY – MODERN TIMES – FRANCE

Artefact name Roof gutter element

Authors Christian. Degrigny (HE-Arc CR, Neuchâtel, Neuchâtel, Switzerland) & Mathea. Hovind (University of Oslo, Department of archaeology, conservation and history (IAKH-UiO), Oslo, Oslo, Norway)

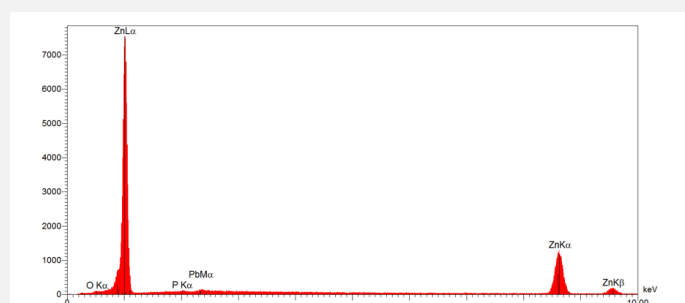
The roof gutter element is composed of Zn with P and Pb at lower concentrations (Fig. 6). The latter is probably originating from the solder that was applied to adjoin several metal sheets for the roof gutter.

Fig. 6: Chemical composition of the metal. Method of analysis: SEM-EDS. Lab. of Electronic Microscopy and Microanalysis, Néode, HEI Arc,

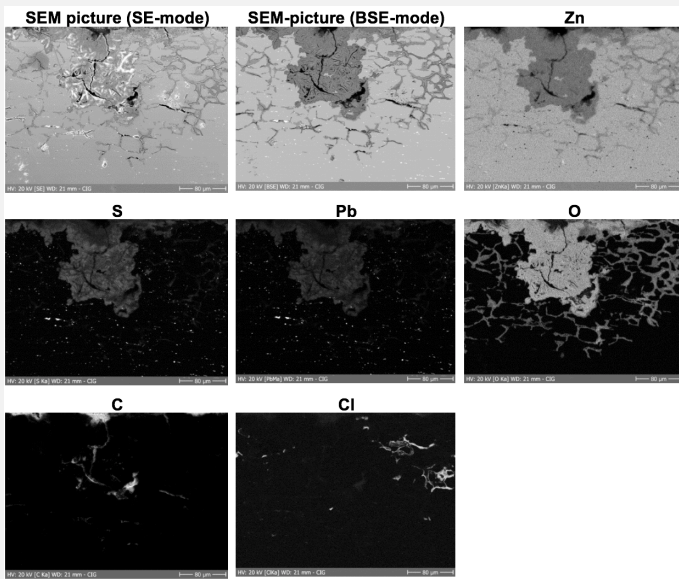
Fig. 14: SEM image and elemental chemical distribution of a selected area of Fig. 11 (rotated almost 180° and reversed). Method of analysis: SEM-EDS. Lab. of Electronic Microscopy and Microanalysis, Néode, HEI Arc,

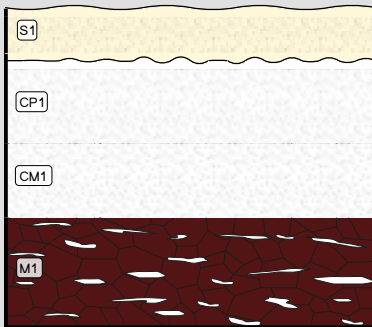
Fig. 5: Stratigraphic representation of the sample taken from the roof gutter (surface "b") in cross-section (dark field) using the MiCorr application. The characteristics of the strata are only accessible by clicking on the drawing that redirects you to the search tool by stratigraphy representation. This representation can be compared to Figs. 11 and 12, Credit UiO-IAKH, M.Hovind.
