ROOF GUTTER ELEMENT – ZN ALLOY – MODERN TIMES – FRANCE

Artefact name	Roof gutter element
Authors	Christian. Degrigny (HE-Arc CR, Neuchâtel, Neuchâtel, Switzerland) & Mathea. Hovind (University of Oslo, Department of archaeology, conservation and history (IAKH-UiO), Oslo, Oslo, Norway)
Url	/artefacts/713/

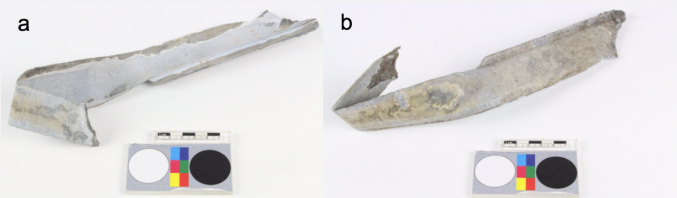
Fig. 1: Roof gutter element having different appearances on each of its surfaces: "a" on the left and "b" on the right,

Description of the artefact	A roof gutter element with remains of lead solder (Fig. 1). Its surfaces are covered by a white, strongly adherent oxide layer. Surface "b" is slightly darker in colour than surface "a" due to the presence of soil particles. Dimensions: L = 265mm; W = 47mm; T = 1mm; WT = 93g.
Type of artefact	Architectural element
Origin	Château de Germolles (14th century), Mellecey, Bourgogne, France
Recovering date	Unknown
Chronology category	Modern Times
chronology tpq	1900 A.D. ▼
chronology taq	2000 A.D. ▼
Chronology comment	19th-20th century
Burial conditions / environment	Outdoor atmosphere
Artefact location	Haute Ecole Arc Conservation-Restauration
Owner	Château de Germolles, Mellecey, Bourgogne
Inv. number	None
Recorded conservation data	Not conserved

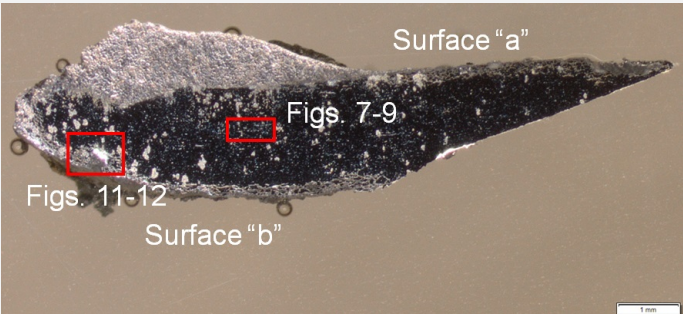
Fig. 4: Micrograph of the sample taken from the roof gutter showing the locations of Figs. 7-9 and 11-12. The uppermost area (in white) is remains of solder, while the zinc metal appears dark grey to black (the white patches are due to secondary oxidation of the sample),

A cross-section (Fig. 4) was cut out where the metal is at an angle of approximately 90° to the flat surface. Its upper edge corresponds to surface "a" and contains remains of solder, while the lower edge corresponds to surface "b".

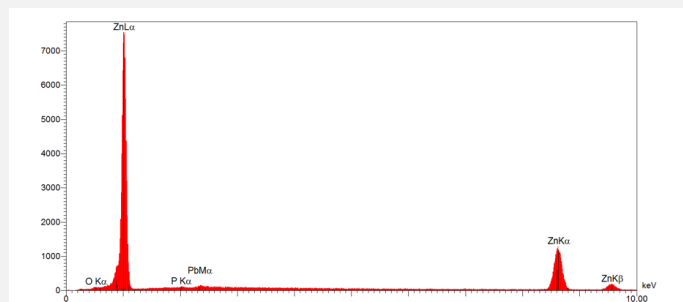
The roof gutter element is composed of Zn with P and Pb at lower concentrations (Fig. 6). The latter is probably originating from the solder that was applied to adjoin several metal sheets for the roof gutter.

Fig. 6: Chemical composition of the metal. Method of analysis: SEM-EDS. Lab. of Electronic Microscopy and Microanalysis, Néode, HEI Arc,

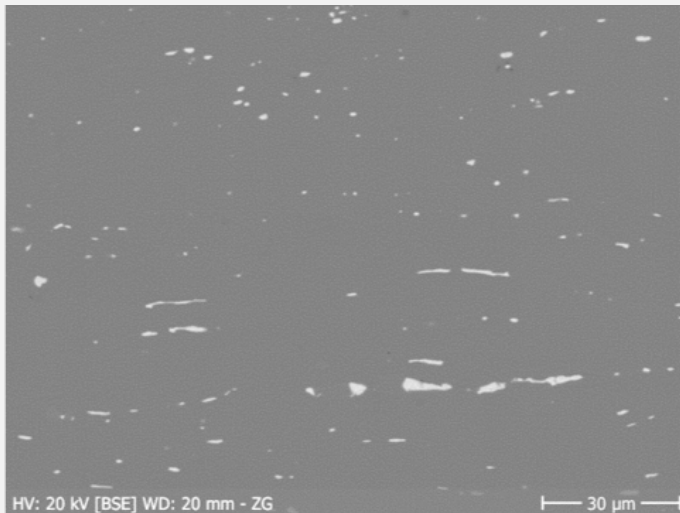
The metal appears white to light grey under bright field (Fig. 7). Under polarized light however (Fig. 8), the microstructure of the metal is visible as small polygonal grains appearing in various shades of brown, a coloured effect due to the anisotropic properties of the metal (Scott 1991: 49). In the SEM-image, white elongated inclusions are visible (Fig. 9) consisting mainly of Zn and Pb with some O (Fig. 10).

Fig. 9: SEM-image (BSE-mode) of the metal sample from Fig. 4 (detail) showing the white elongated inclusions,

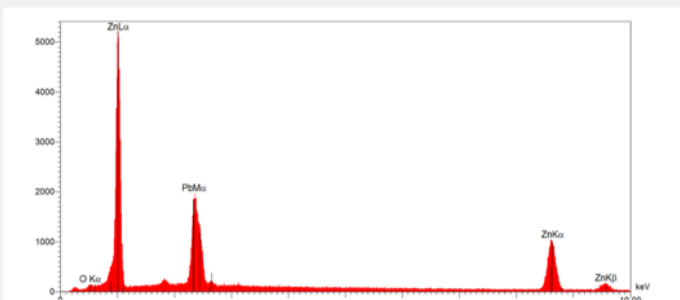
Fig. 10: SEM-EDS spectrum showing the composition of the elongated inclusions from Fig. 9. Method of analysis: SEM-EDS. Lab. of Electronic Microscopy and Microanalysis, Néode, HEI Arc,

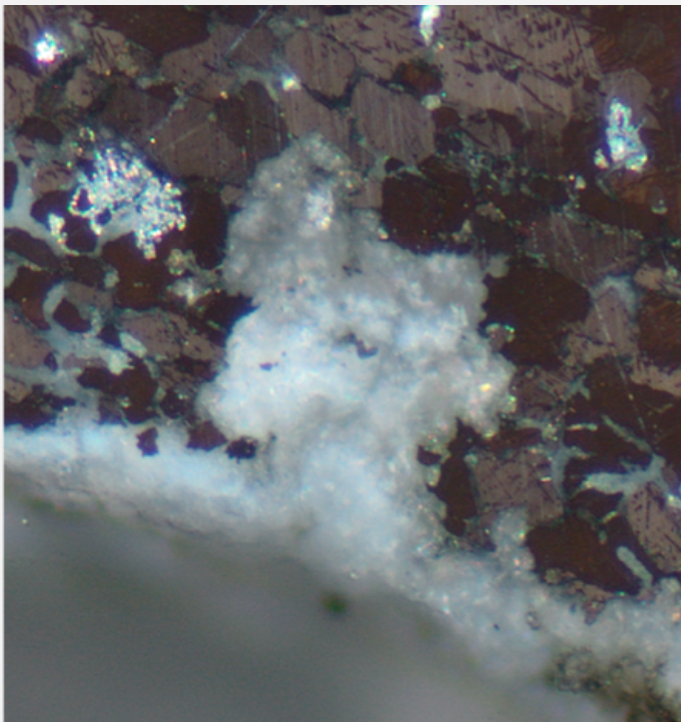
The metal is suffering from intergranular corrosion visible as a white corrosion product (CP1) located within crevices and along the grain boundaries (Figs. 11 and 12). Both the porous and powdery corrosion product (CP1) and the corroded metal (CM1) appear dark grey in bright field (Fig. 11) and white-grey under polarized light (Fig. 12). They both consist of Zn and O (Table 1). The external corrosion product (CP1) contains some S (and not Pb as suggested by Table 1 and Fig. 14) which is probably due to atmospheric pollution. The structural composition of the corrosion product was determined by crystallographic analysis (XRD) to consist of a mixture of zincite (ZnO) and pure zinc (Zn) (Table 2, Fig 13). Mapping of the corroded area by SEM-EDS displays a similar composition but shows additionally the presence of Cl in some of the veins of the corroded metal (Fig. 14). S1 (soil material) is found on the very top of CP1.

Fig. 12: Micrograph similar to Fig. 11 but under polarized light, the corrosion product (CP1) and the corroded metal (CM1) appear white,

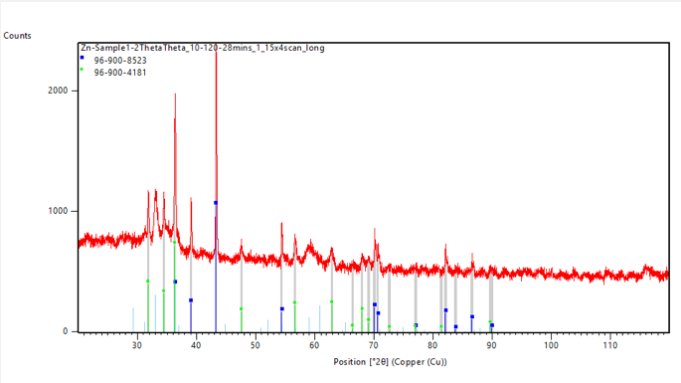
Stratum	Components*
CP1	Zincite (ZnO), Zinc (Zn)

Fig. 13: XRD-spectrum for the analysis of powder sample 1. Ref. 96-900-8523 (in blue) corresponds to pure zinc and 96-900-4181 (in green) to zincite (ZnO),

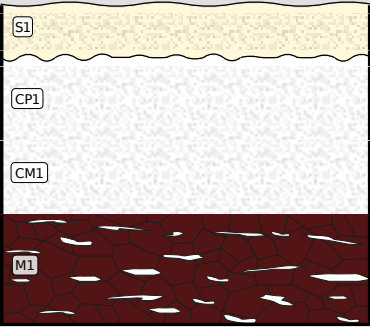
Fig. 5: Stratigraphic representation of the sample taken from the roof gutter (surface "b") in cross-section (dark field) using the MiCorr application. The characteristics of the strata are only accessible by clicking on the drawing that redirects you to the search tool by stratigraphy representation. This representation can be compared to Figs. 11 and 12, Credit UiO-IAKH, M.Hovind.
