# DOMED CAP NUT – ZN AL SN CU ALLOY – MODERN TIMES – FRANCE

<b>Artefact name</b>	Domed cap nut
<b>Authors</b>	Christian. Degriigny (HE-Arc CR, Neuchâtel, Neuchâtel, Switzerland) & Mathea. Hovind (University of Oslo, Department of archaeology, conservation and history (IAKH-UiO), Oslo, Oslo, Norway)
<b>Url</b>	/artefacts/714/

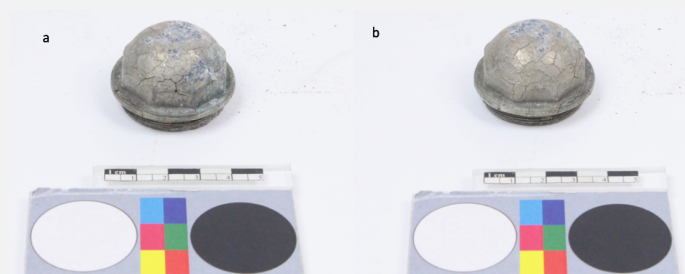
Fig. 1: Octogonal domed cap nut. Profile "a" and "b", to the left and right, respectively,

<b>Description of the artefact</b>	A domed cap nut made of a cast alloy with a metallic plating (Fig. 1). Its shape is octagonal and the inside is hollow. The plating is heavily cracked, leading to surface flaking. The metal appears to be consumed by some kind of internal corrosion. Dimensions: L (∅) = 40mm; H = 28mm; T = 5mm; WT = 49g.
<b>Type of artefact</b>	Cap
<b>Origin</b>	Château de Germolles (14th century), Mellecey, Bourgogne, France
<b>Recovering date</b>	Date unknown
<b>Chronology category</b>	Modern Times
<b>chronology tpq</b>	<input type="text" value="1900"/> A.D. ∨
<b>chronology taq</b>	<input type="text" value="2000"/> A.D. ∨
<b>Chronology comment</b>	19th - 20th century
<b>Burial conditions / environment</b>	Outdoor atmosphere
<b>Artefact location</b>	Haute Ecole Arc Conservation-Restauration
<b>Owner</b>	Château de Germolles, Mellecey, Bourgogne

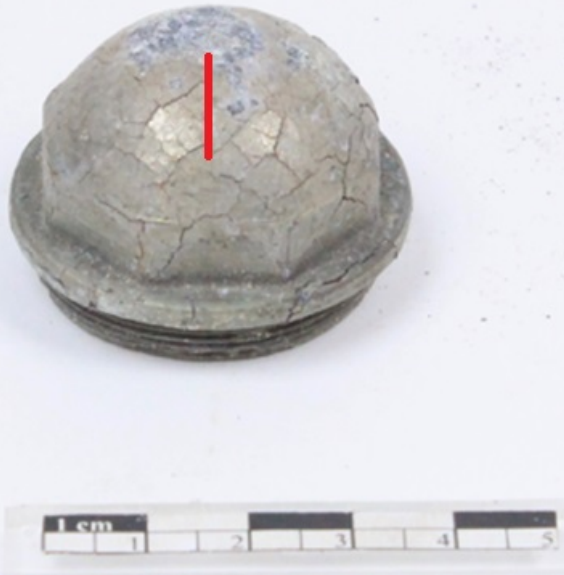
Fig. 2: Zone of the artefact submitted to visual observation and location of sampling area (a cross-section of the metal marked by the red line),

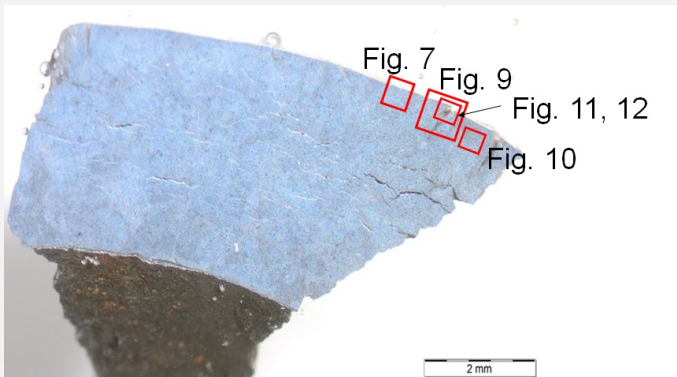
Fig. 4: Micrograph of the cross-section of the sample taken from the domed cap nut showing the locations of Figs. 7 and 9-12,

<b>Description of sample</b>	The sample is a cross section of the metal, representative of the domed cap nut. It shows external cracks extending from the metal surface and into its structure in addition to internal cracks, visible as thin lines along its longitudinal axis (Fig. 4).
<b>Alloy</b>	Zn Al Sn Cu Alloy
<b>Technology</b>	None
<b>Lab number of sample</b>	NZC2018 (Ni/Zn Cap, sampled in 2018)
<b>Sample location</b>	HE-Arc CR, Neuchâtel, Neuchâtel
<b>Responsible institution</b>	Haute Ecole Arc Conservation-Restauration
<b>Date and aim of sampling</b>	March 2018, study of corrosion stratigraphy and chemical analyses

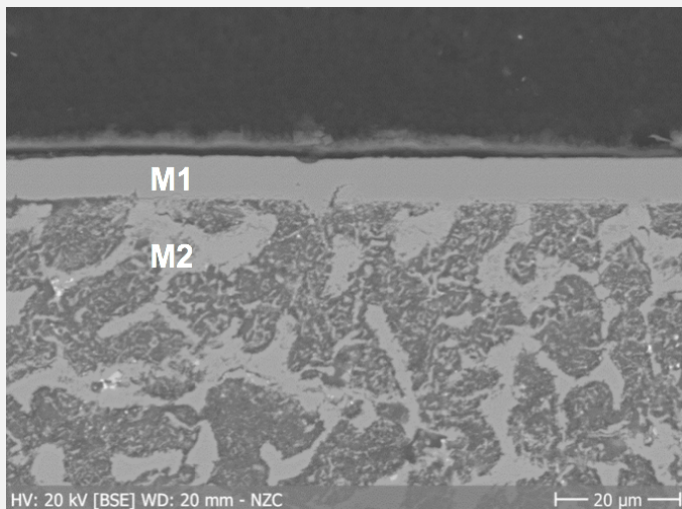
The metal of the domed cap nut (M2) consists of a Zn/Al/Pb/Cu/Sn alloy (Table 1) externally covered by a nickel-based plating (M1) (Figs. 7 and 8) containing some cobalt (Co). The bulk metal (M2) has a dendritic microstructure appearing light grey in bright field, while the interdendritic phase appears white (Fig. 9). The latter is Zn-rich, while the dendritic phase consists of approximately equal amounts of Zn and Al (Table 2, Fig. 11). Observation in SEM (BSE-mode) reveals the presence of Pb-nodules, visible as white irregular spots with a scattered distribution, in addition to opaque grey patches which are rich in Al and Fe (Fig. 10).

Fig. 7: SEM-image (BSE-mode) of a selected area from Fig. 4 (detail), showing the metal plating (M1) and the bulk metal (M2),

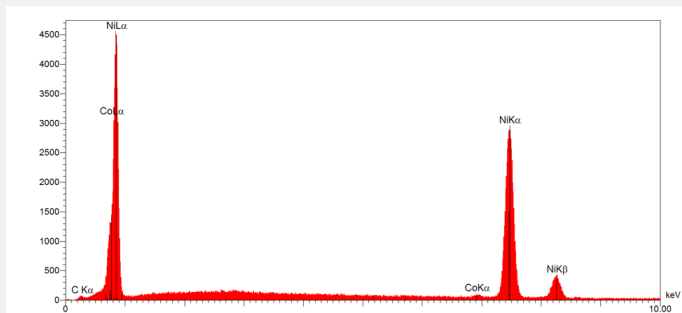
Fig. 8: EDS-spectrum showing the chemical composition of the metal plating (M1). Method of analysis: SEM-EDS. Lab. of Electronic Microscopy and and Microanalysis, Néode, HEI Arc,

The domed cap nut is nickel plated (6-7 micrometers).

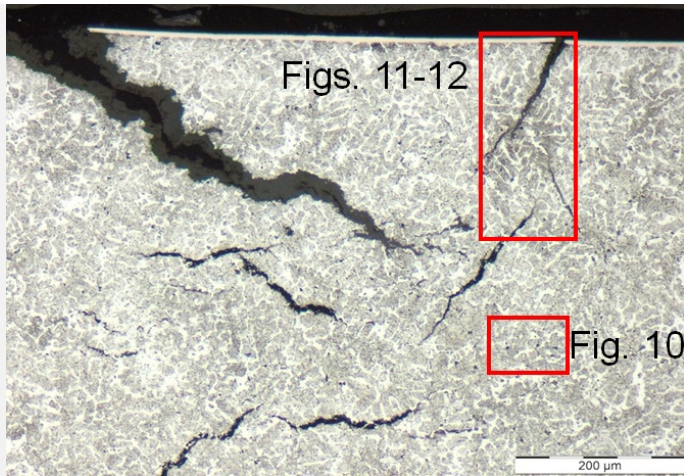
Fig. 9: Micrograph of the metal sample from Fig. 4 (detail), unetched, bright field. The dendrites appear light to dark grey while the interdendritic phase appears white. The metal is characterized by surface cracks as well as internal cracks. The lower red rectangle corresponds to Fig. 10 while the areas

selected for elemental chemical distributions (Figs. 11 and 12) are marked by the upper red rectangle,

The dendritic phase is heavily oxidized compared to the interdentritic phase (Table 2 and Fig. 12). The corrosion has developed throughout the entire metal body, generating cracks (Fig. 9). The cracks are Zn and O-rich (Fig. 12) and could be composed of zinc carbonate. It could be a case of zinc pest, an intergranular corrosion phenomenon known to cause disintegration in poor quality alloys (Selwyn 2004, Zhang 2011).

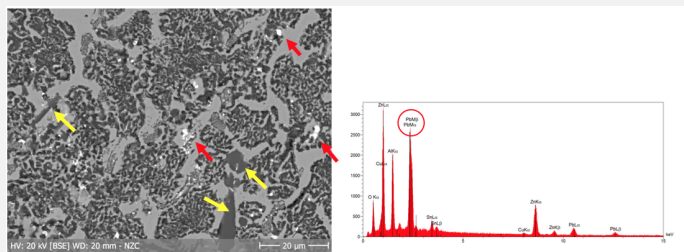
Fig. 10: SEM-image in BSE-mode (left) and EDS-spectrum (right), showing the appearance and the chemical composition of the Pb inclusions (red arrows). The inclusions appear white, the dendrites appear dark grey/black and the interdentritic phase appears grey. Grey opaque patches (yellow arrows) are Fe- and Al-rich phases,

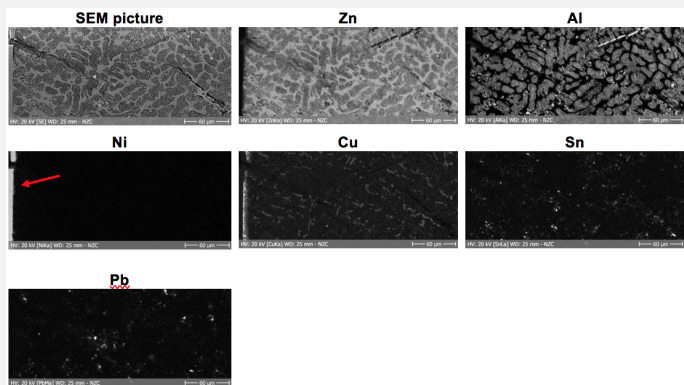
Fig. 11: SEM image and elemental chemical distribution of the selected area from Fig. 9 (rotated 270° and inverted). Method of analysis: SEM-EDS. Lab. of Electronic Microscopy and Microanalysis, Néode, HEI Arc,

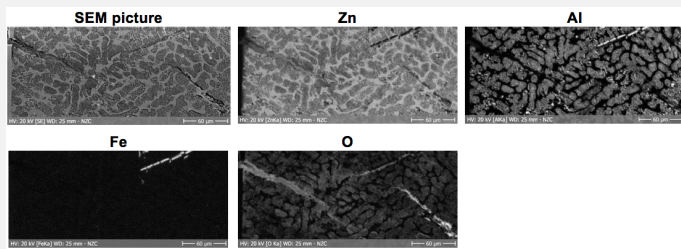
Fig. 12: SEM image and elemental chemical distribution of the selected area from Fig. 9 (rotated 270° and inversed). Method of analysis: SEM-EDS. Lab. of Electronic Microscopy and Microanalysis, Néode, HEI Arc,

The domed cap nut is made of nickel plated Zn/Al/Pb/Cu/Sn alloy. It has a dendritic microstructure, indicative of production by casting (probably a die cast). The deterioration of the metal could be due to absence of cohesion between the different phases which enabled the penetration of oxygen during the manufacture of the alloy and the formation of internal corrosion products, eventually leading to expansion of its internal structure (zinc pest).

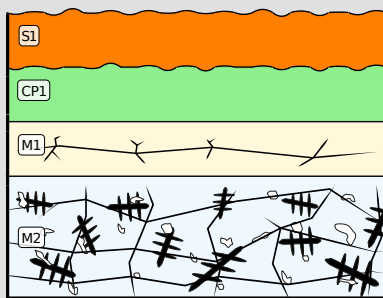
Fig. 5: Stratigraphic representation of the sample taken from the domed cap nut in cross-section (dark field) using the MiCorr application. The characteristics of the strata are only accessible by clicking on the drawing that redirects you to the search tool by stratigraphy representation. Stratigraphy representative of an area with intact metal plating (M1). S1 represents Fe-polluted soil while CP1 is a green translucent corrosion product, Credit UiO-IAKH, M.Hovind.
